CASE STUDY PROTECTING A CHURCH FROM FUTURE SUBSIDENCE

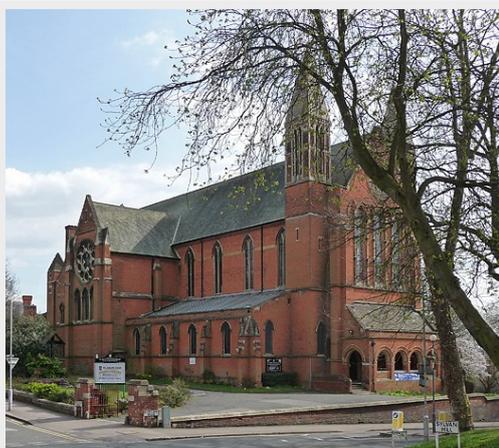
1 Trees around the church have played a role in shifting the underlying clay soil.

Cracks at St Johns have been monitored closely from the turn of the millennium for signs of serious subsidence. For the last 15 years they have progressively worsened at least partially caused by mature trees which had self seeded in the previous century. Annually the south side of the building was rotating down and out, and would then retreating slightly in winter, but each year that it was happening, the movement continued to worsen. The QI report for the church identified it as a high priority concern, the architect predicting that there would be a significant structural failure in the next 24 months. This led the church to begin exploring options to secure the wall and ensure the structural integrity of the building.

The major two stages of the work that were crucial to securing the south side of the church were the underpinning of the south wall and removal of several trees that were exacerbating soil movement. Whilst this work was underway, the community was still able to use the building, and indeed the progress of the work became a central point of interest that drew in local residents to the church building, some for the first time.

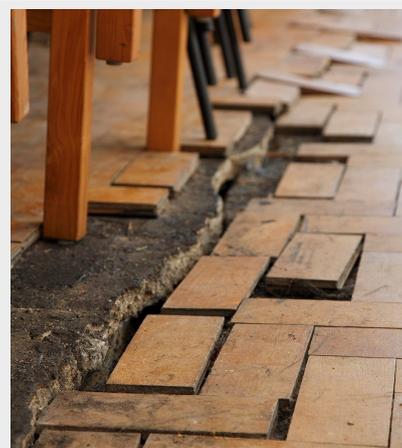
3 Cracking was visible throughout the building (Credit—James Balston)
