Annex B

Church Buildings Council
Church House, Great Smith Street, London SW1P 3AZ

PM: 2259

Pastoral Measure Report: Astwood, St Peter Diocese: Oxford Dedication: St Peter Listing: II* NGR: SP 950 473

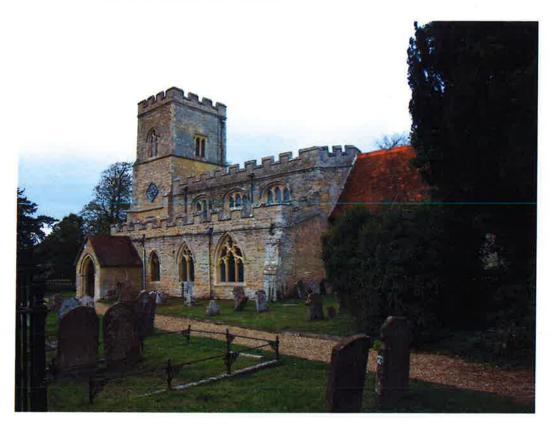
The church seen from the south-east

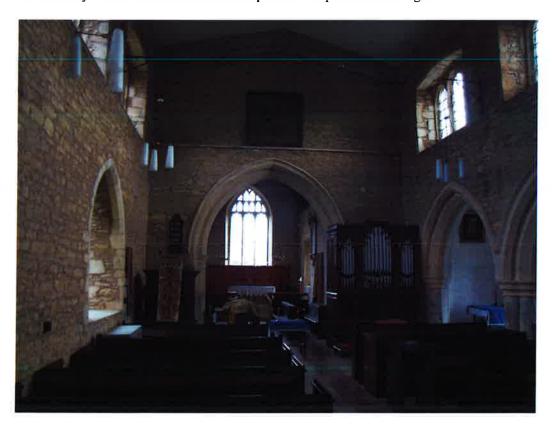
The church interior looking east
