**THE CHURCH OF  
ST. GEORGE THE MARTYR  
BOROUGH  
SOUTHWARK**

**AN APPRAISAL OF THE BELL FRAME**

**Compiled by Dr. John C. Eisel *FSA*.**

**NOVEMBER 2011**

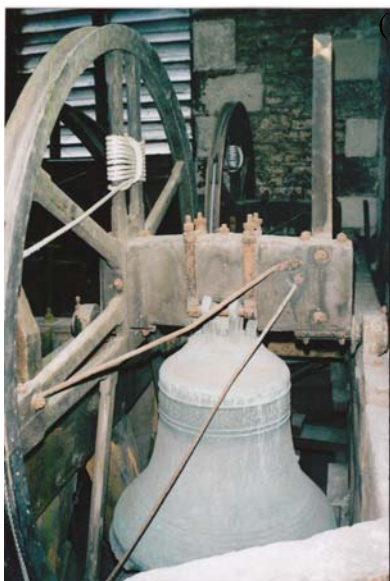
**(Left) Typical ironwork supporting the second bell, viewed from the north.**

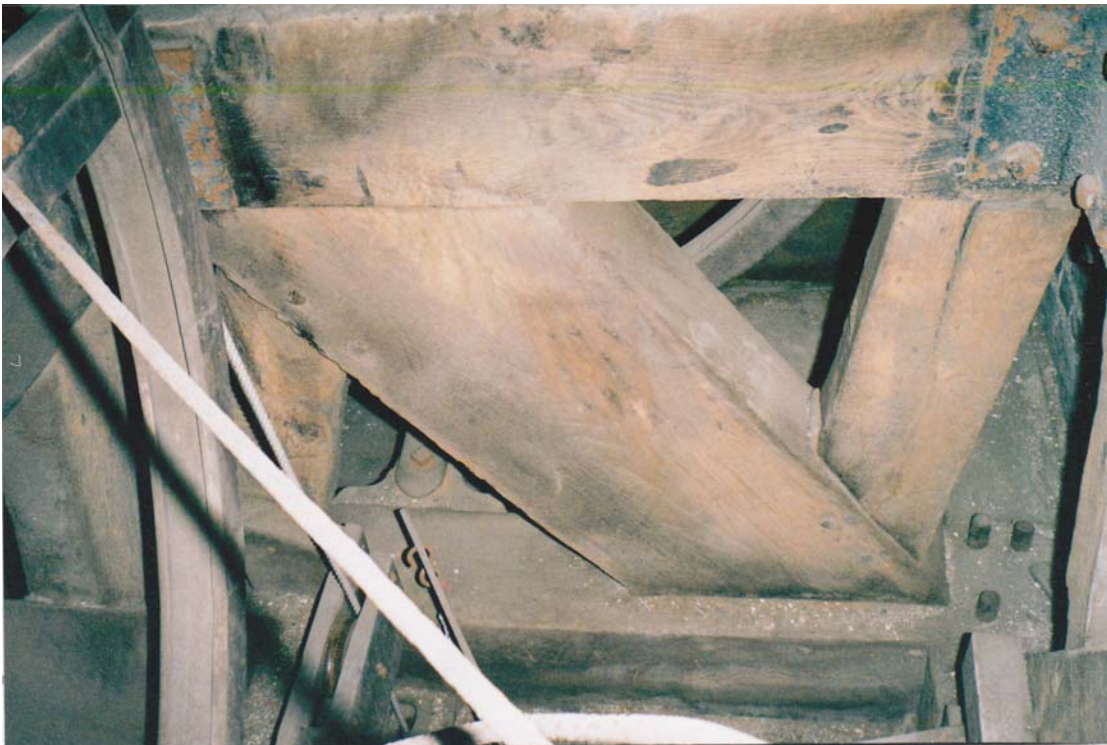
**Typical use of a double jack-brace, on a massive brace at the south-west corner of the pit for the sixth bell.**
