THE CHURCH OF ST. GEORGE THE MARTYR BOROUGH SOUTHWARK

A LEVEL 2 RECORD OF THE BELL FRAME

December 2011

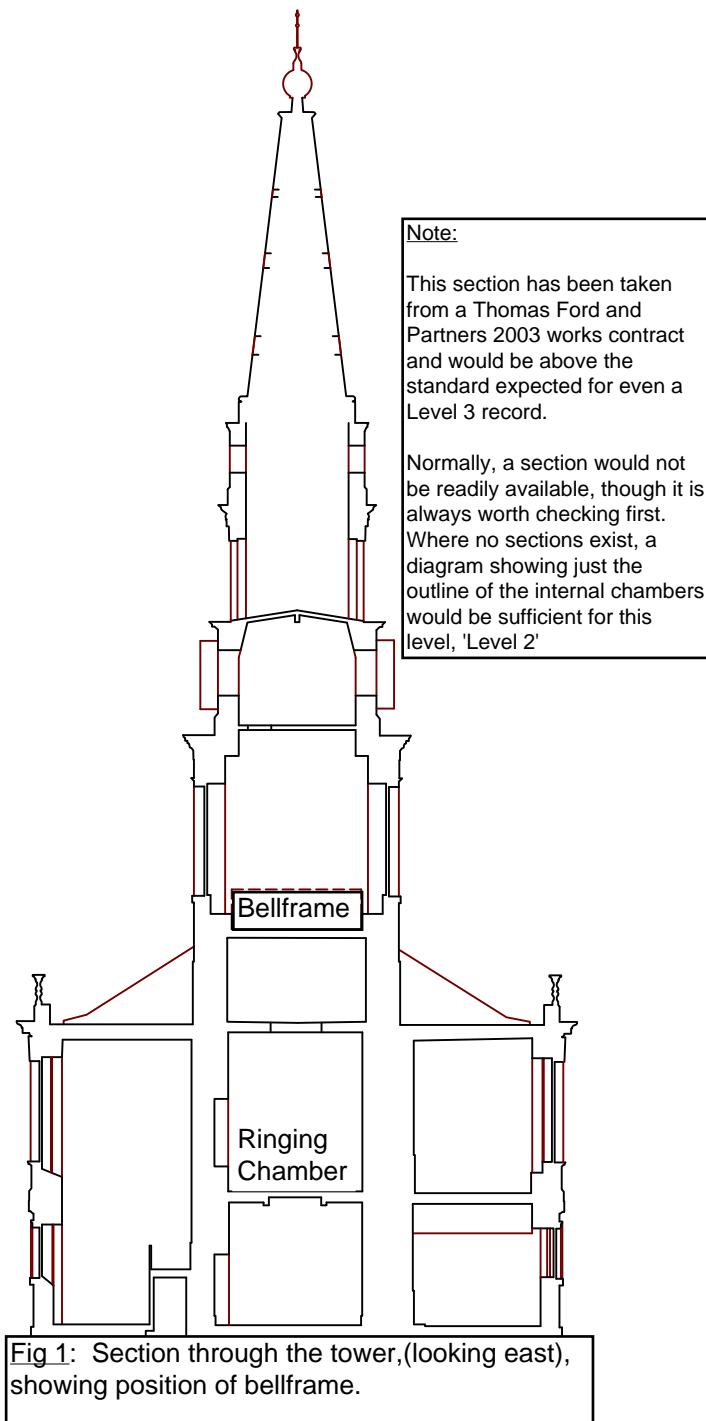
The Church of St. George the Martyr, Borough, Southwark.

The tower is placed at the west end of the church (Plate 1 & Fig. 1), and is clasped by both the north and south aisles, so that the ends of the aisles and the lower part of the tower form a single composition, with a pillared portico surrounding the west doorway and completed by a balustrade around the tops of the ends of the aisles. Externally the tower, which projects above the façade, is clad in Portland stone, but the core is made of

Access to the clock room in the lower octagonal stage, is, as mentioned above, via a ladder which rests on the frame-heads just inside the entrance to the belfry. (Figs. 1 & 2) In the centre of the floor is a wooden clock case, which now houses only the electric motor which drives the motion work for the hands on the external dials. One clock weight lies on the floor.

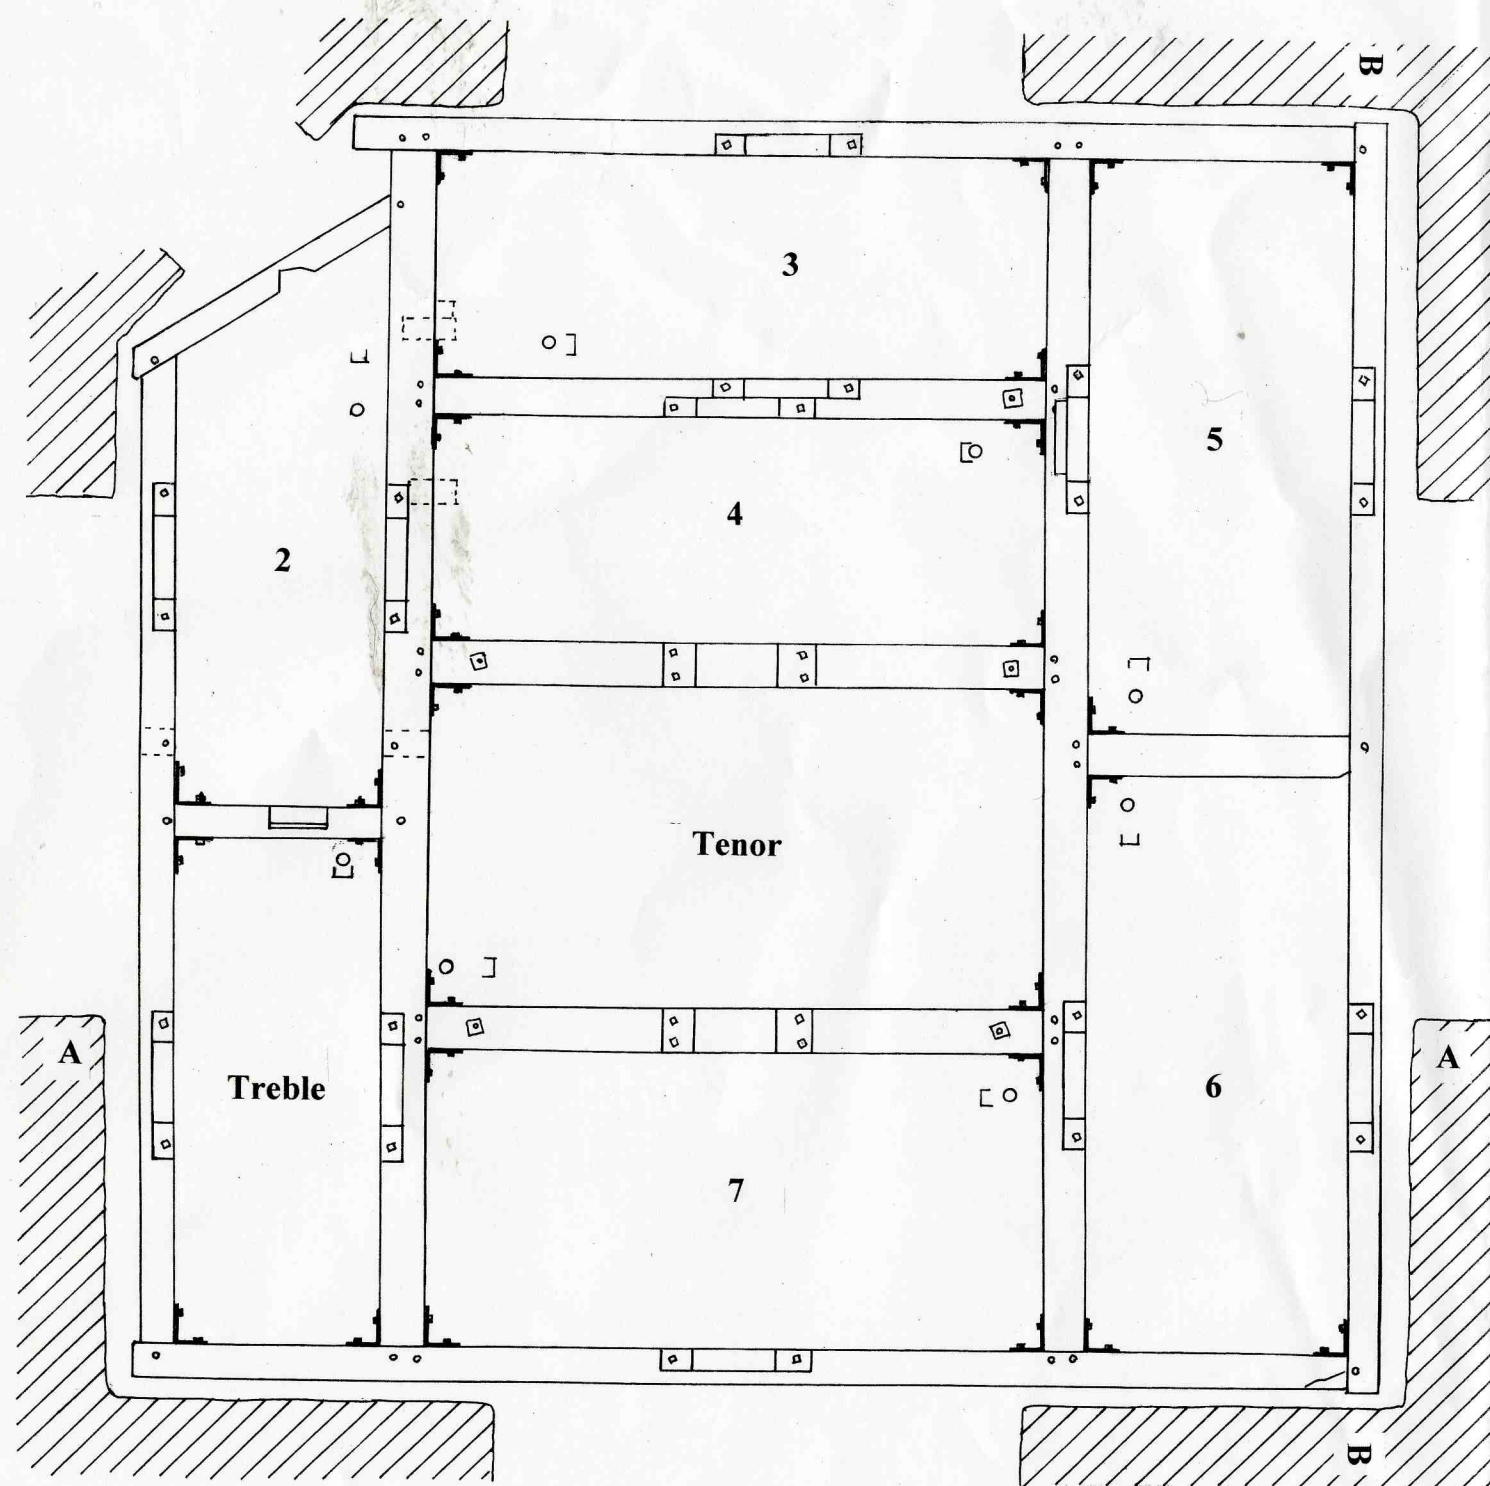
Figure 2. Plan of the bell frame at frame-head level, showing relation to the tower walls.

This was installed in 1735-6, after the completion of the church, and is of conventional layout (Pickford Type 8.3). Approximately square, because of the angle at the north-west corner where the spiral stair gives access to the belfry, at this corner the frame is also angled. On the west side the treble and second bells swing north-south, mouth to mouth, while on the east side the fifth and sixth bells swing north-south, mouth to mouth. These are separated by four parallel pits, with the bells swinging east-west, containing, in order from the north, the third, fourth, tenor and seventh bells. The rope circle is clockwise. (Fig. 2) In order to improve the rope circle in the ringing chamber there has been a slight amount of drawing of the ropes both in the belfry and in the intermediate chamber, in the ringing chamber, but despite this the rope circle is still not as good as it might be.

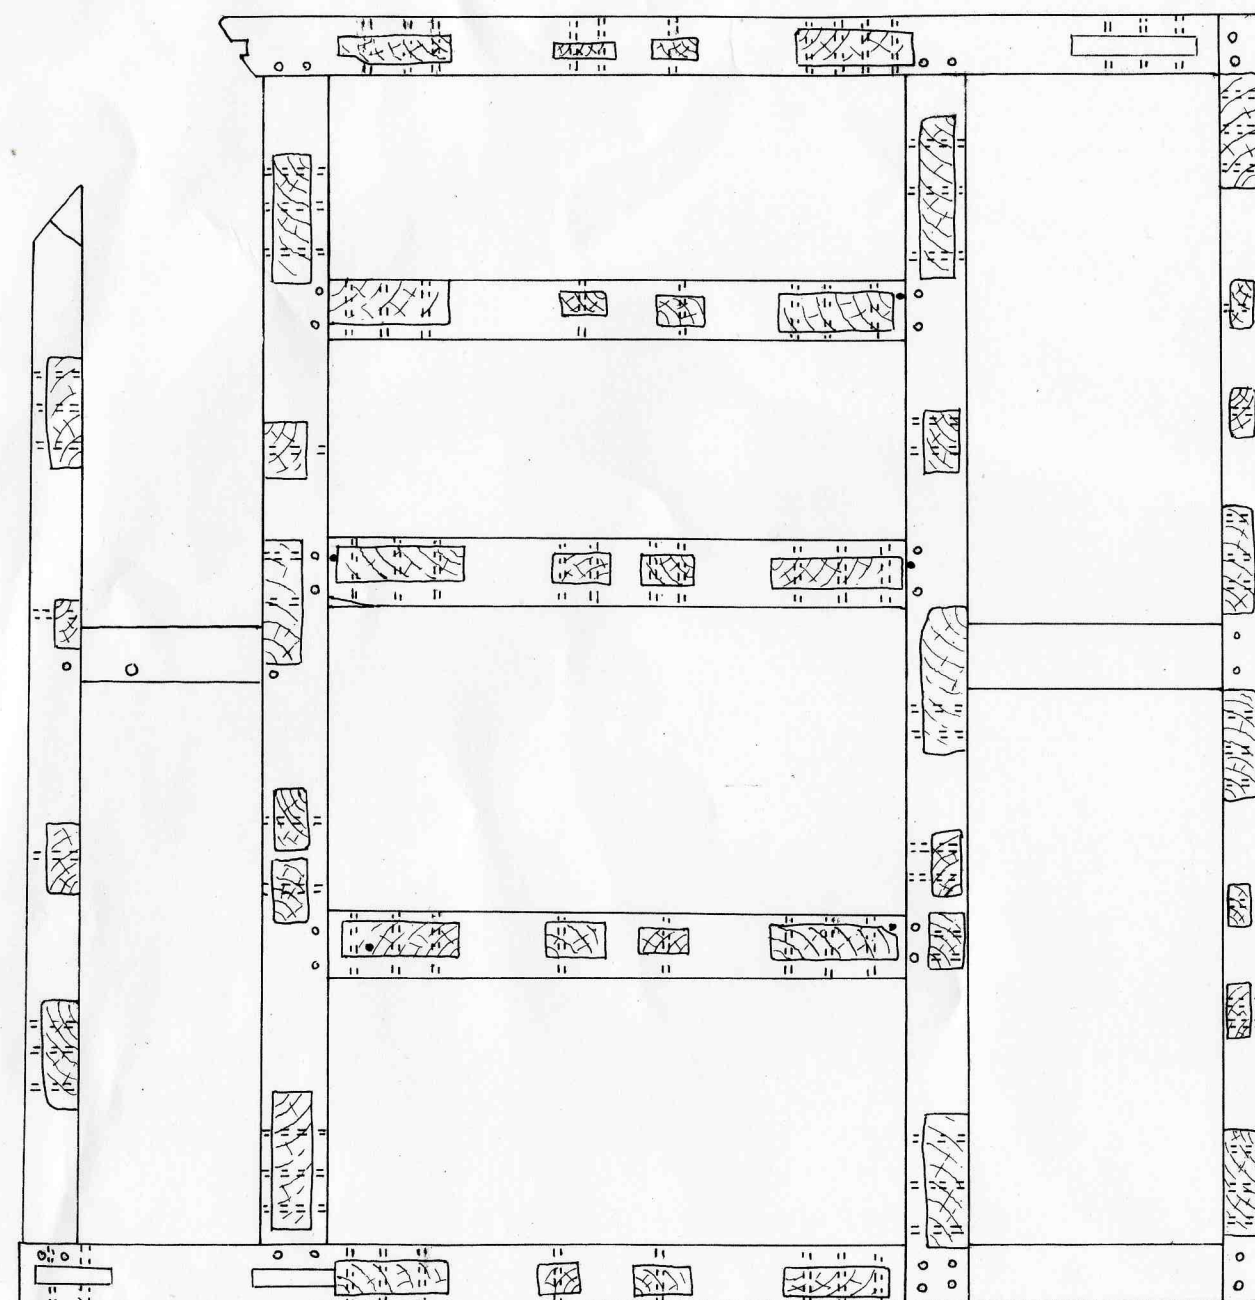
Figure 3. Plan of the sills of the bell frame.

From the jointing of the lower sills the sequence of installing the frame can be deduced. (Fig. 3) First the sill against the east wall was placed in position, then the sills against the north and south walls were engaged at the east end at an angle, and then swung into position. From the lap joint at the south end of the inner truss for the fifth and sixth bells it is clear that this sill was engaged at the north end and then the south end lowered into position, the cross-piece in the middle being engaged first. Next, the internal east-west sills of the four parallel pits were installed, and were closed at the west end by engaging the closing timber at the south end at an angle, and then swinging this into position at the north end, the mortice being open at the west end to enable it to be engaged. Then the sill on the west side of the frame was engaged at the south end, with the north end raised, and the small cross piece between the two pits engaged and the sill lowered into position. This would only be possible if the tenons in the cross piece were short.

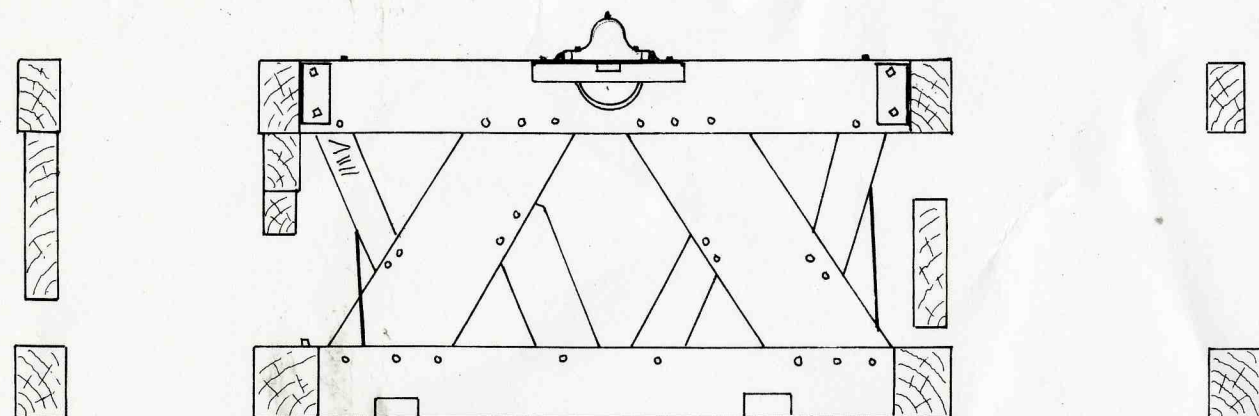
Figure 4. Section A – A, south elevation.

For the four parallel pits, each bell hangs at the centre of a truss which is formed by two substantial braces, inclined to the centre, each of which is double jack-braced. (Fig. 4) In the frame each main brace has double jack braces. The north-south trusses are of three different types. That on the east side has two pairs of braces, with a bell hung more or less in the centre of each. (Fig. 5) The two trusses that close the four east-west parallel pits have a pair of braces at the south end, but at the north end only a single brace inclined towards the centre of the frame. (Fig. 3) Thus on the west side, bells five and six do not hang at the centre of a pair of braces. On the west side of the frame there is a third

The jack braces themselves are of very variable size, and several exhibit signs of reuse, although the limited size makes it impossible to say where they had been previously used. One at least is of considerable age, this being the upper jack brace at the west end of truss between the seventh and tenor bells, which has scratch marks about three inches long, perhaps dating from the sixteenth century. (Plate 3 & Fig. 4) Apart from these scratch marks, there are no other signs of reuse in this particular timber.

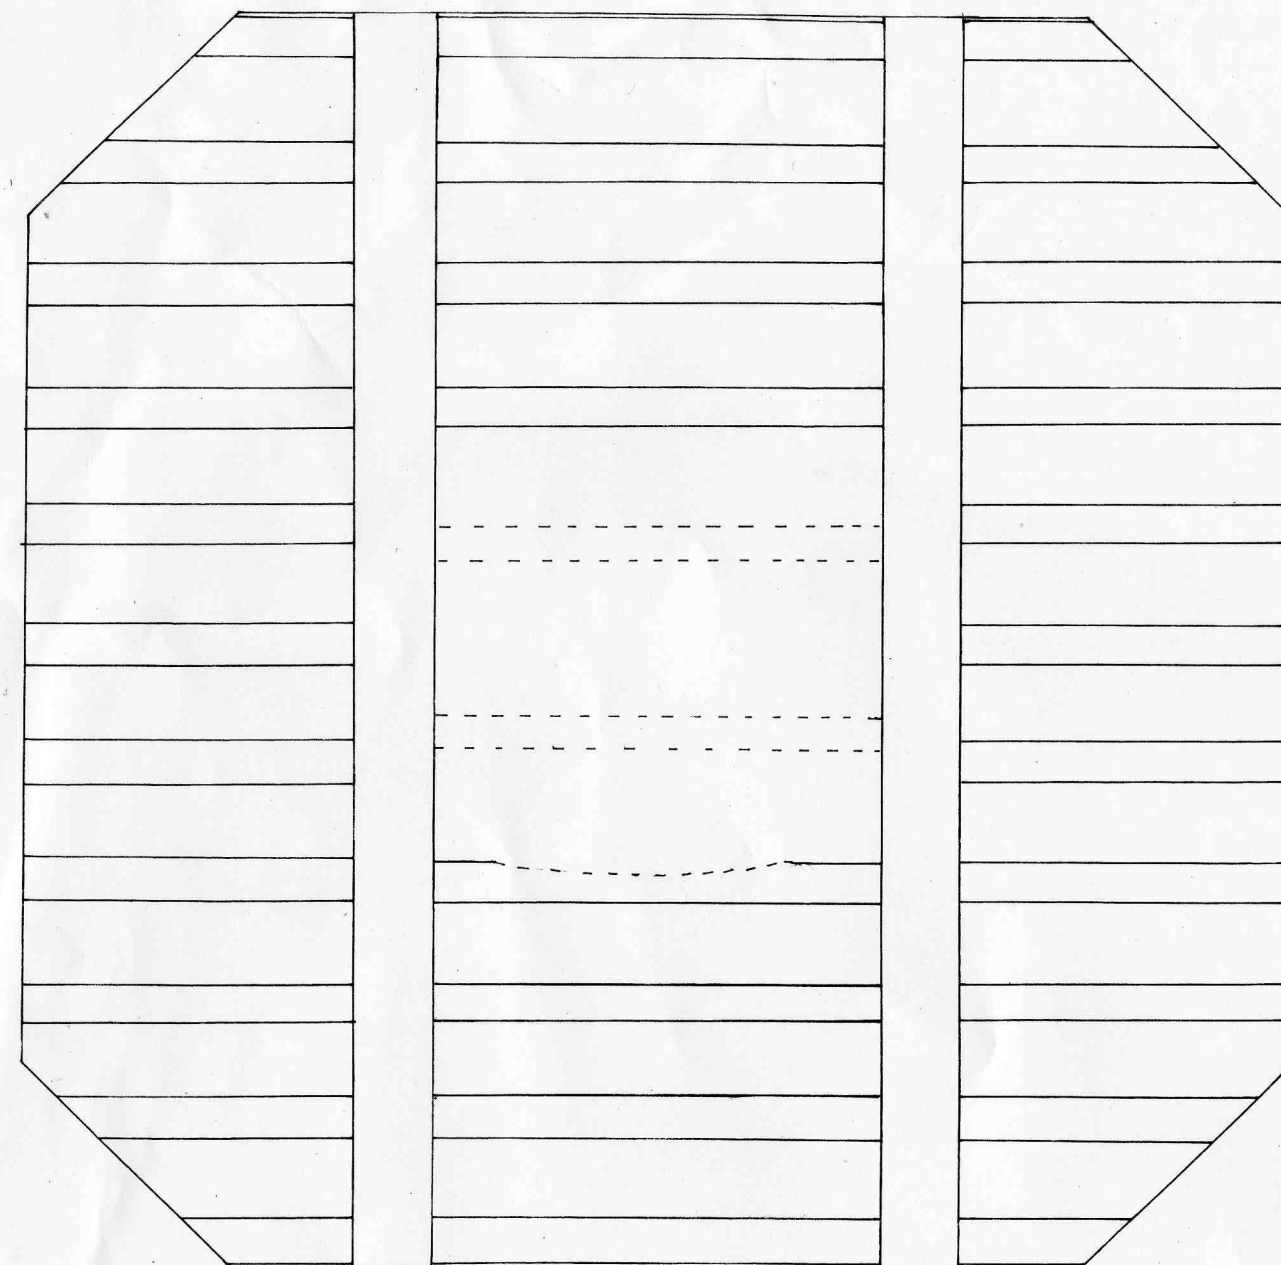
Figure 6. Sketch plan of the timbers of the supporting floor

The sills of the frame are all jointed together on the level and as such are designed to sit on a floor. Initially there was no mechanical connection with the floor, and it was not until 1936 that the frame and floor were tied together with tie rods. The floor is integral with the tower and consists of two large north-south timbers, about 30 cm wide by 35 cm deep, dividing the area into uneven thirds, resting on wall plates built into the north and south walls. On the east and west sides there are 11 timbers, each about 15 cm wide by 22 cm deep, spanning from the main timbers to the tower walls, equally spaced, but the outer ones of uneven length because of the angling of the walls in the corners at this level. The outer ends of these timbers also rest on wall plates built into the walls, and the inner ends are double tenoned to the primary timbers, and probably pegged from the top, although this is hidden. Centrally, the middle three corresponding timbers were not installed, the space under the tenor bell being used for a bell hole to raise the bells into the belfry. (Plate 6) In this central space two softwood timbers have been slotted, the rest of the structure being of oak, with a trap above. Outside the central area the timbers are covered with boards laid north-south, tying the whole structure together and effectively making it a diaphragm.

Generally the floor is as it was laid, except that a board has been removed beneath the treble bell, and a similar slot cut along the pit of the third bell. This slot, which is comparatively recent, cuts across the boards which are laid north-south and thus reduces the efficiency of the floor.

Immediately below the supporting timbers four tie bars have been installed, more or less parallel to the four walls and close to them, and these are designed to tie the corners of the tower together. These were probably installed as part of the work carried out in 1930.
