**WITNESS STATEMENT**

Statement of **XXXX XXXXXX, BA (Hons), PG Dip Cons**

The purpose of the statement is to ensure that the Court considers the impacts that metal theft, in particular the theft of lead has on historic buildings in general, and the XXXXXX Church of XXXXXX (a Grade II Listed Building).

The XXXXXX Church of XXXXXX in XXXXXX is a Grade II listed building (Ref. No: XXXXXX), having been first listed on XX XXXX XXXX.

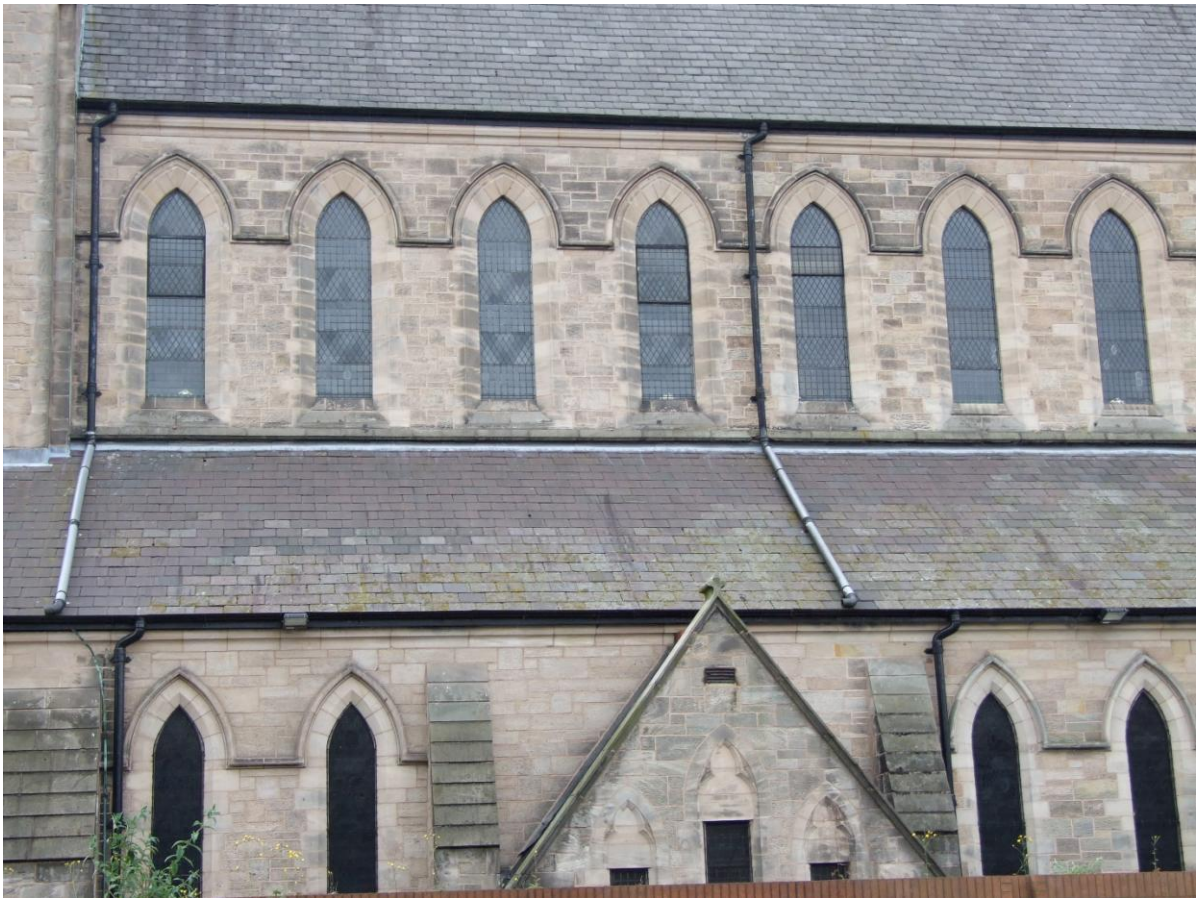
**Exhibit MS1.**

**Exhibit MS1. XXXXXX Church, XXXXXX. Showing intact flashing on North Aisle**

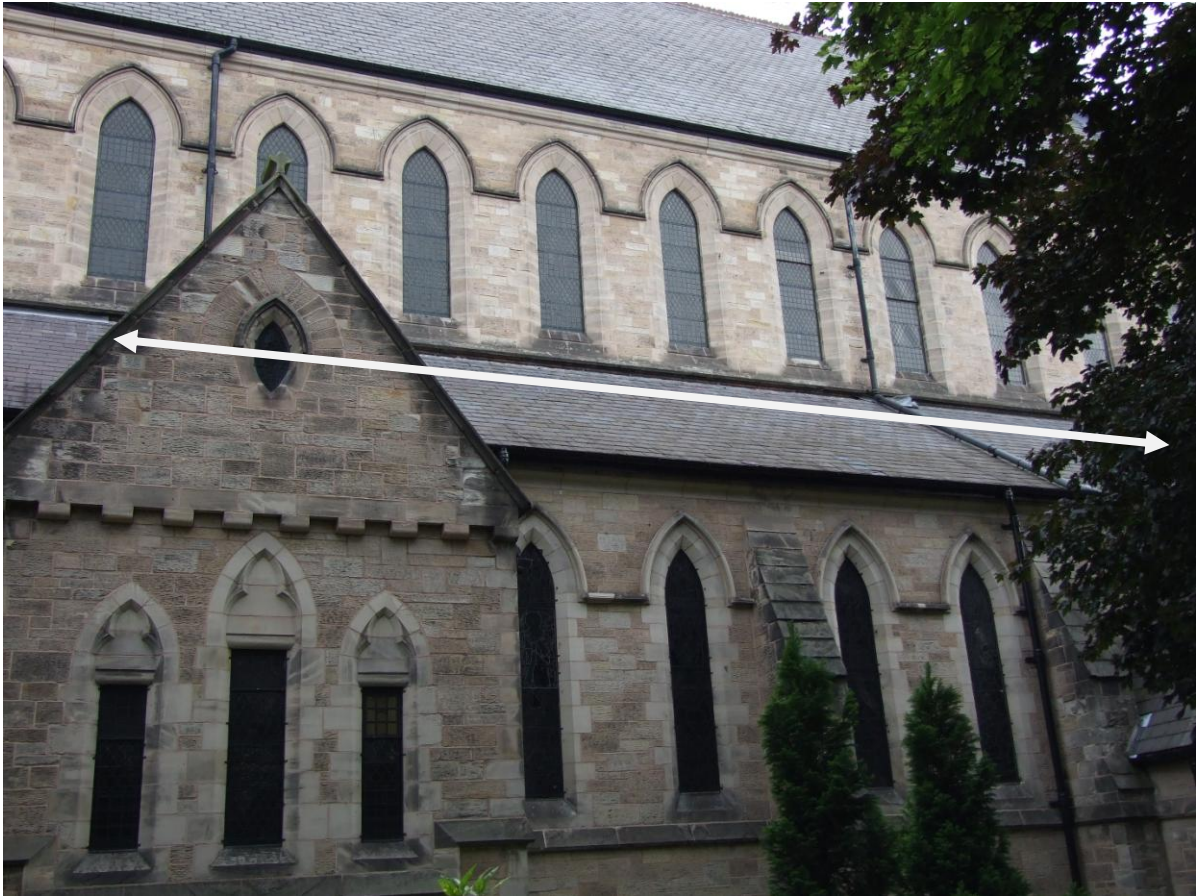
**Exhibit MS2**

In the case of XXXXXX Church a length of approximately 25 metres of lead flashing has been removed from the south side of the Church. On Thursday 24 June at 11 AM I captured some images of the Church using a Canon Ixus 9501S digital camera. I produce these images as Exhibit MS1 (showing the intact flashing on the north side of the aisle); Exhibit MS2 (the length of removed flashing indicated by an arrow), and Exhibit MS3 (sections of damaged flashing left behind a downpipe).

Fortunately, damage to surrounding roof slates appears slight from visual inspection, however closer examination is required to determine whether the existing slates would withstand re-laying.

The very fact that lead flashing has been installed at this point indicates the vulnerability of this point of the structure, joining the aisles to the main body of the church. Water will no longer be diverted down the slope of the roof, but enter the building, risking damage to the good quality timber boarded ceilings internally, as well as damaging the plaster work and potential water staining to the sandstone columns.

**Exhibit MS2. XXXXXX Church, XXXXXX. Length of lead flashing removed from the south aisle (indicated by arrow)**

In cases where lead sheet has been removed, the sub-strate also has to be repaired and any underlay replaced. (Lead sheet requires a smooth sub-strate to allow for thermal movement). To re-fix flashings several courses of slates/tiles have to be lifted, the flashing laid and the tiles re-fixed. Even if the slates were not damaged during the theft of lead, it is possible that disturbing them in order to relay the lead could cause them to split requiring them to be replaced, which in turn is another cost.

The disruption and expense caused to the Church will far outweigh the cost received from the sale of the stolen lead. It is estimated that the cost to engage specialist contractors to replace and repair the stolen lead flashing may be a factor in the region of 10 – 15 times greater than the value of the lead itself (£800 - £1,200).

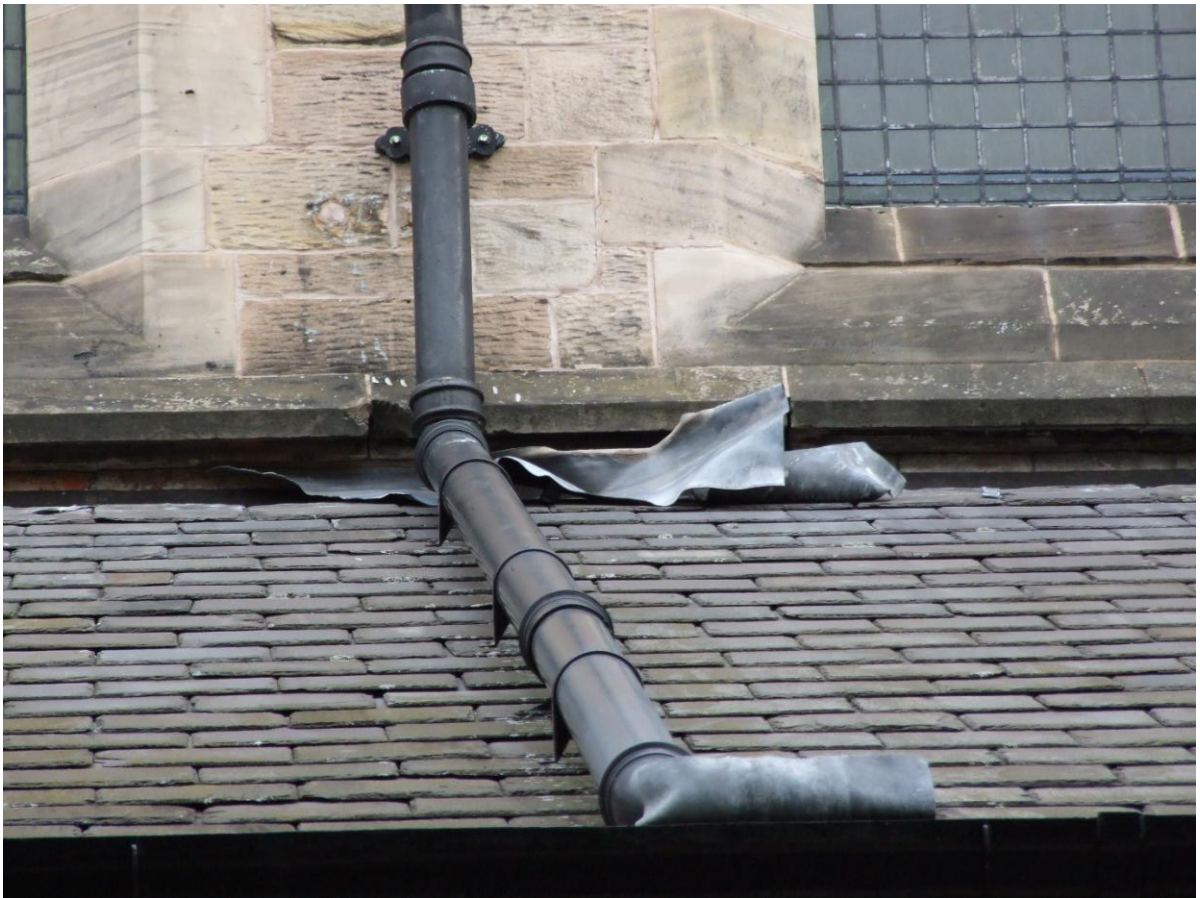
**Exhibit MS3**

**Exhibit MS3. XXXXXX Church, XXXXXX. Damaged lead flashing left behind downpipe.**
