Carlisle Cathedral: South Porch repairs (1 of 2 projects funded)

Carlisle Cathedral: Roof Repairs (2 of 2 projects funded)

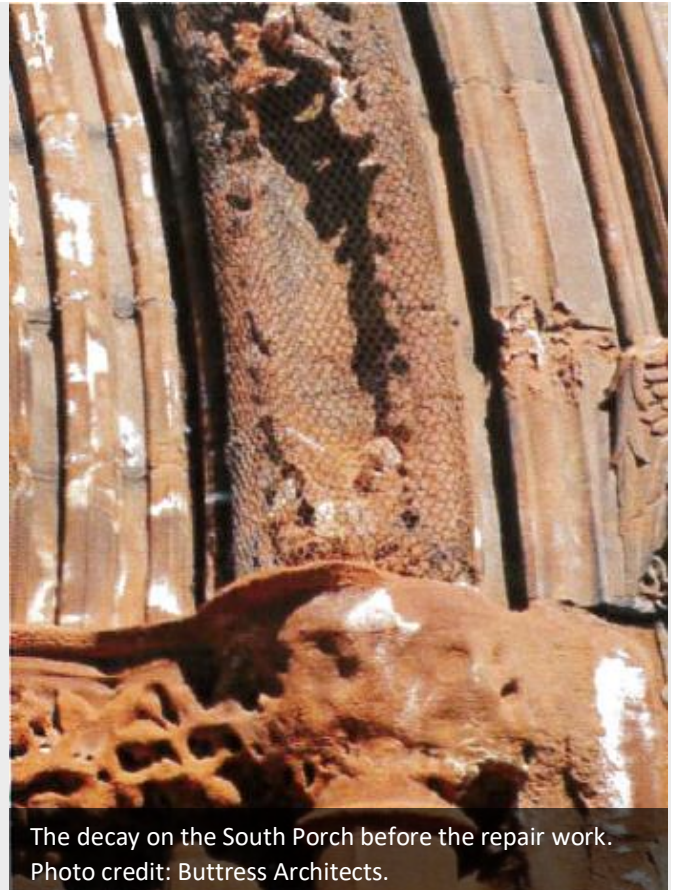
This application was to carry out conservation and consolidation works on the richly carved South Porch archway, which is built from local sandstone. The stiff leaf carving of the porch was in a softer version of this stone, and had weathered very badly, making it unsafe. It was netted to prevent falls of stone fragments. The label stops and capitals also needed re-carving or replacing. The erosion of the stone was allowing water to penetrate into the main body of the doorway, exacerbating the deterioration.

The decay on the South Porch before the repair work.
Photo credit: Buttress Architects.

Lambert Walker Ltd were commissioned to carry out repairs to the stonework of the south porch. Restoration works began in Spring 2015 and were complete in the Autumn of 2015. The works included the removal of decayed sections, replacement of old stone with newly carved and cut stone and the installation of a new damp-proof lead membrane.

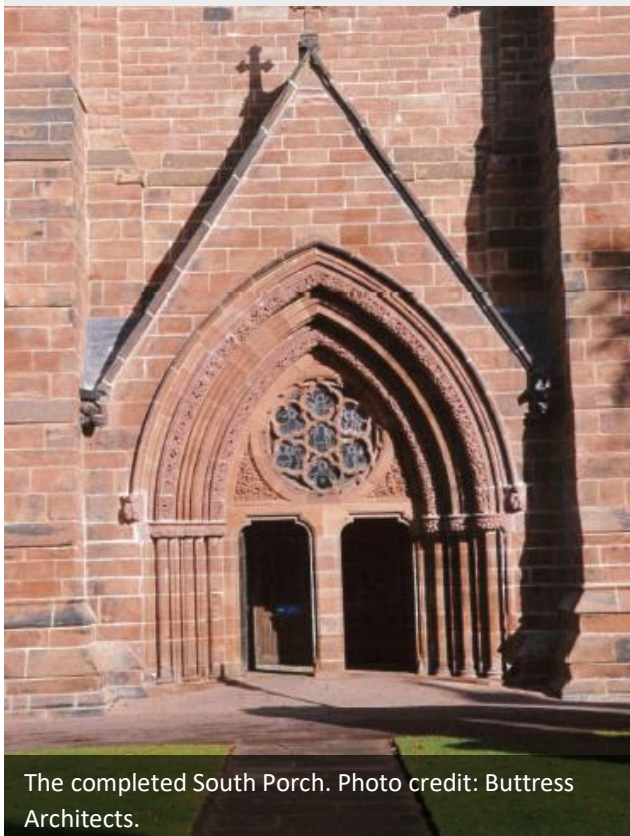
The porch has been made waterproof as a result of the work and as a result the decay to the masonry has been arrested. The delicate stone carvings, which had been almost totally lost, have been replaced resulting in a much more inviting entrance to the Cathedral. The stonework also won an award for Craftsmanship in the Natural Stone Awards 2016.

The completed South Porch. Photo credit: Buttress Architects.

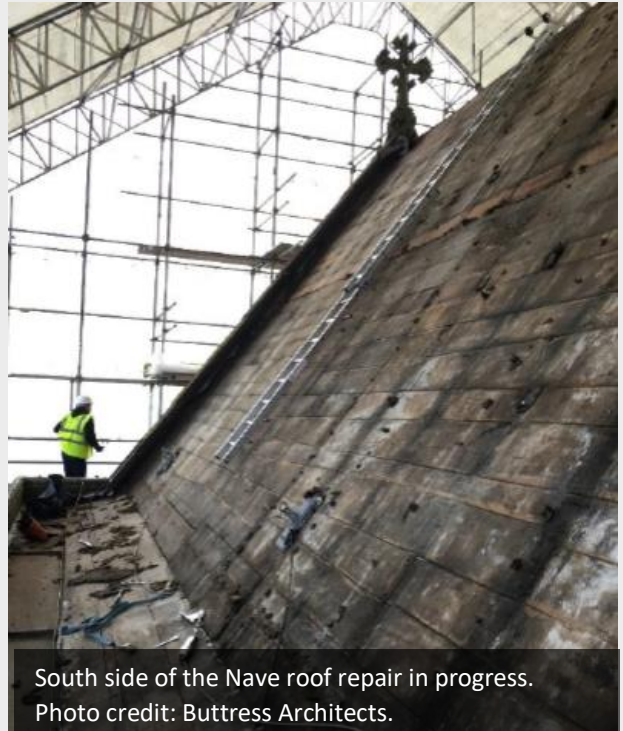
This re-leading of the nave and nave aisle roofs had been identified as a priority in the 2014 Quinquennial Inspection report. They were last replaced in 1934 and had reached the end of their lives, with slippage, cracking and failed patches to the lead sheeting. Without the roof repairs the building would not have remained watertight for much longer and that would have significantly compromised its ability to remain safe and open.

South side of the Nave roof repair in progress.
Photo credit: Buttress Architects.

Manchester-based J Hempstock and Co Ltd were contracted to carry out the specialist leadwork. The contract commenced in September 2016, with an anticipated completion date of January 2017. Tenders for the project awarded £400,000 in July 2016 came in significantly under budget, due partly to a crash-pad safety system that had been included in the estimates turning out not to be required. An agreed extension of the project scope to include re-roofing the copper roof of the North Transept in lead (leaks and damage to this roof had become apparent in the past three years) extended the project to December 2017. The works included repairs to the high roof and aisle roofs, replacement of copper sheeting with new lead sheets and reforming of guttering. The total claimed for the combined roof works was £359,000; the remaining underspend was passed back for re-allocation by the Fund's Expert Panel.

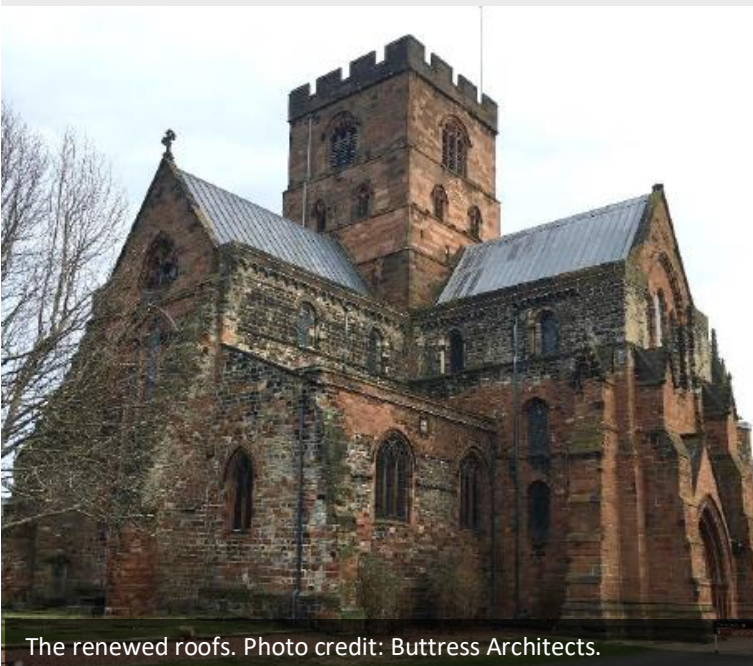
The repair works to the Nave, Nave Aisles and North Transept mean that the Cathedral is now waterproofed, which will prevent further water damage from occurring. The replacement of the old copper sheeting on the North Transept with new lead sheets unifies the appearance of the roofs of the cathedral and reduces noise in wet weather.

The renewed roofs. Photo credit: Buttress Architects.
