# Southwell Cathedral: South Quire Aisle Lead Roof (1 of 2 projects funded)

## Southwell Cathedral: North Side Roofs (2 of 2 projects funded)

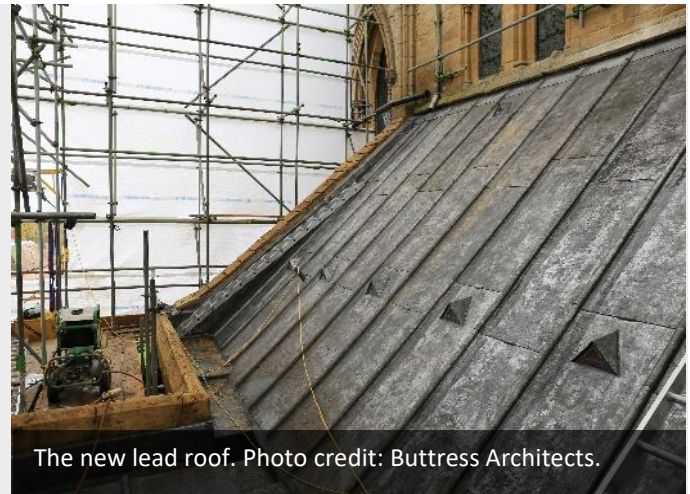
The new lead roof. Photo credit: Buttress Architects.

The works were all completed and included replacing the old roof, which was made entirely of slate, with a new lead roof, re-profiling of the parapet gutters and repairs to the roof timbers.

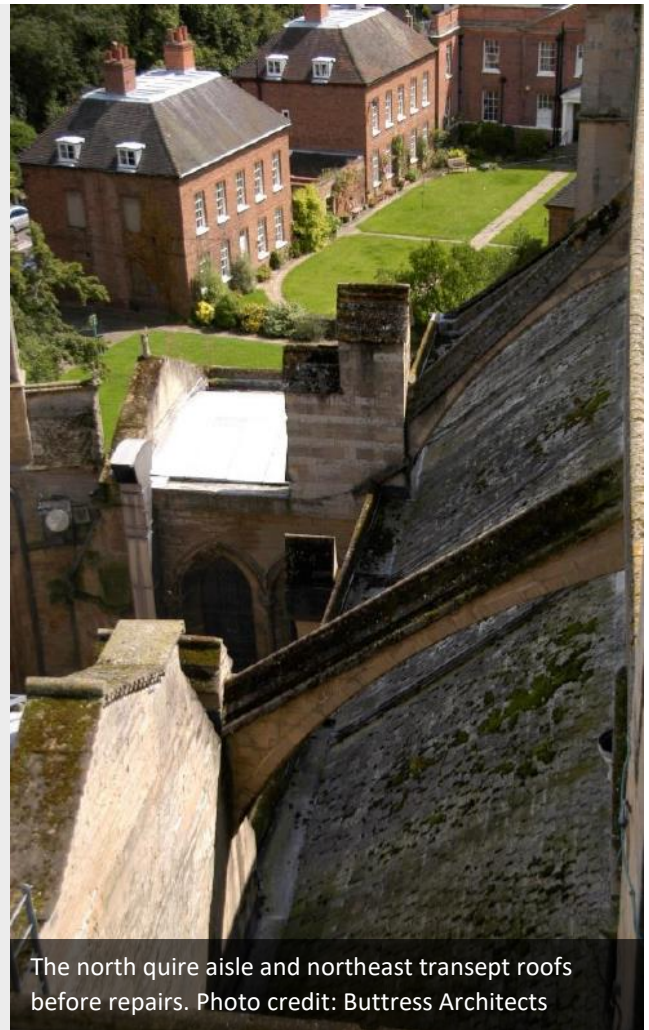
The project was part of a programme to replace in lead the eastern roofs and followed on from the previous grant which covered south quire aisle roofs. The quire aisle roofs were originally lead-covered but may have been tiled in slates, presumably as a cost-cutting measure, as early as the 18th century. The present slate covering dated from the 1880s and was worn out, with slipped and broken slates that were difficult to access. The roof was prone to leaks; the most recent Quinquennial Inspection found that there had been a series of leaks over recent years. Water had been able to penetrate into the cathedral through the vaults and rot had occurred in places. If not addressed now, damage and costs would have escalated.

The north quire aisle and northeast transept roofs before repairs. Photo credit: Buttress Architects

Despite a delay in receiving planning permission, the project was completed within the timescales and the project was effectively managed. The works included stripping out and preparation, timber repairs and replacements, gutters, leadwork, and other works including roof ladders, lightning protection and rainwater downpipes. The extent of timber repairs required was less than originally budgeted for. The tendering for both projects was combined into one single contract, which led to significant cost benefits, allowing the roof repairs to be extended into adjacent areas with the agreement of the fund's Expert Panel, and an underspend of c. £45,000 to be returned to the fund for re-allocation.
