Derby Cathedral: infrastructure repairs (1 of 3 projects funded)

Derby Cathedral: Song School Roof Repairs (2 of 3 projects funded)

Derby Cathedral: Nave Roof Repair (3 of 3 funded projects)

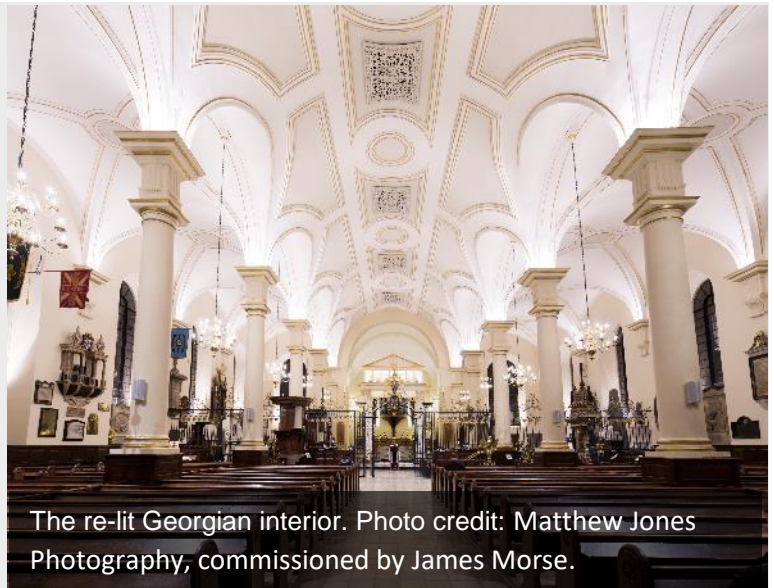
The re-lit Georgian interior. Photo credit: Matthew Jones Photography, commissioned by James Morse.

Works were completed between May 2014 and August 2015. They included re-wiring the building, replacing the aluminium sheathed cables with copper, replacing heat exchangers, and making the whole safe. The application also covered lighting cabling replacement, to be done alongside the electrical works, with new light fittings introduced. The boiler and heating system were also replaced.

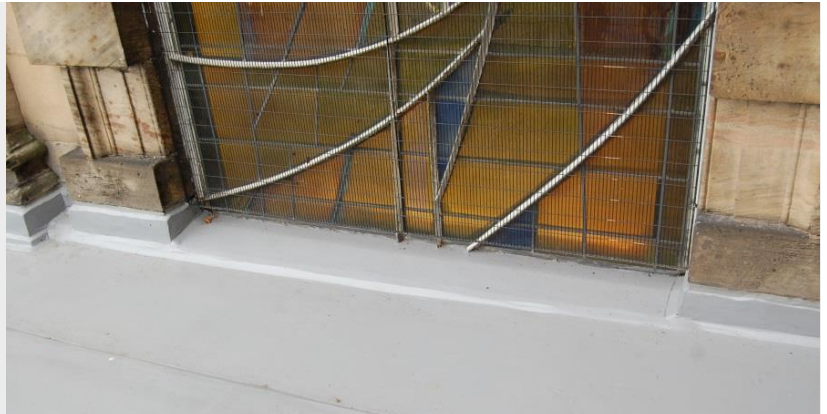
This package of works focused on repairs and replacement to the early 1970s flat roofs at the east end of the cathedral, which were failing, threatening stonework damage, and allowing water ingress. These roofs covered the 20th century Comper extension with its Song School, used by the cathedral choir. Built to enable the original parish church to function as a cathedral, it also houses the kitchen, offices, meeting room, vestries and lavatories. The roofs were at imminent risk of falling at the time of application, with 5 by 3-metre rain-catchers installed to catch the leaks.

The junction with the Ceri Richards' window showing the fall away from the window to reduce the likelihood of water ingress. Photo credit: Robert Kilgour, architect.

The flat roofs were repaired by Midland Stone Masonry between August to September 2015. Repairs involved roof repairs, leadwork, and masonry to secure the structural integrity of the roof, repair existing damage and halt / prevent water ingress. Rigid cell insulation was incorporated to improved thermal performance. There was an underspend compared to the original forecasted cost. This was reallocated by the Fund's Expert Panel to other urgent works.

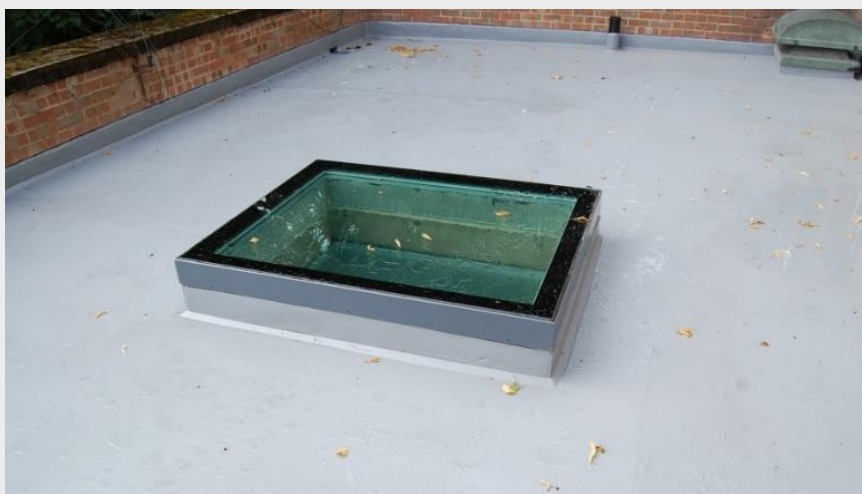
The new roof light installed over the entrance corridor. Photo credit: Robert Kilgour, architect.

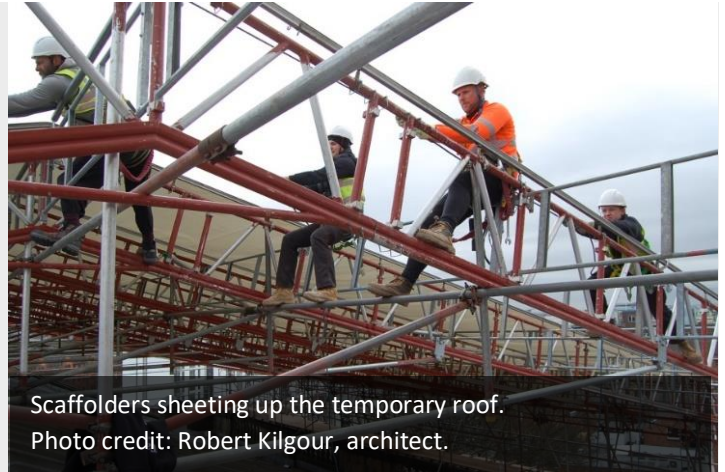
Scaffolders sheeting up the temporary roof.
Photo credit: Robert Kilgour, architect.

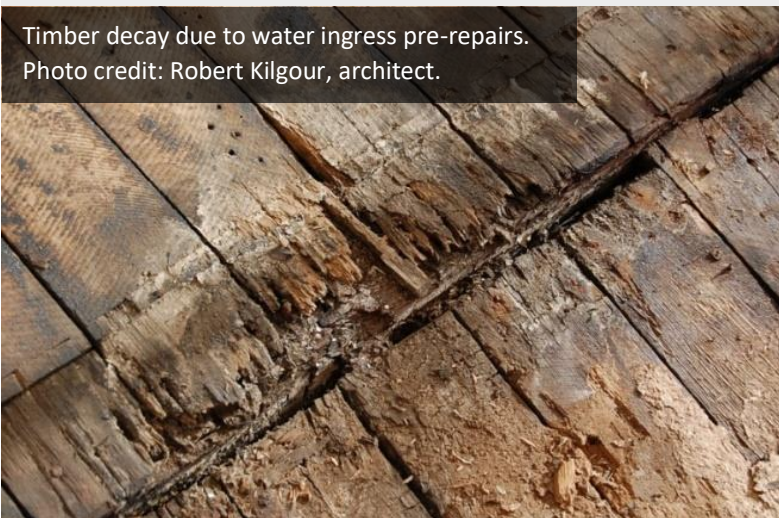
The poor condition of the roof was not known about until high-level access for works facilitated by the previous grants, when it was discovered that Derby Cathedral's lead roof was not properly laid 50 years ago. Funding was sought for an emergency scheme of work to re-cast and re-lay the roof, preventing water ingress, preserving the newly-restored interior and the electrical and heating works funded under phase one of this scheme, and keeping the cathedral safe and open. Costs included the necessary provision of a temporary roof whilst works were going on.

Timber decay due to water ingress pre-repairs.
Photo credit: Robert Kilgour, architect.

The scheduled timeline for works ran from May 2016 to August 2017. Repairs included a new lead roof as well as stonework, coping stone and balustrade repairs, and provision of overflows. Two roof access hatches were installed to improve access, so that the verger team no longer have to squeeze through a window and down a ladder to gain access to the parapet gutters for maintenance.
