Ely Cathedral: South Transept Repair (1 of 3 projects funded)

Ely Cathedral: Emergency Rewiring (2 of 3 projects funded)

Ely Cathedral: South Nave Aisle Roof & High-Level Repairs (3 of 3 projects funded)

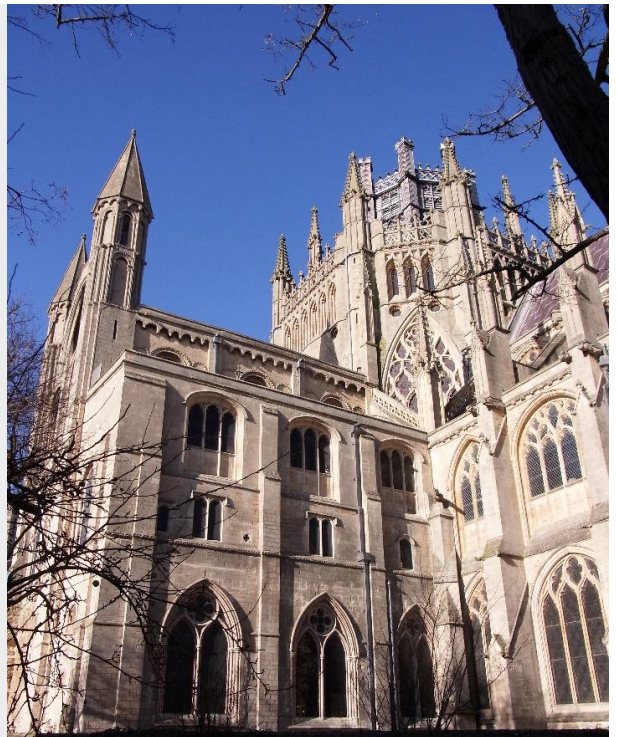
This project repaired the lower half of the south and east faces of the south transept, including urgently needed glazing repairs, masonry conservation, and health and safety improvements to internal galleries which visitors access for exhibitions. The need for the work was identified in the 2011 Quinquennial Inspection, with the perilous state of the stained glass having been identified as far back as 2006. No conservation or repair had been undertaken since the 19th century. Fourteen windows required repair and treatment, following a methodology which had been applied around the rest of the cathedral. Two of these were outstanding examples of 19th-century work and were in very poor condition, with their remaining lifespan being estimated in 2006 to be only a further five to ten years.

The south transept. Photo credit: Purcell Architects.

Works were completed to timescales and involved the cleaning, repointing and repair of the external masonry to the lower sections of the transept south and east elevations and also the re-leading and repair of the windows to the transept east aisle and the remaining unrepaired windows to the transept south front.

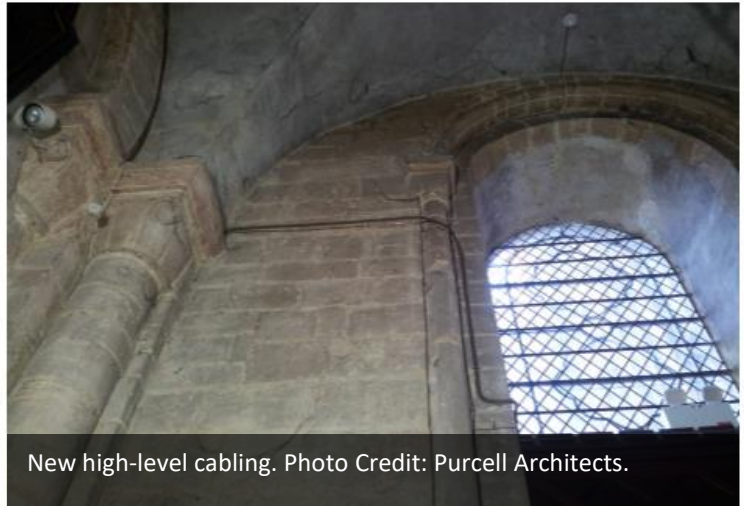
The work was urgent because there had been significant corrosion of the MICC (mineral insulated copper-clad) cables and there was danger of failure of the electrical system supporting lighting, emergency lighting, fire alarms, lighting and power circuits. These failings became apparent following a complete electrical test of the building completed in 2013 after a series of power cuts and concerns over the electrical systems in the cathedral. As providing lighting and power is a key part of the cathedral's welcome to visitors and worshippers, there would have been a direct impact on that if the cabling had failed entirely. Ultimately, without the safety systems supported by the cabling, parts or all of the cathedral would have needed to be closed to the public.

New high-level cabling. Photo Credit: Purcell Architects.

The work started in 2015 by the electrical contractor V. J. Skerry Limited of Huntingdon. It included the rewiring of the north side of the cathedral within the North Porch, Lady Chapel, North Transept, North Nave Aisle and North Choir Aisle as well as the South Choir Aisle. Further work included the installation of additional mains socket outlets and coaxial cabling to existing and new TV monitor positions along the north and south side of the Nave and Choir. The second phase of the project continued with South Nave Aisle, South Transept, South Porch, West Front and Galilee Porch, together with the Shop and Refectory, to complete the rewiring of the cathedral.

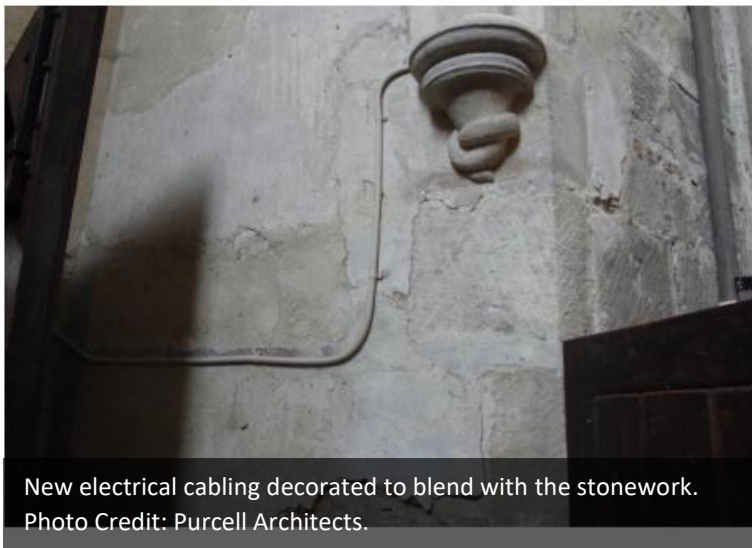
New electrical cabling decorated to blend with the stonework.
Photo Credit: Purcell Architects.

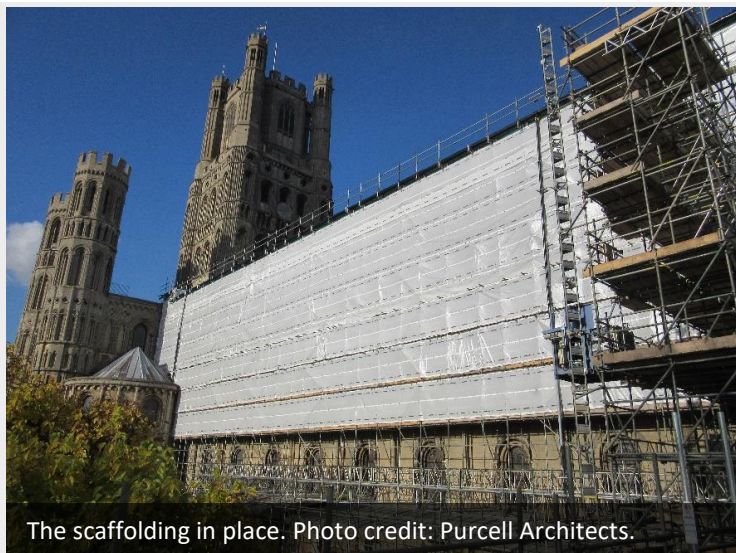
This application was for re-roofing the leaking South Nave Aisle roof and masonry and glazing repairs to the triforium windows, the first phase of a three-phase project to repair the South Aisle masonry, glazing and roofing. There had been concerns about water coming in onto the nationally important exhibits of the Stained Glass Museum in the triforium: regular leaks had been noticed, requiring a number of patch repairs. The Quinquennial Inspection had identified major problems with the glazing and stonework as well as the roof.

The scaffolding in place. Photo credit: Purcell Architects.

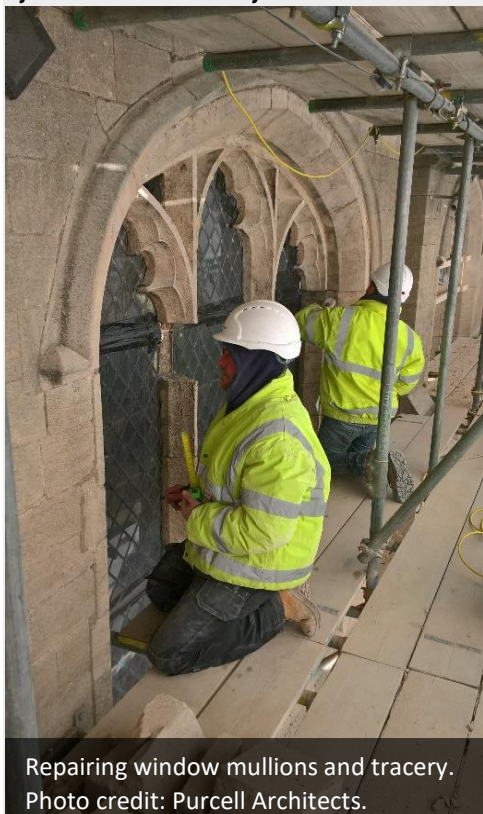
Repairing window mullions and tracery.
Photo credit: Purcell Architects.

The funding for this project was secured in November 2016 and work began in August 2017. The project was due to complete in April 2018 but completion was delayed when the main contractor went into administration in May 2018 and was ongoing at the time of writing. The project focused on three key aspects: (i) the re-roofing of the leaking South Nave Aisle roof and replacement of the rainwater goods; (ii) the re-glazing and repair of the quarry-glazed South Nave triforium windows including mullion and tracery repairs; (iii) the cleaning, repointing and repair of the external masonry to the triforium elevation from triforium string course level upwards.
