Hereford Cathedral: Sound System (1 of 3 projects funded)

Hereford Cathedral: Roof Repairs (2 of 3 projects funded)

Hereford Cathedral: North Aisle Roof Repairs (3 of 3 projects funded)

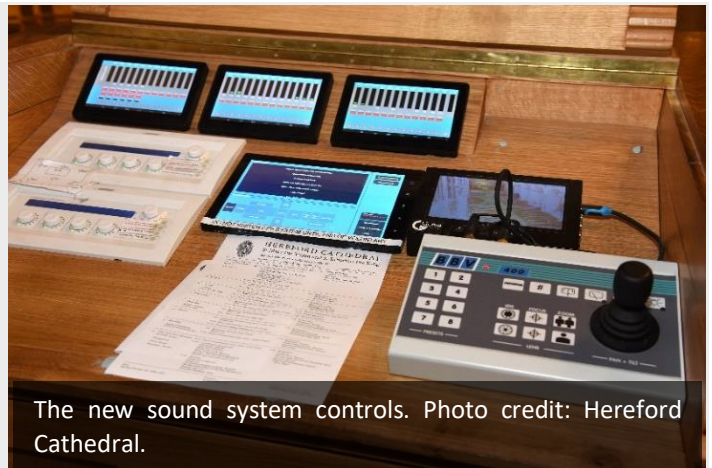
The new sound system controls. Photo credit: Hereford Cathedral.

Works were completed between June 2014 (award) to July 2015 (scheduled practical completion). This included installation of a new sound system and hearing loop, with updated controls and increased functionality. The majority of works were completed on time, with an extended snagging period to identify any problems.

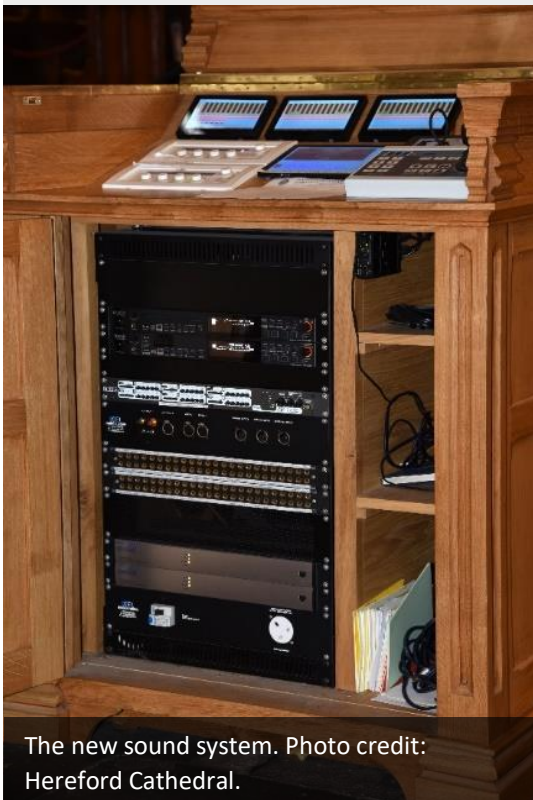
The new sound system. Photo credit: Hereford Cathedral.

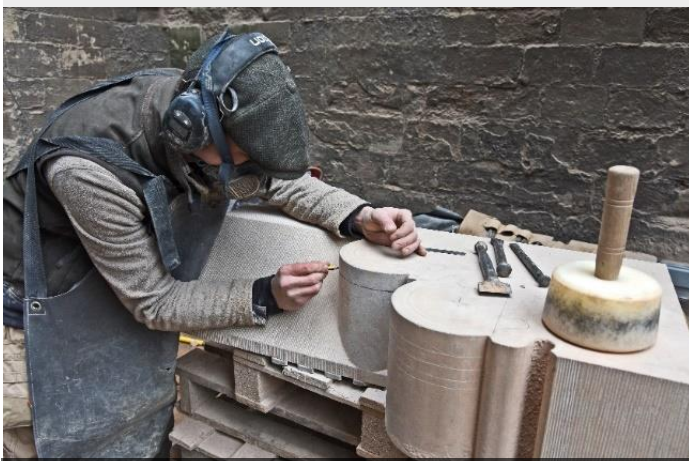
This project was to undertake work on the lead roofs and masonry of the Booth Porch and north quire aisle, and former choristers' vestry roof. Lead slippage and deterioration had occurred to the roofing, leading to water ingress, and excessive damp was also encouraging wood-boring beetle.

Stonemason working on repairs. Photo credit: Hereford Cathedral.

Works were completed between Sept 2014 (application) and November 2015 (scheduled practical completion). Multiple points of water ingress had developed, and in places, the timbers were starting to collapse. Works included leadwork, repairs to stone copings, and replacement of guttering and rainwater goods. The Booth Porch and north quire aisle form a continuous run of roof which created savings in terms of scaffolding, access and efficient use of resources.

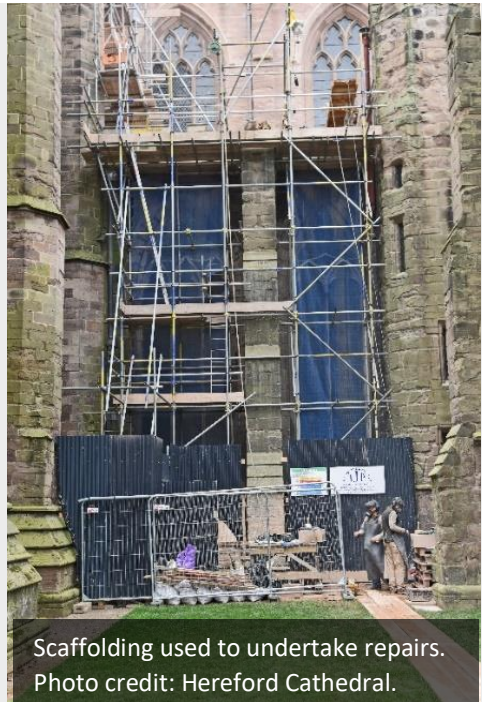
The 2011 Quinquennial Inspection had identified the work to the lead roofs and masonry of the north aisle as the highest priority of the roof repairs required at the cathedral, and further urgent repair needs were identified when the previous project was being undertaken (the cathedral had hoped to complete this work as part of the previous project, but the partial grant level did not permit this). There were serious defects to the leadwork, rainwater goods and masonry and a strong probability that many timbers beneath the lead would show signs of serious decay. The impact of the problems on the interior of the cathedral could be seen in the vaults of the ceiling, where water ingress had discoloured the plaster and caused flaking and efflorescence in a number of places in the north aisle, with fragments of plaster falling to the floor beneath. The first bay (of seven) at the west end showed damage to the stonework as well as to the vaulting where water had penetrated through the roof and ceiling due to damaged rainwater goods which had led to ineffective drainage and pooling.

Scaffolding used to undertake repairs.
Photo credit: Hereford Cathedral.

Works were completed between Oct 2016 and Feb 2018 and included replacing the lead roof covering, repairing timber substrates and structure, and undertaking repairs to weathering masonry, gutters and outlets.

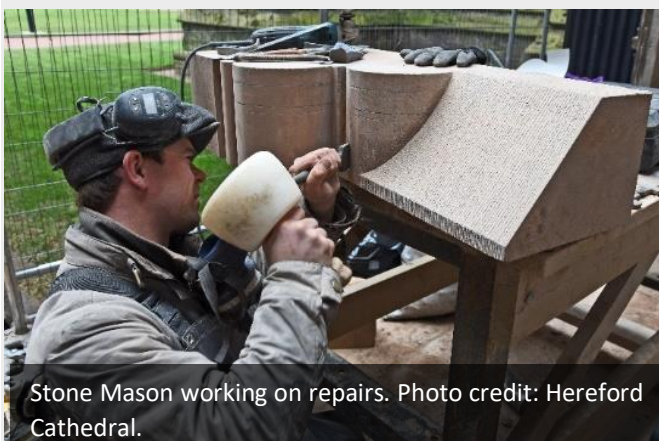
Stone Mason working on repairs. Photo credit: Hereford Cathedral.
