Manchester Cathedral: South Aisle and Chapel Roof Repairs (1 of 2 projects funded)

Manchester Cathedral: Emergency Tower Repairs (2 of 2 projects funded)

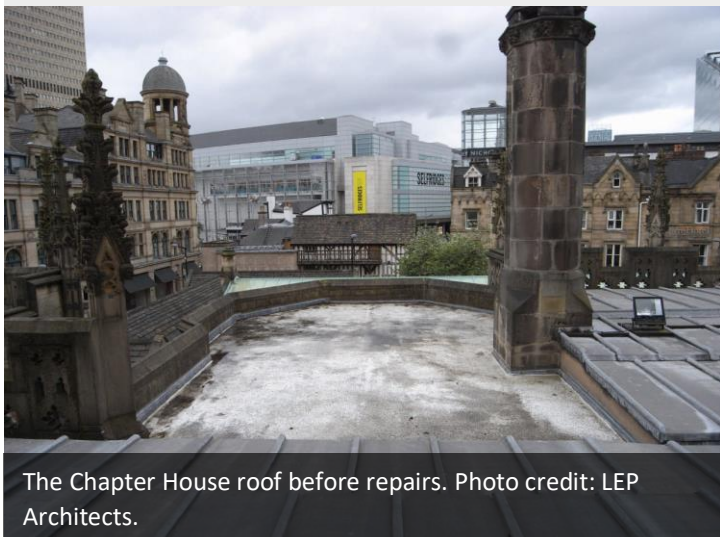
Replacement roofing was needed on the south-east area of the cathedral. Numerous cracks in the lead roof to part of the south quire aisle, Jesus Chapel and Fraser Chapel had been observed, and the flat asphalt roof of the Chapter House, which had replaced an octagonal pyramid roof damaged by bombing in 1940 leaked and required replacing before it failed completely. The cathedral had wanted to re-instate the original pyramidal roof to the Chapter House. In assessing the grant, Expert Panel members were supportive of this aim in general, but given the demands on the fund for fundamental and urgent repairs elsewhere, the reinstatement element was not deemed as high a priority and a partial grant was given for replacing the flat roof. The cathedral had been fundraising for several other projects including the organ and work to the interior, and commented that raising money for such 'invisible' roof repairs was particularly difficult.

The Chapter House roof before repairs. Photo credit: LEP Architects.

The roofing works are complete, were on schedule and essential for the cathedral. They included carpentry, timber repairs, fast fixing, lead sheet covering and flashings, copper strips, sheet coverings and flashings repairs, and repair, renovating and conserving of masonry.

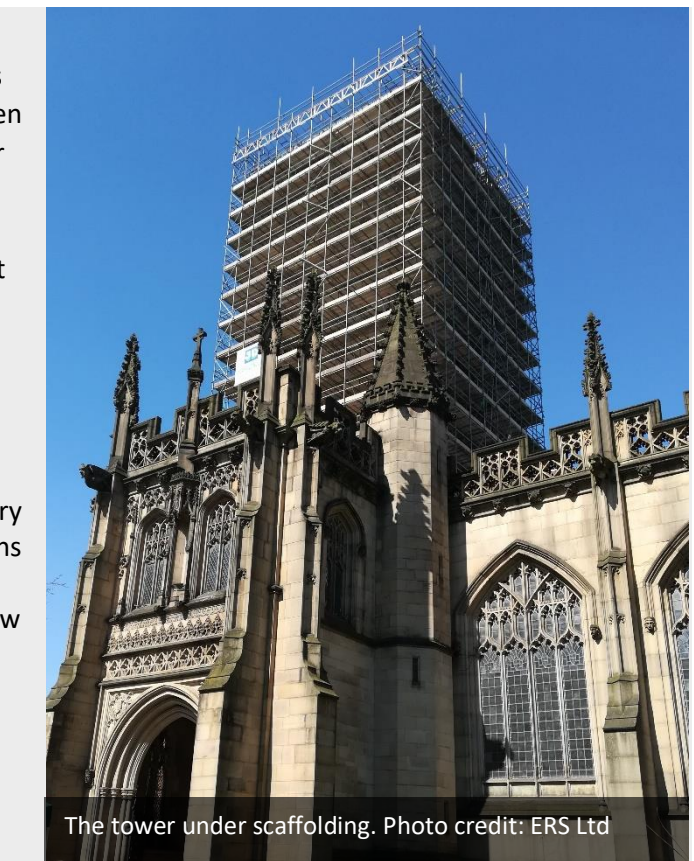
The tower under scaffolding. Photo credit: ERS Ltd

Work commenced in June 2017 and was still under way at the time of writing. The majority of the work is related to the repair and consolidation of the masonry works on the elevations of the tower, addressing the issues of loose stone, louvres replacement and the removal of vegetation from the tower. The tower roof is also being replaced.

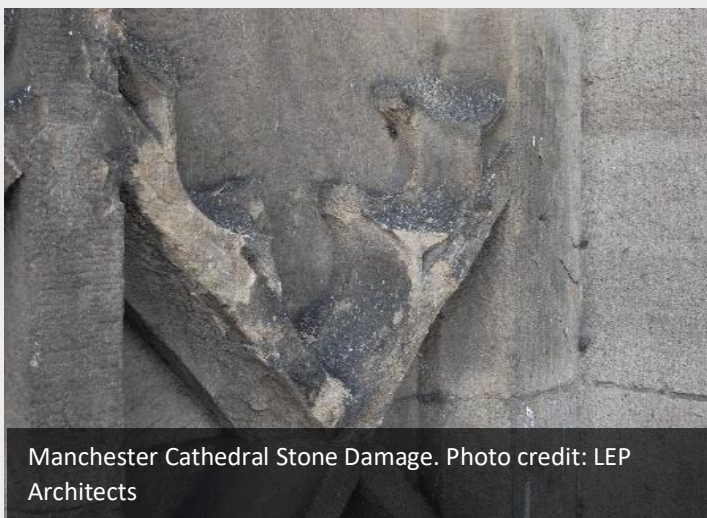
The 2013 Quinquennial Inspection reported serious defects to the masonry of the cathedral's west tower, and since then there had been falls of stone that required the entire tower to be covered in netting to protect the public and the building. In 2016 the Cathedral Architect had observed further deterioration and had manually removed significant quantities of masonry, including sections of louvres and a number of finials that were loose enough to pose a significant danger to pedestrians below.

Manchester Cathedral Stone Damage. Photo credit: LEP Architects
