## Wells Cathedral: North Nave Aisle Roof Repairs (1 of 3 projects funded)

## Wells Cathedral: North Quire Aisle Parapets Repairs (2 of 3 projects funded)

## Wells Cathedral: Nave Roof Repairs (3 of 3 projects funded)

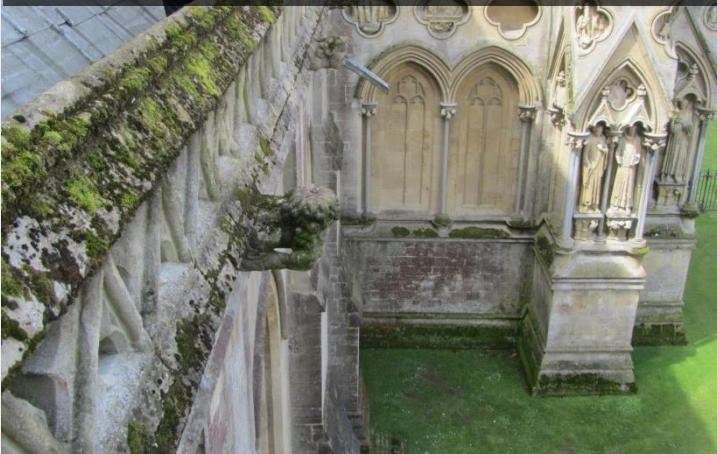
The blocked gutter overflow chute in the foreground was reinstated. Photo credit: Nick Cox Architects.

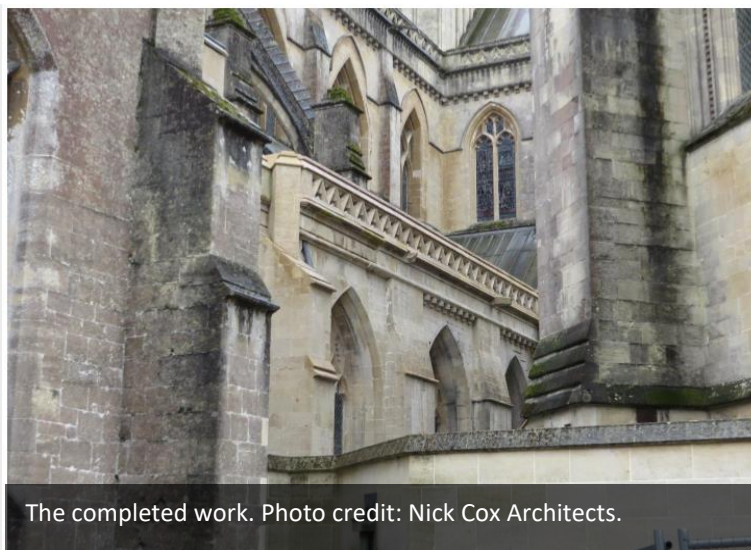
The poor condition of the parapets to the north quire aisle (12th to 14th century) and adjacent structures had been identified in the 2013 Quinquennial Inspection as an area of concern. There were signs of notable decay of individual stones and many very open joints and displaced masonry, such that vegetation was becoming established in places, and water penetration threatened the interiors below.

The completed work. Photo credit: Nick Cox Architects.

The works to carry out stone repairs and stone cleaning to the North Quire Aisle parapets took place between August 2015 and April 2016. The principal contractor was Sally Strachey Historic Conservation. The work involved cleaning of the stonework, including sulphate encrusted areas, repairing stonework and removing and re-fixing lead flashings, improvements to rainwater disposal. An underspend of c. £13,000 was returned to the fund for re-allocation by the Expert Panel.

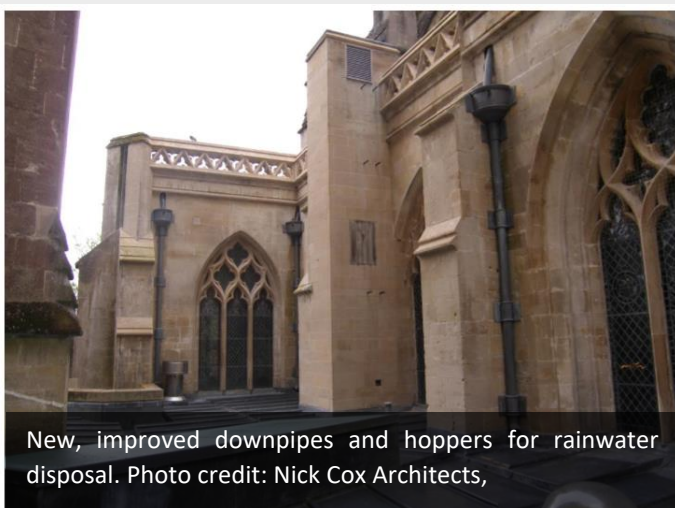
New, improved downpipes and hoppers for rainwater disposal. Photo credit: Nick Cox Architects,

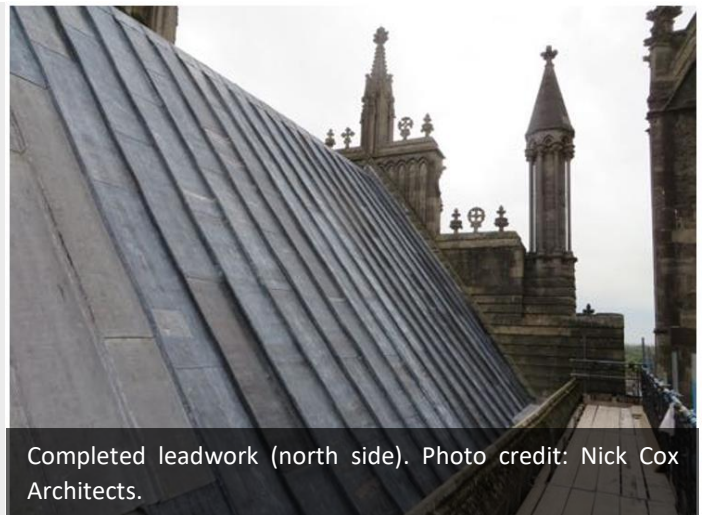
Completed leadwork (north side). Photo credit: Nick Cox Architects.

The works were carried out between May 2017 and December 2017 by Ellis & Co (Somerset) and involved: stripping, recasting and relaying the lead to both roof areas, including the gutters and rainwater outlets; carpentry repairs as necessary to timber substrate and roof structure; stone repair and replacement to high level masonry and parapets; removing and re-fixing lead flashings at parapet level; redecoration and localised replacement of gutter brackets, and strengthening of localised area of existing walkway to accommodate increased loading during the works. The original project cost estimate of £393,000 was exceeded by nearly £100,000 because of the complexity of the scaffolding task being underestimated and, once access was possible, the discovery of higher levels of timber decay than expected, up to 90% in places. The fund's Expert Panel re-allocated a further £90,000 towards the work from underspend elsewhere, and the balance was contributed by the Friends of Wells Cathedral.

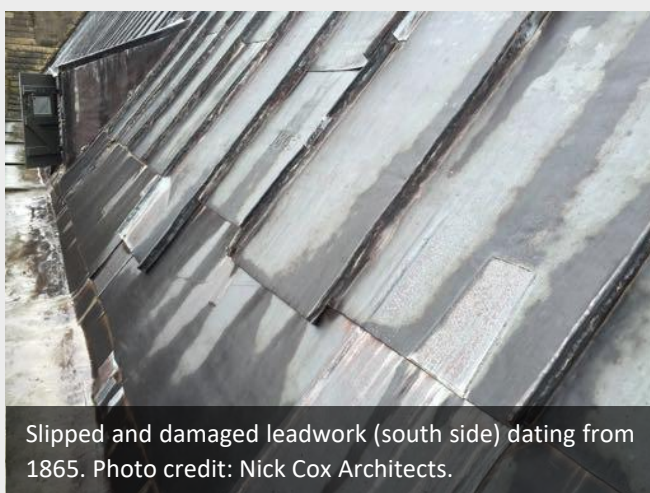
The need for repairs to the nave roof was reported in the 2013 Quinquennial Inspection and became acute in July 2016, when leaks became apparent after heavy rainfall where lead sheets had slipped. Much of the leadwork dated from the 1860s or even earlier and was extremely thin in places, with much patching. Urgent repairs were needed to avoid prolonged exposure of the original medieval timbers and stone vaults of the nave to water penetration and the risk of decay setting in.

Slipped and damaged leadwork (south side) dating from 1865. Photo credit: Nick Cox Architects.
