CASE STUDY ADJUSTING TO SUBSIDENCE, AS PART OF A MAJOR REORDERING

Key Points

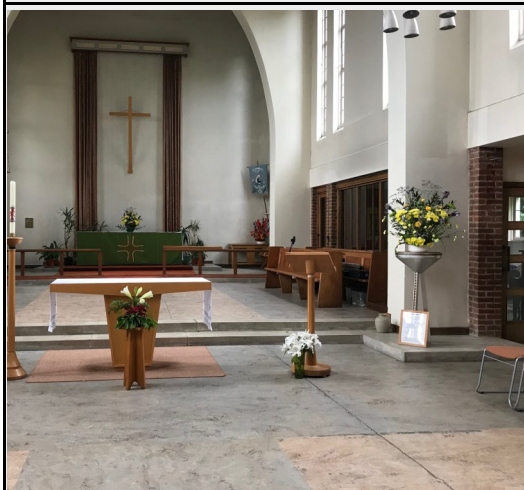
1 View of the crack in the floor that had emerged in St Edward’s, as a result of subsidence in the surrounding area.

Large parts of Mottingham St Edward’s were built on concrete foundations. As the temperature in the UK has increased as a result of climate change the clay soil that surrounds these foundations has started to shift causing widespread cracking problems in buildings and infrastructure throughout the town. The church is no exception to these community-wide problems. In St Edwards this problem of subsidence became evident with the appearance of a large crack along the floor of the church and cracking in the walls that had likely expanded gradually over a period of 50 years. Whilst this level of subsidence is currently at a manageable level, engineers and insurance consultants advised that it should be urgently addressed.

- Installing a high quality LVT floor suitable for the needs of community sports groups with sponge backing and additional secondary underlay that create a floating floor that is more resistant to the propagation of new cracks through the continued process of subsidence.
- Fully repairing the roof to ensure water tightness and sufficient drainage goods.
- Integrating sustainability goals throughout project including the securing of the heating envelope through installation of insulation, secondary glazing for the windows, and switching to LED lighting.
- Adding more substantial facilities as a single toilet was no longer suitable for the growing church's needs alongside larger kitchen facilities that were installed.

The new floor has been installed and utilised by the large number of community groups. The multiple layers of the floating floor allow for additional shift that would not have been possible with the previous floor. This has secured the floor over the long term and allows the church to move its focus onto other needs.

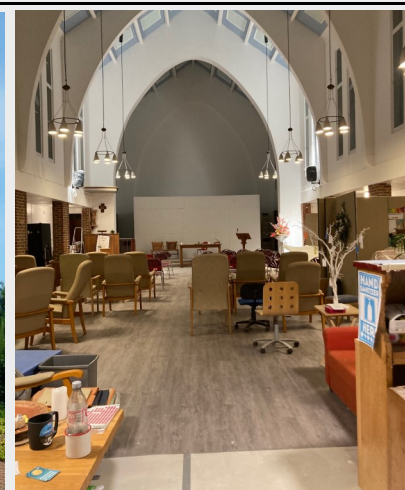
3 The new floor can be seen here in the nave, which is set up for use by one of the many local groups.
