CASE STUDY TAKING EARLY PREVENTATIVE ACTION ON DAMP INGRESS

1 St Mary and St Davids is a Grade I-listed Major Parish Church in Herefordshire.

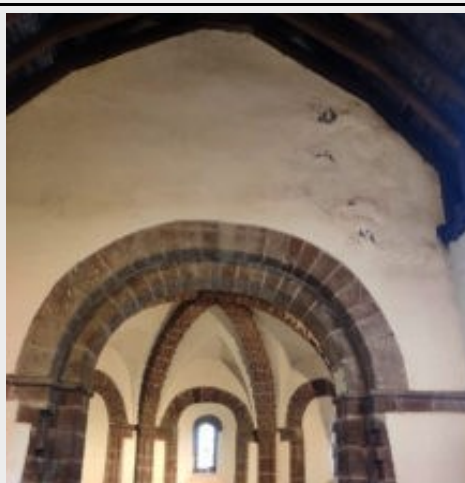
2 Interior damage caused by the presence of damp can be seen here.

Through the quinquennial inspection process it was noticed that the lead flashings on the roof of the Church of St Mary and St David had degraded to a significant extent. Following incidences of driving rain, a weather condition that will be more prevalent throughout the next century, damp ingress got into two parts of the church. This caused damage, particularly to some areas of old plaster that had begun to separate from the walls.

It was recommended by the quinquennial architect that work began on the roof as quickly as possible to prevent further water getting into the building and then repair work to take place on the impacted areas.

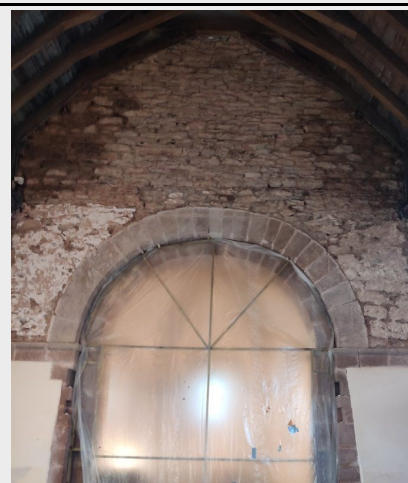
3 The restoration work required plaster to be stripped away.

- To strip out all the old lead from the flashings that had degraded and replace it. This ensured that the building was once again protected from further water ingress, particularly during storm events that had likely caused some of the initial problem.
- Inside the church the work focussed on stripping the walls that had already been badly affected by the damp ingress. This was largely areas which had old plaster that, as a result of the damp, had come away from the wall.

The inside of the church is currently being allowed to dry out. In September they plan to begin the replastering process in the way that is sensitive to the look of the surrounding old plaster work. The final stage will be completed with application of a new coat of lime wash paint.
