Church Commissioners
Mission, Pastoral and Church Property Committee
Mission and Pastoral Measure 2011

The parish of Castleford: the churches of St Paul, Glasshoughton; All Saints, Hightown; St Michael and All Angels, Castleford

Note by Joanna Chandler-Clarke

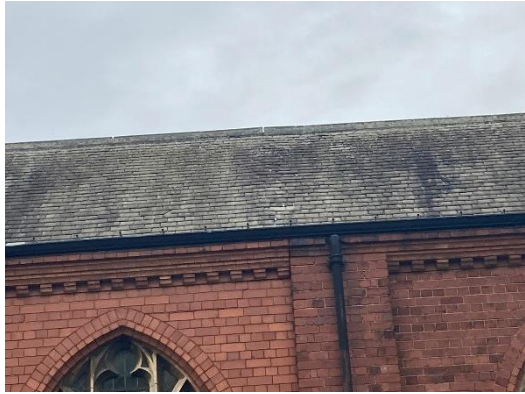
Priority	Description	Photograph	Costing Band
D	The cast iron downpipes would benefit from renovation including re-caulking of seals. A number of downpipes are missing stand-off bobbins which should be replaced when renovations go ahead.

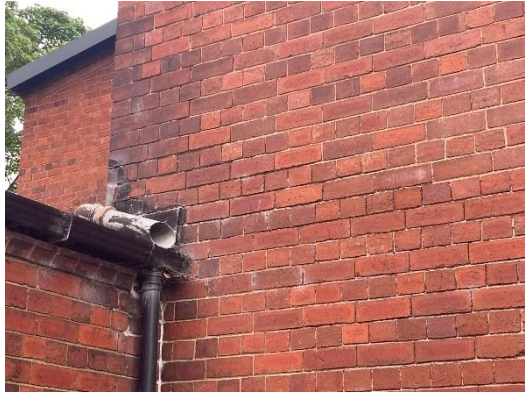
Priority	Description	Photograph	Costing Band
B	The valley gutter where the Vestry abuts the Chancel is susceptible to blocking up due to the number of trees on the site and the position of the existing downpipe from the Chancel. Debris should be cleaned seasonally as part of an ongoing maintenance strategy, and the downpipe arrangement should be altered to minimise future risk to the valley.

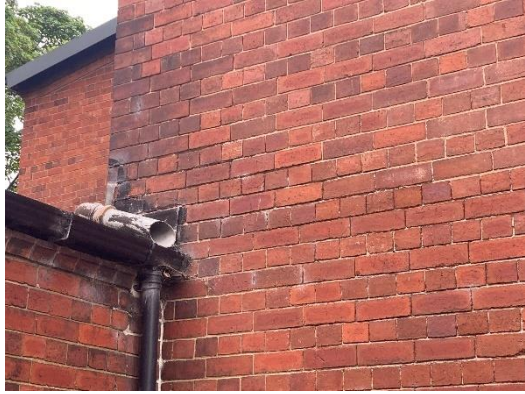
2
B	The North elevation gutter to the Vestry Lady Chapel is of inadequate size to cope with the water run-off from the Chancel and the Vestry roof where the pipe discharges into the gutter. Either a large hopper should be added here or a wider gutter should be installed.

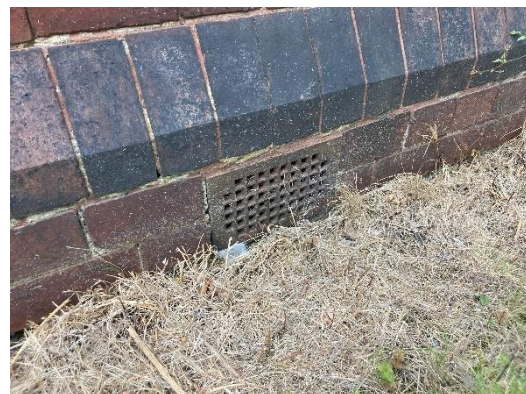
The cast iron ventilation grilles to this elevation are rusting and require re-decoration.

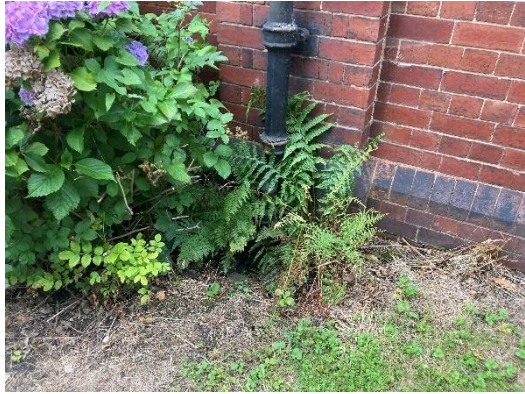
Priority	Description	Photograph	Costing Band
A	Each of the gulleys are severely blocked with some having high levels of vegetation growth. Vegetation should be removed and gulleys unblocked.

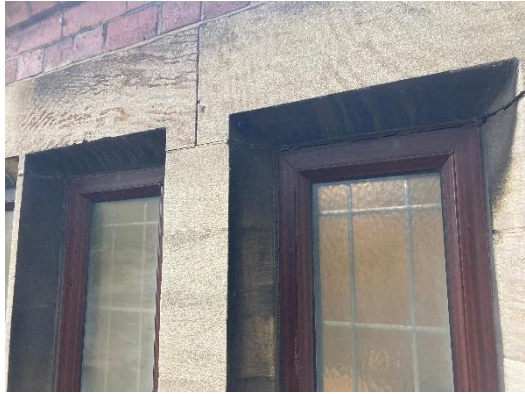
Priority	Description	Photograph	Costing Band
D	To the uPVC windows of the Lady Chapel, the silicone has started to split and this should be resealed. This could be caused by the adjacent step fracture moving the window stones and stretching the silicone.

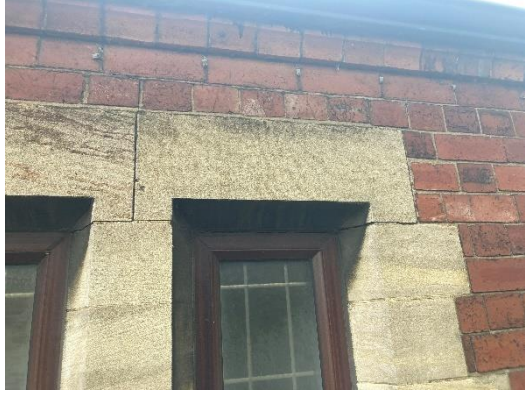
1
C	There is displacement to the Lady Chapel window surround stones. Allowance should be made for the stones to be reset and repointed with helical bar repair, with the repairs kept under observation for signs of further movement, subject to structural engineer's confirmation.

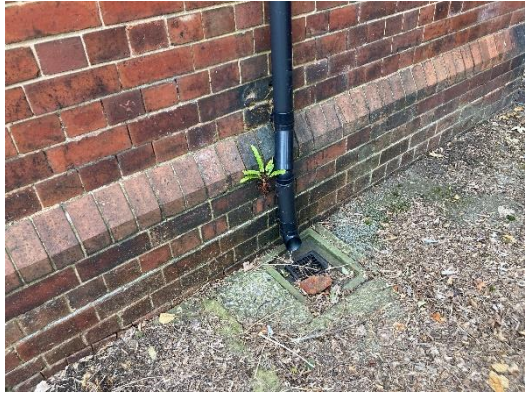
Priority	Description	Photograph	Costing Band
B	The plastic downpipe to the Vestry South West corner is broken at the bottom, lacks a shoe, does not appear to discharge into any gully and is spilling onto the plinth. A new shoe should be installed extending into the gully.

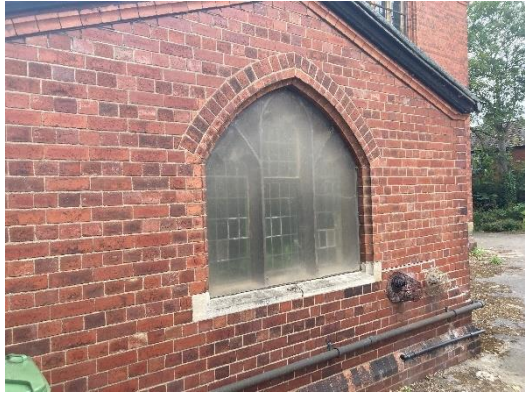
Priority	Description	Photograph	Costing Band
C	There is an open joint to the window sill which should be repointed in a lime mortar.

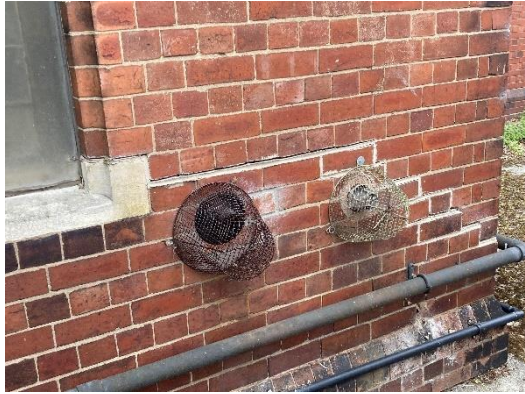
1
C	There is a horizontal fracture that progresses to a step fracture, running from the window sill through to the plinth. Allowance should be made for the fracture to be repointed in lime mortar and helical bar stitched, with the repair kept under observation for signs of further movement, subject to confirmation by structural engineer.

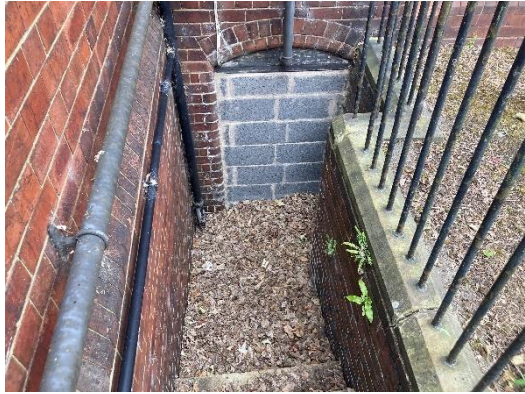
Priority	Description	Photograph	Costing Band
C	There is vegetation growth to the retaining wall of the boiler house steps, which should be removed and any recessed joints repointed.

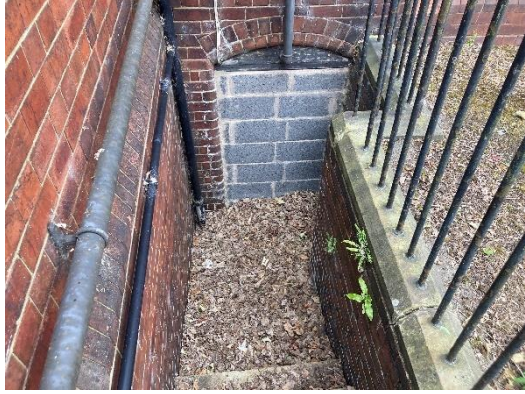
1
C	The boiler house entrance opening has been blocked up preventing access, it would be beneficial to gain access to determine the condition of this space and whether it is having a detrimental affect on other areas of the building.

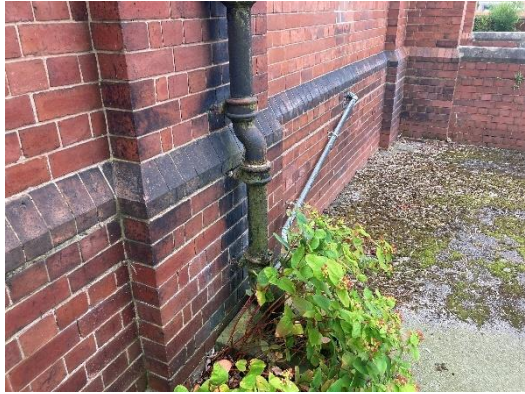
Priority	Description	Photograph	Costing Band
B	The cast iron downpipes require an overhaul, as they have started to rust. They should be fully redecorated with joints resealed and mounted on new bobbins with secure fixings.

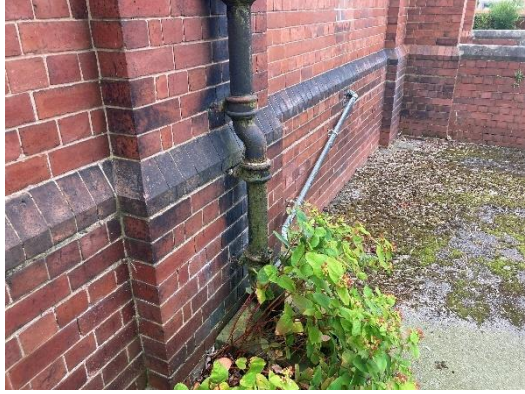
2
A	Each of the gulleys are severely blocked with some having high levels of vegetation growth. Vegetation should be removed and gullies unblocked.

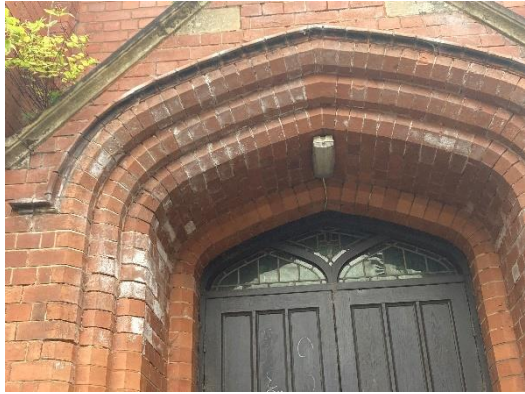
Priority	Description	Photograph	Costing Band
B	There is high levels of brick salting, particularly to the doorway arch of the North porch. This is caused by water ingress through the porous masonry of the North porch coping stones. The salts should be brushed off and consideration should be given to re-bedding the copings on a lead DPC.

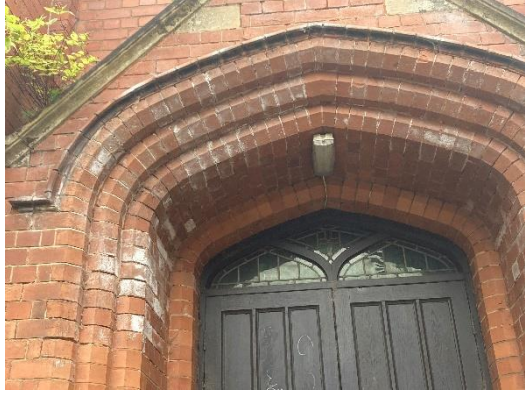
2
C	There are some recessed joints and broken brickwork where a light fitting was installed to the North Porch, with the broken bricks replaced and recessed joints pointed with lime mortar.

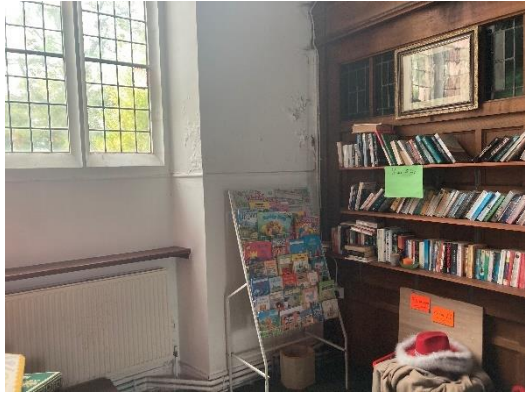
3
D	Further areas of failing paint finish, see above for remedial works.

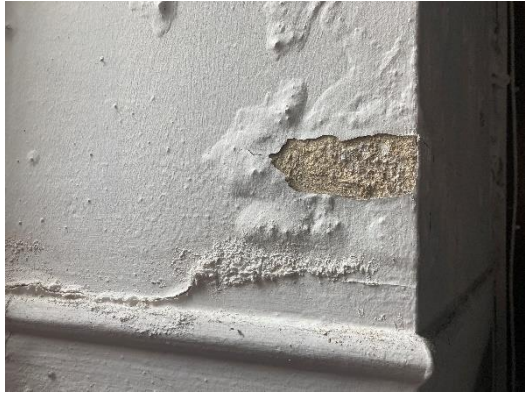
3
D	Further areas of failing paint finish, see above for remedial works.

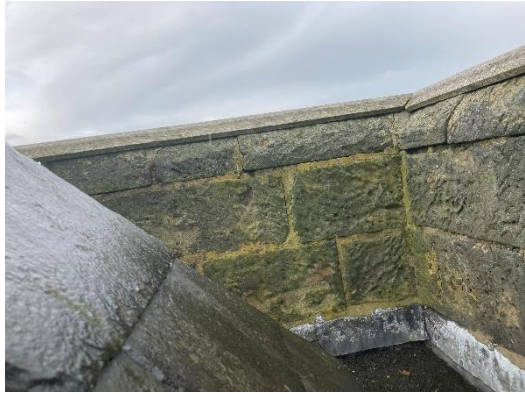
4
B	There is some stone erosion and decay generally to the parapet stonework. This may be caused by the exposed nature of the stonework but also due to the cementitious mortar has been used. Given the external cracking (covered under the elevations section of this report), the parapet stonework should be full rebuilt in lime mortar.

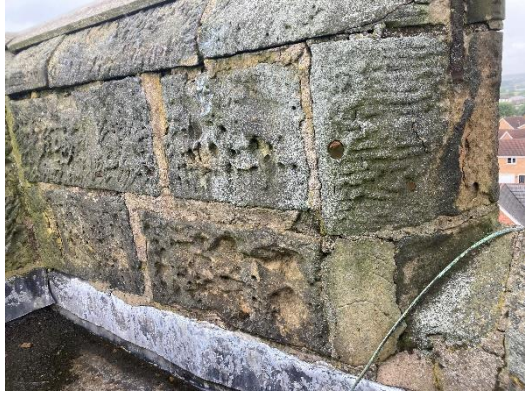
4
B	Timbers have been used to provide edge protection to the crenelations. Consideration should be given to installing a longer term solution, possibly as part of a rebuild of the parapet.

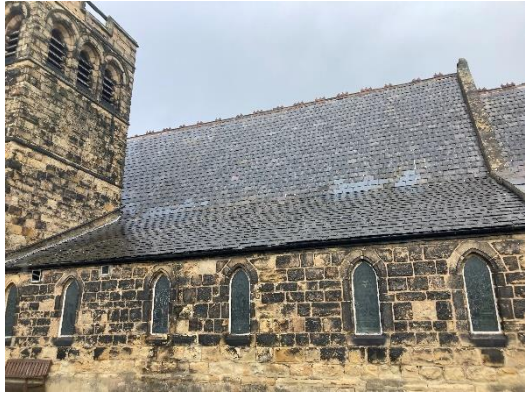
2
D	<p>There has also been damage to the decorative ridge tiles and they should be replaced.</p>

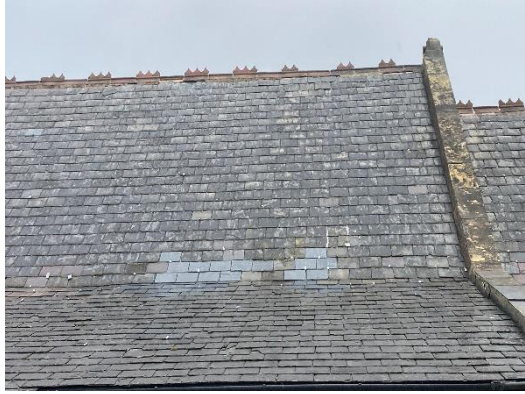
1
C	<p>There are some open joints and missing mortar to the ridge which should be fully repointed.</p>

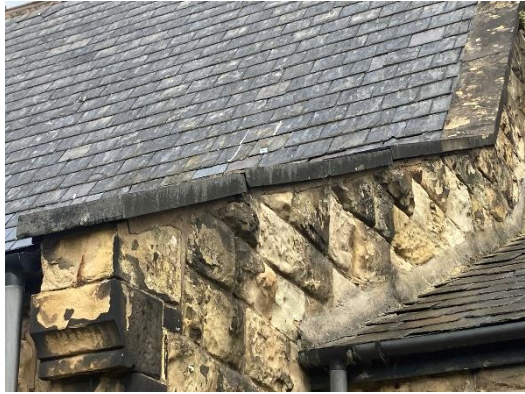
3
C	The coping stones to the east of the South Nave look in acceptable condition, although the mortar joints are recessed. They should also be fully re-bedded onto a lead DPC to assist with waterproofing the Nave.

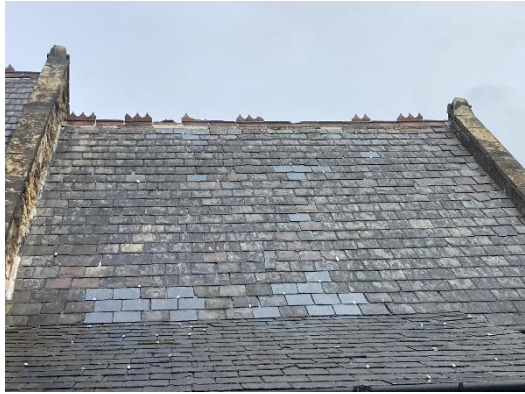
2
D	<p>Similarly to the South aisle and nave roofs, there are some damaged or missing decorative ridge tiles, which should be replaced.</p>

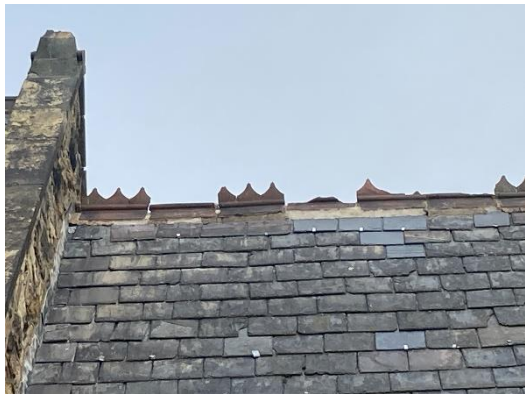
1
C	<p>There is some open joints and missing mortar to the Ridge which should be fully repointed.</p>

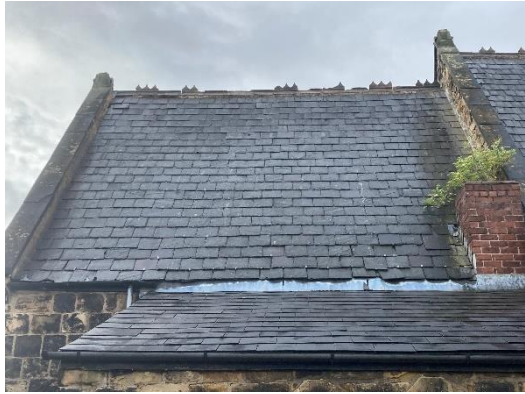
2
A	Nave North Slope There is a section of missing guttering to the north elevation, where water is discharging down the face of the building and onto the infill extension between the church and the whole. This should be replaced urgently.

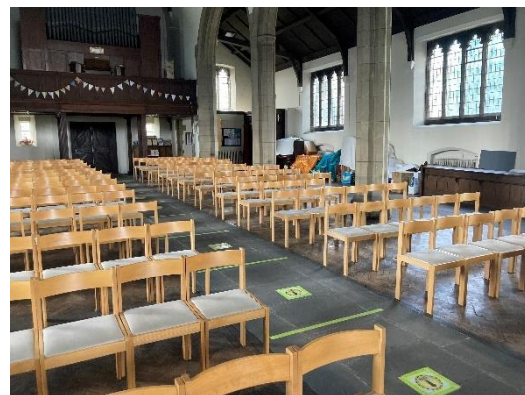
C Numerous areas of loose parquet blocks which should be re fixed into position.

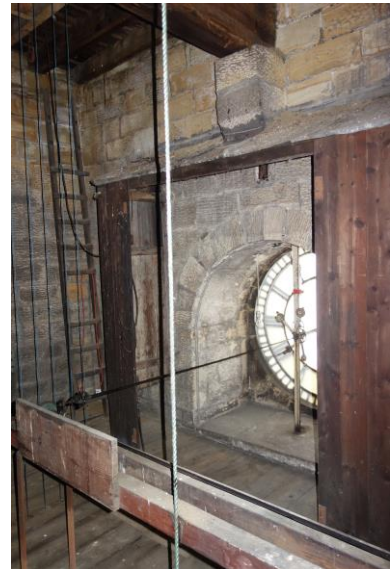
Clock Mechanism Level.
 10.6 Under side of floor to above appears sound. No replacements visible. Walls above are in good order. Two narrow slit windows to the north side show the thickness of the wall at around 900mm with some protective glass on the inner plane in a hinged frame. This appears to be made fast. Opening these up and clearing the bird guano and putting bird spikes would be good. -

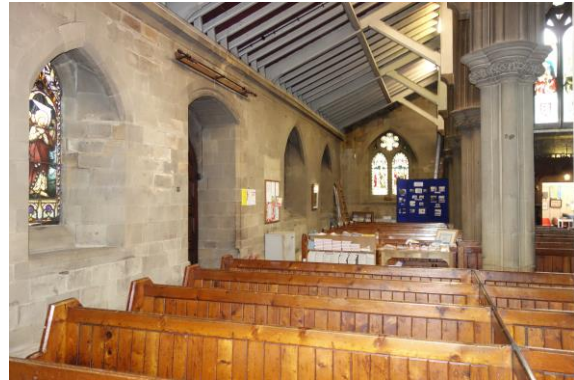
There is distress within the sarking board at each end where the abutments are with parapet copings or south Transept. Obtain timber decay specialist report as above.

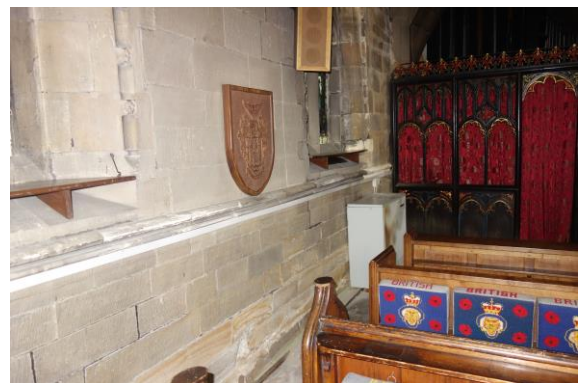
7.20 The bottom three courses of masonry along the length of this Aisle are suffering severely from efflorescence and spalling of stone face and the limestone string is also showing signs of aggressive salting. Investigate and remedy. C
