Edgeley: St Mary's (Test)
Quinquennial Inspection
20/11/2018

Name: Edgeley: St Mary's (Test)

Churchcode: 647002

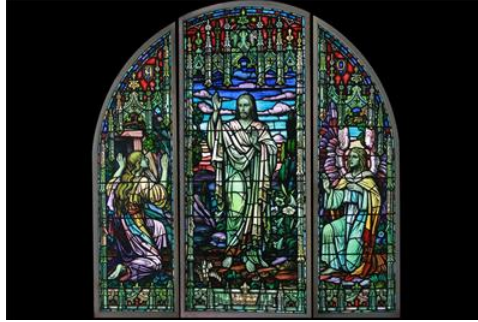
Caption: Window example

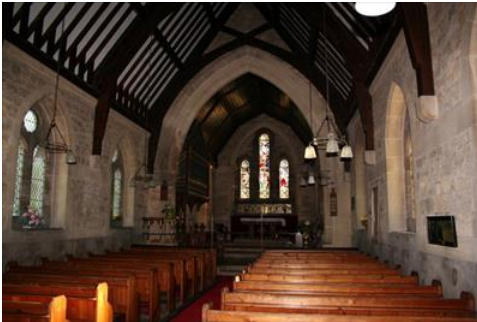
Caption: Window two
