## **The Church of St James the Great, Stoke Orchard, Glos**

### **2020 Wall Painting Conservation Project**

**Mark Perry ACR**  
**Adam Klups FIIC**

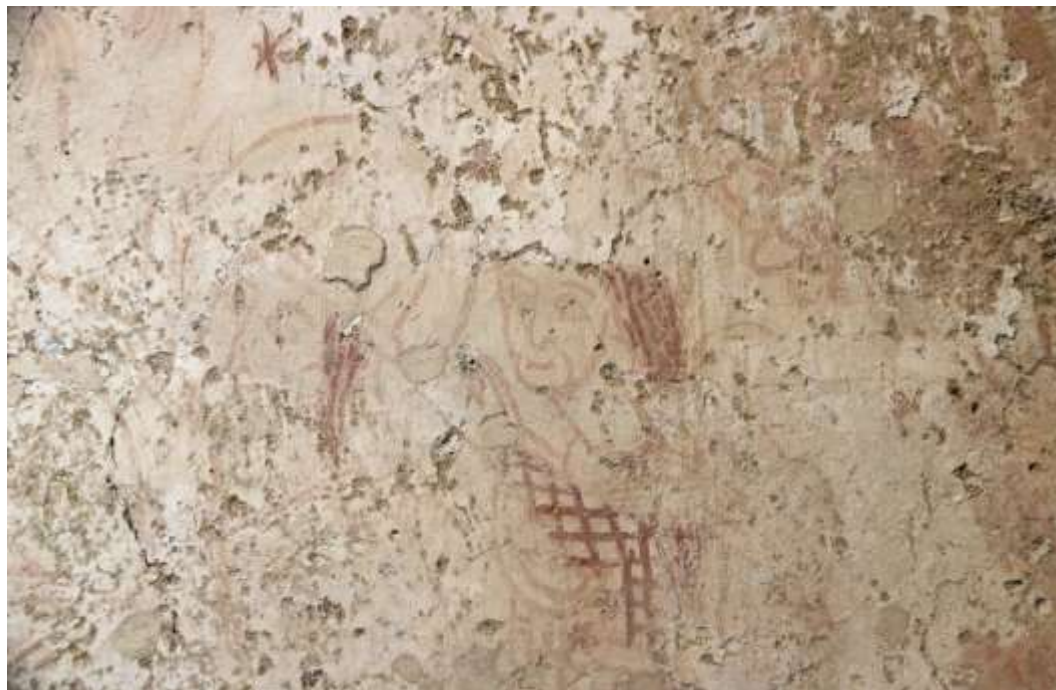
Before treatment

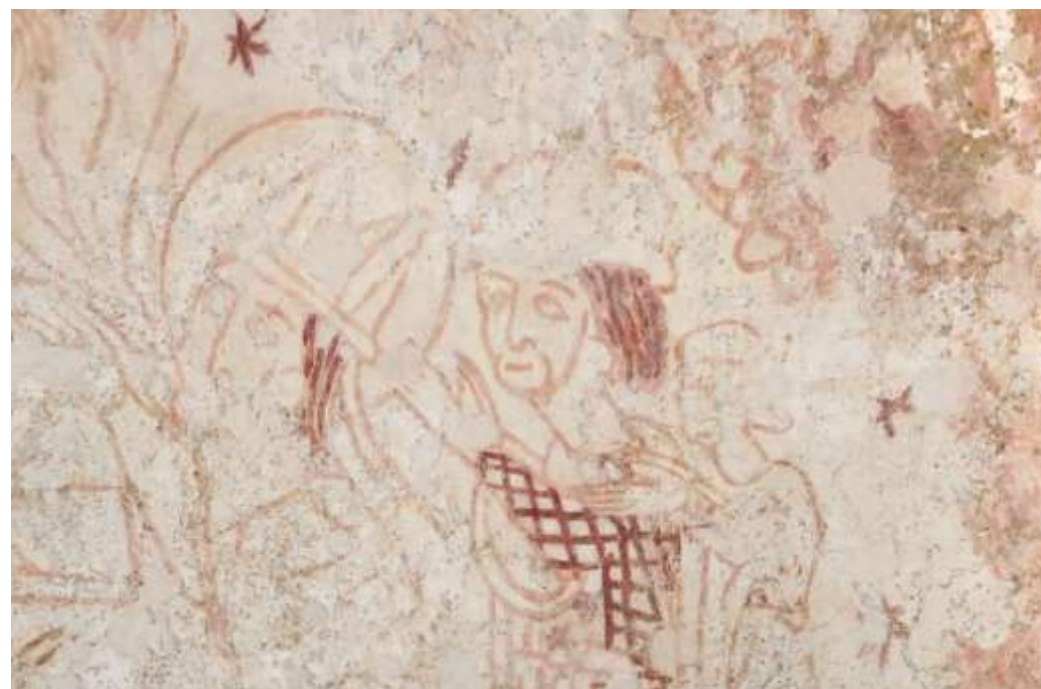
After treatment

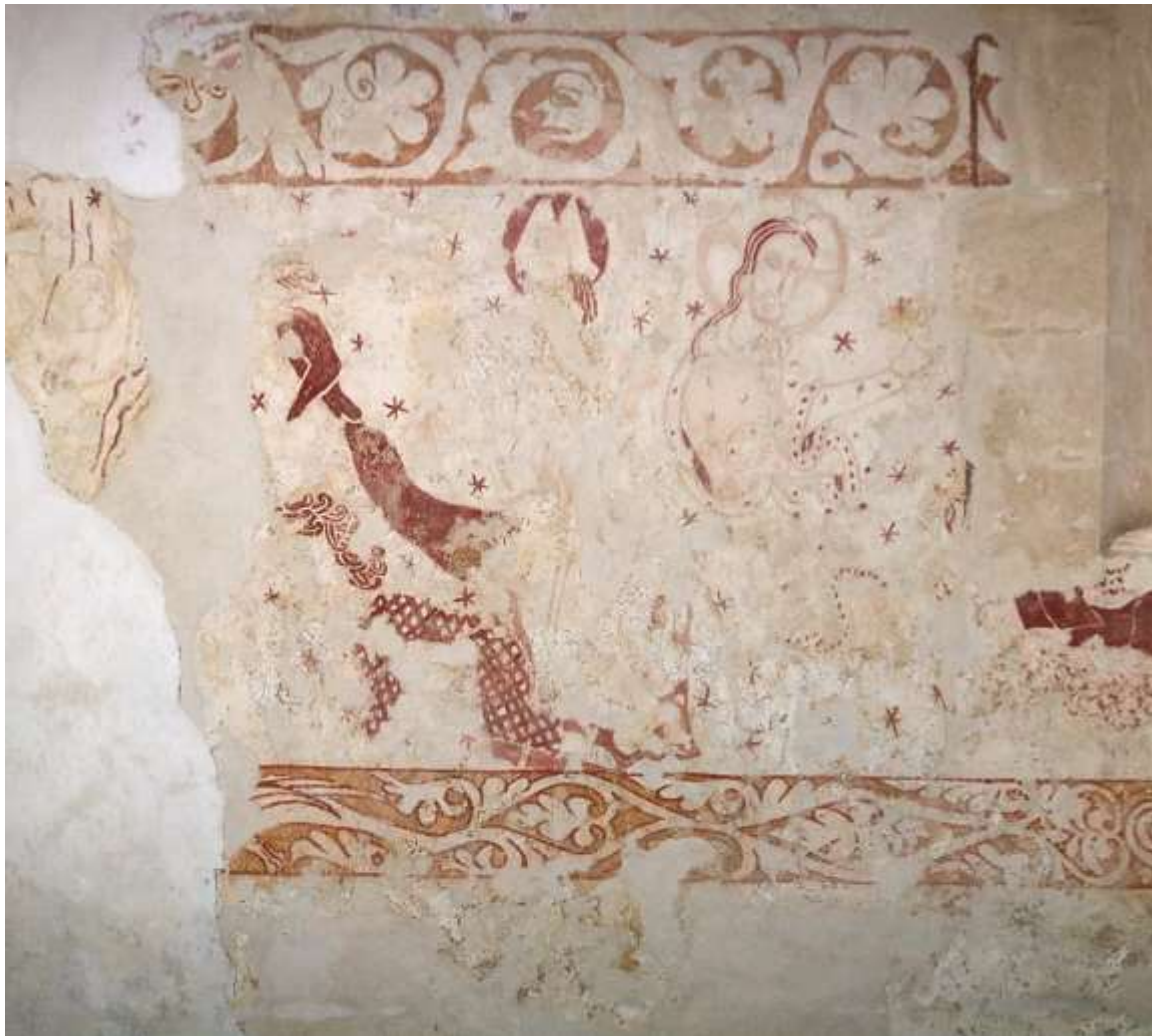
West wall, south side – scenes 17 & 18: St James overcoming the *familiar*; Christ blessing (after treatment). The scenes are separated simply by the figures having their backs to each other.

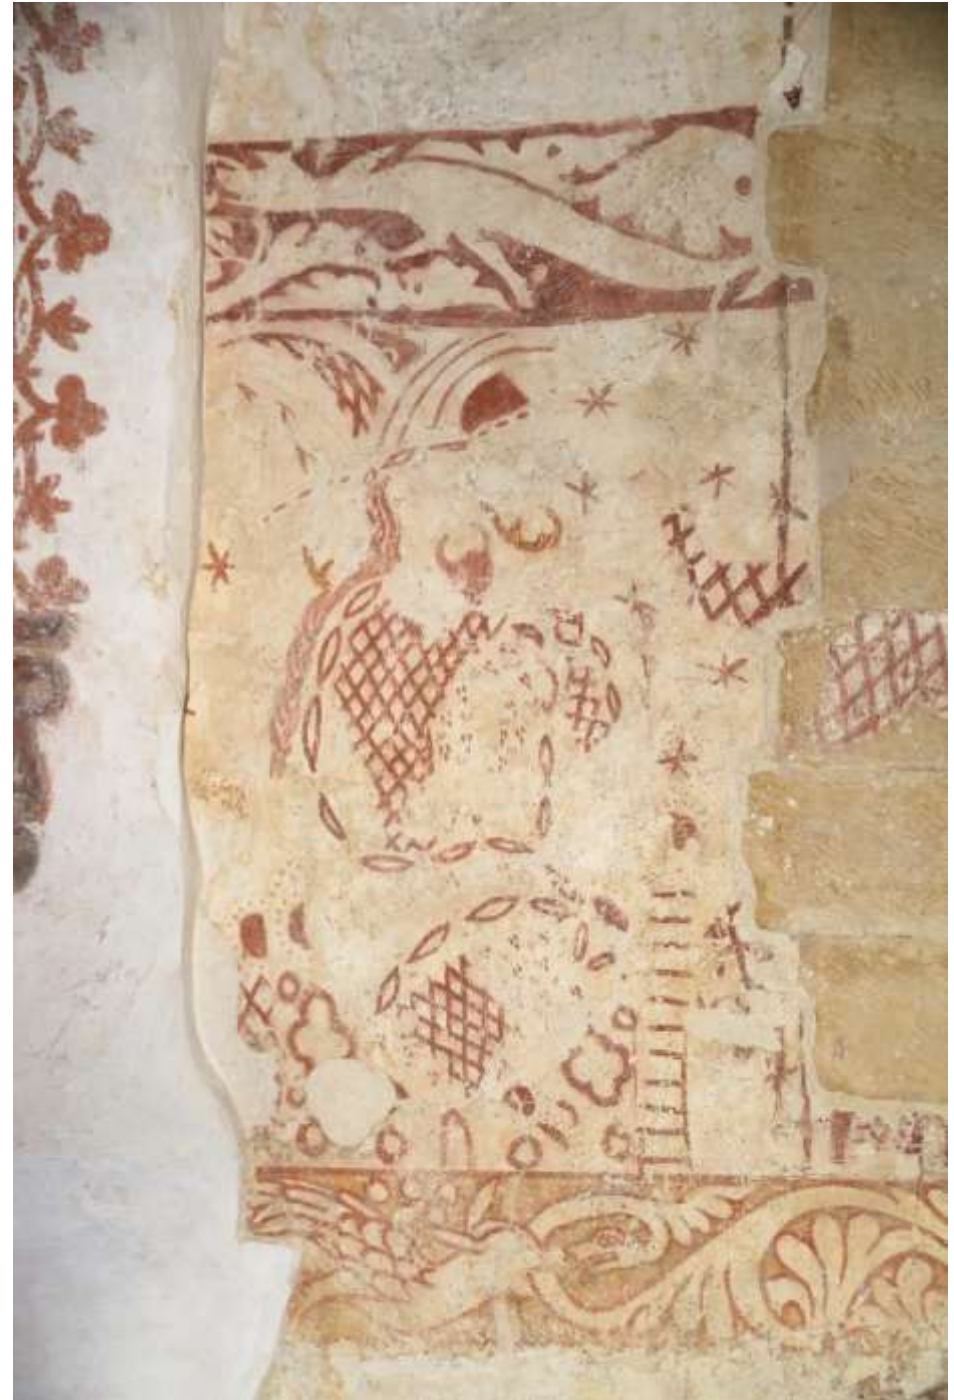
North wall – scene 22; The Scourging of St James (after treatment). The central figure – identified either as the High Priest or Herod Agrippa – has an elaborate headdress, long plait and distinctive patterned dress.

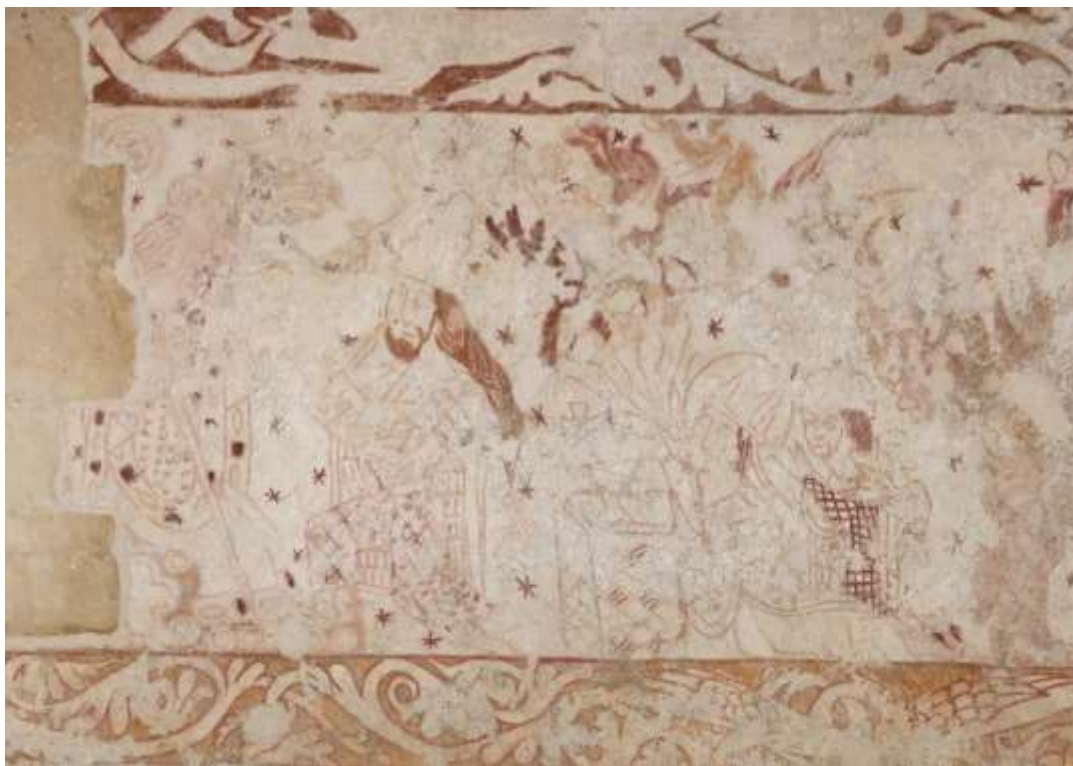
South wall, after treatment: Scenes 4&5 – *Hermogenes' aid sought by the chief Pharisee; he sends devils to attack St James who is saved by prayer. Phletus and his son are pictured behind St James.*

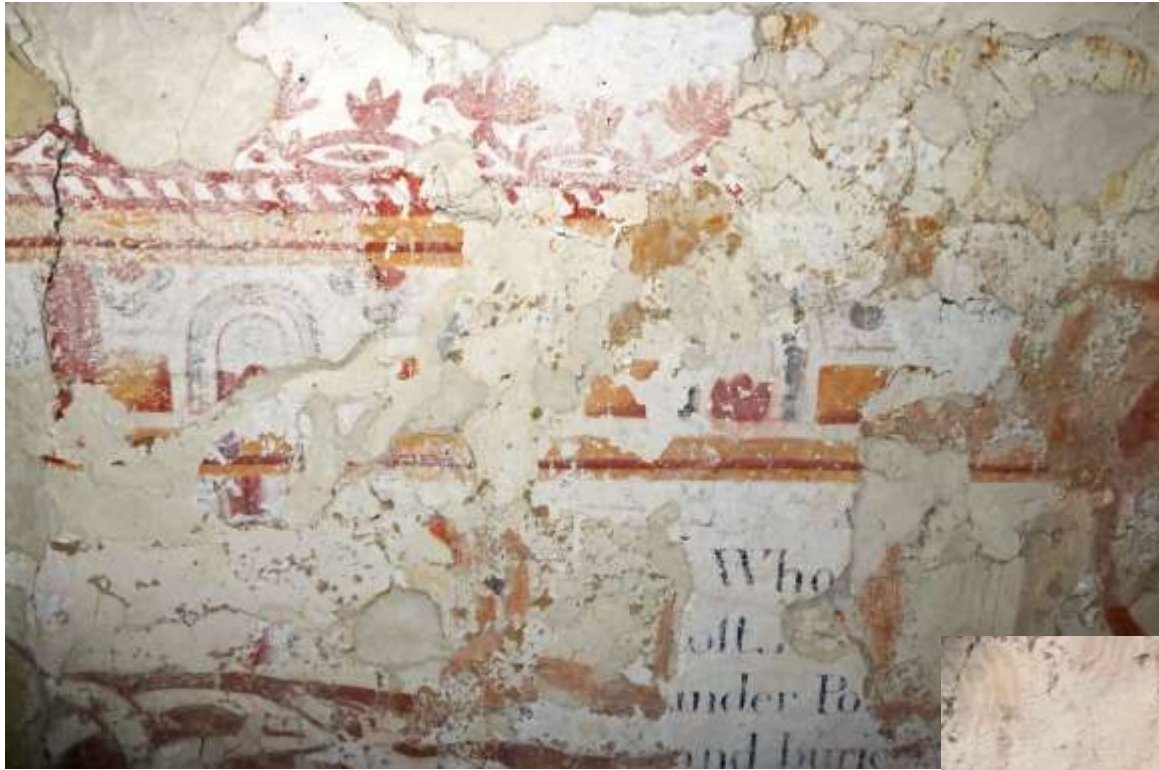
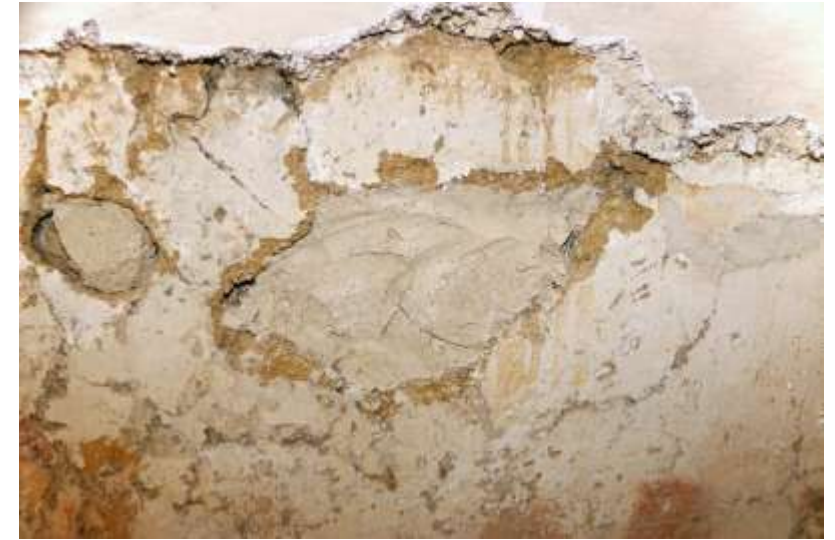
Examples of inappropriate previous repairs and surface losses on the south wall

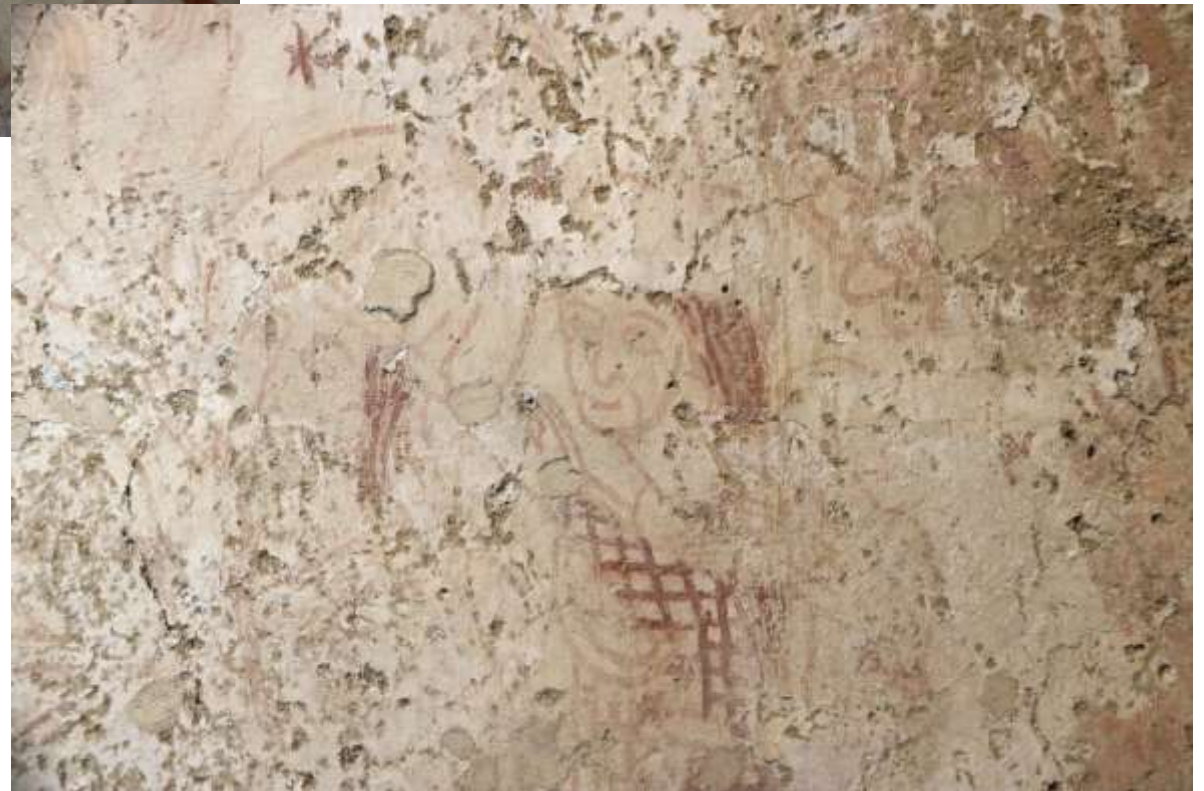
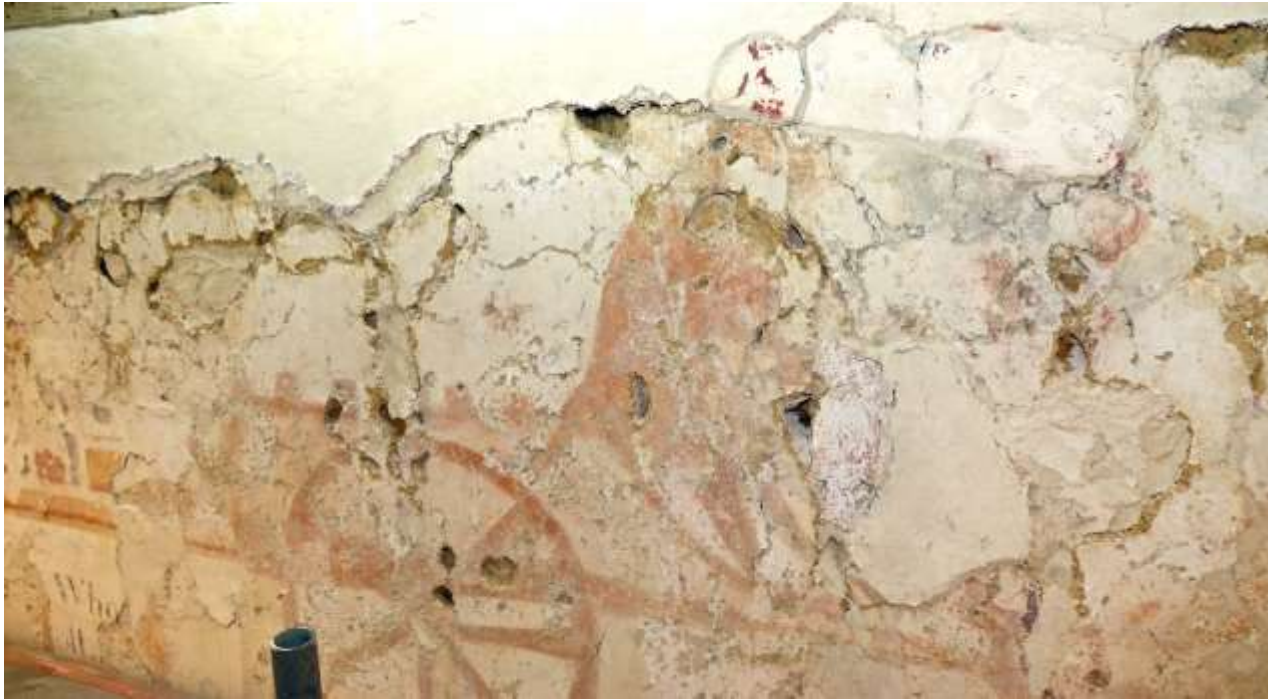
Removal of previous repairs often exposed extensive damaged support plaster, with numerous voids behind the paintings surface, that required grouting

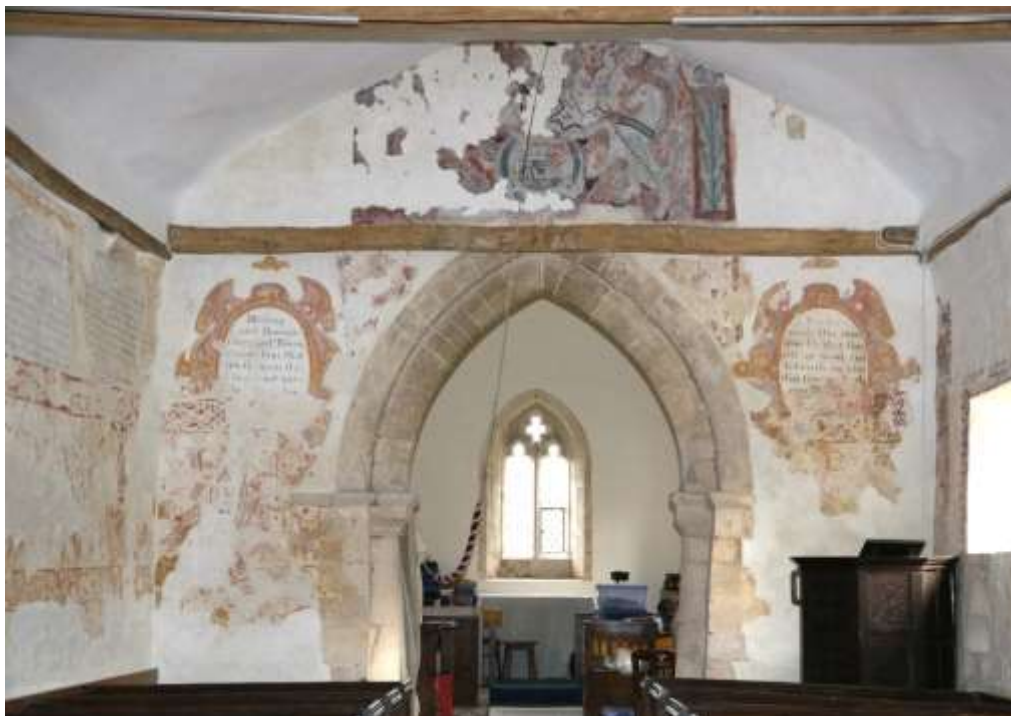
East wall, before &amp; after treatment

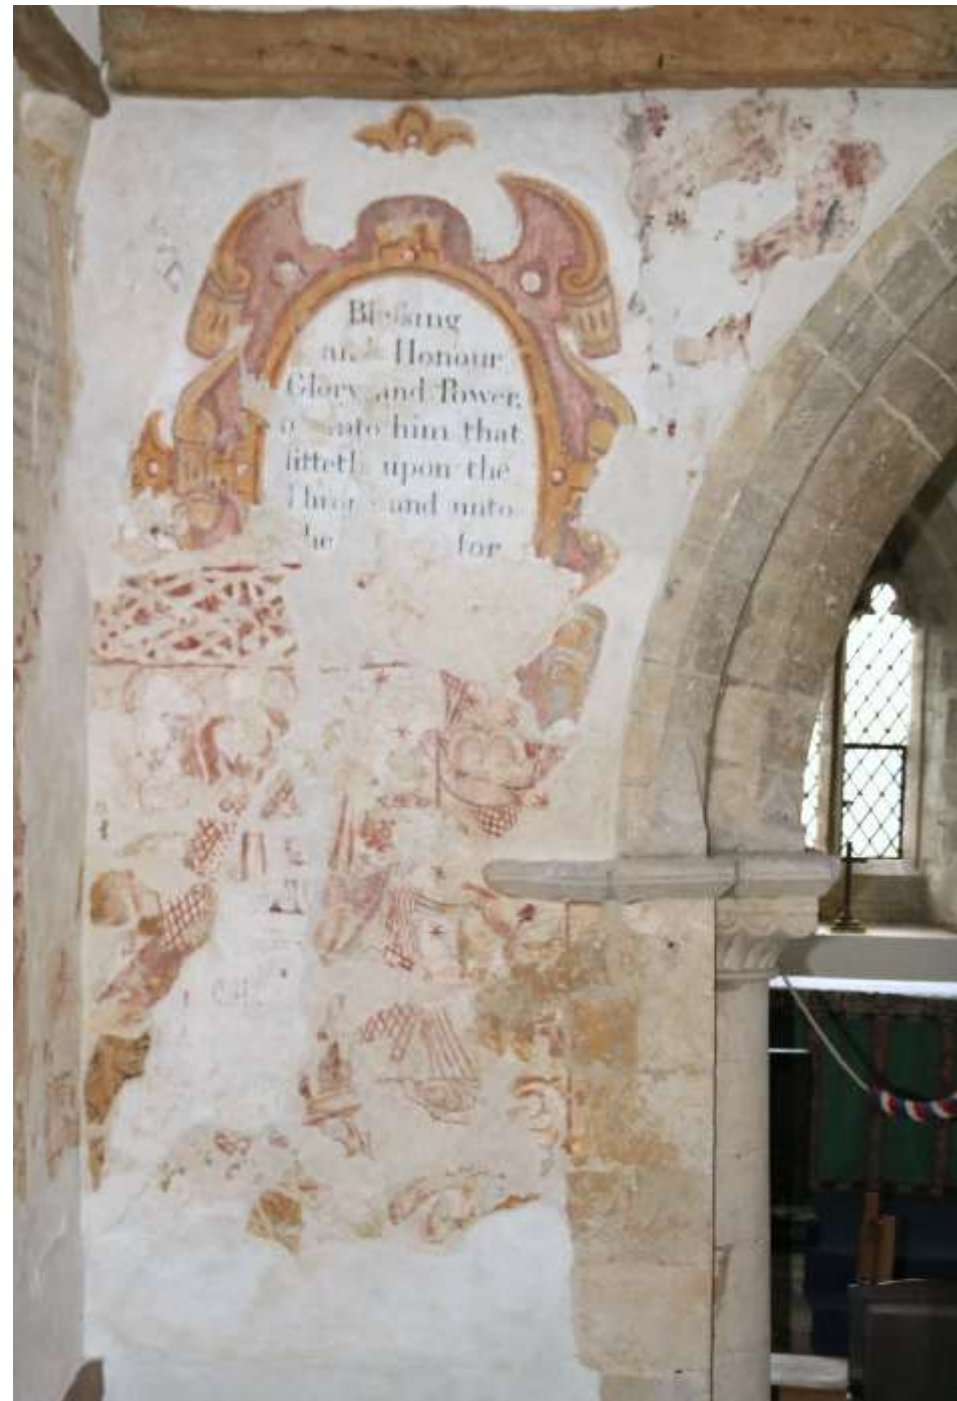
South-east corner, after treatment

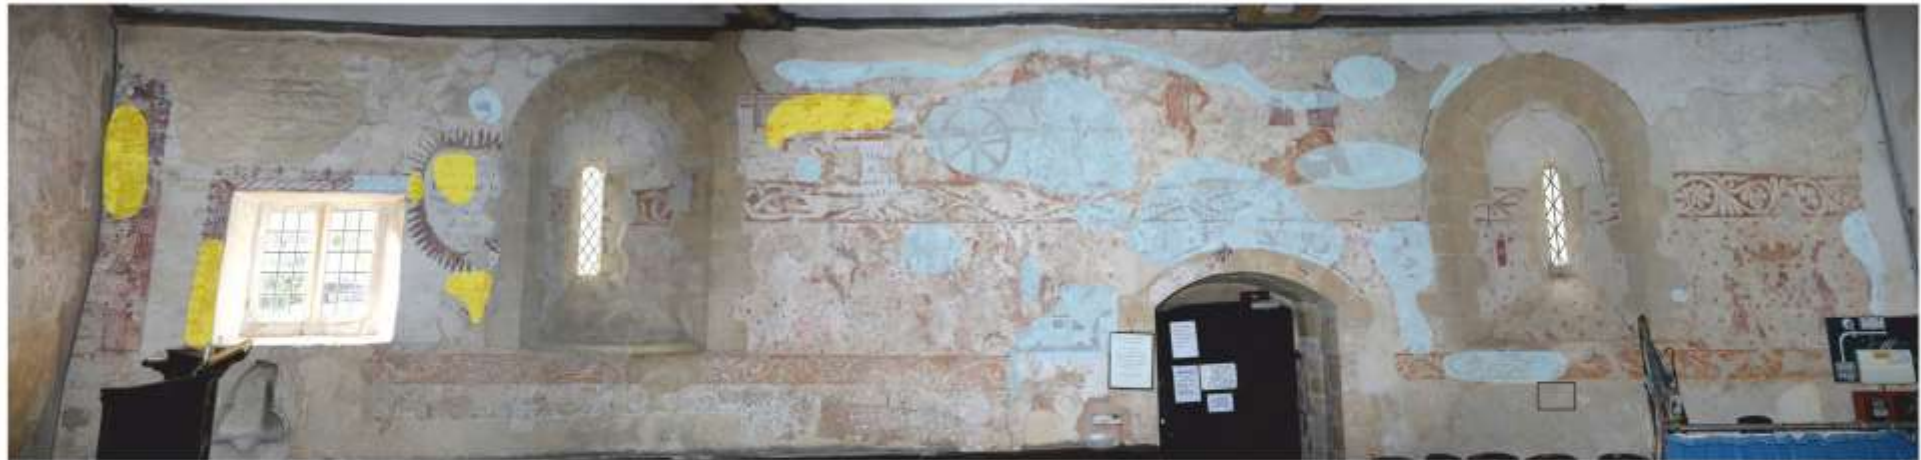
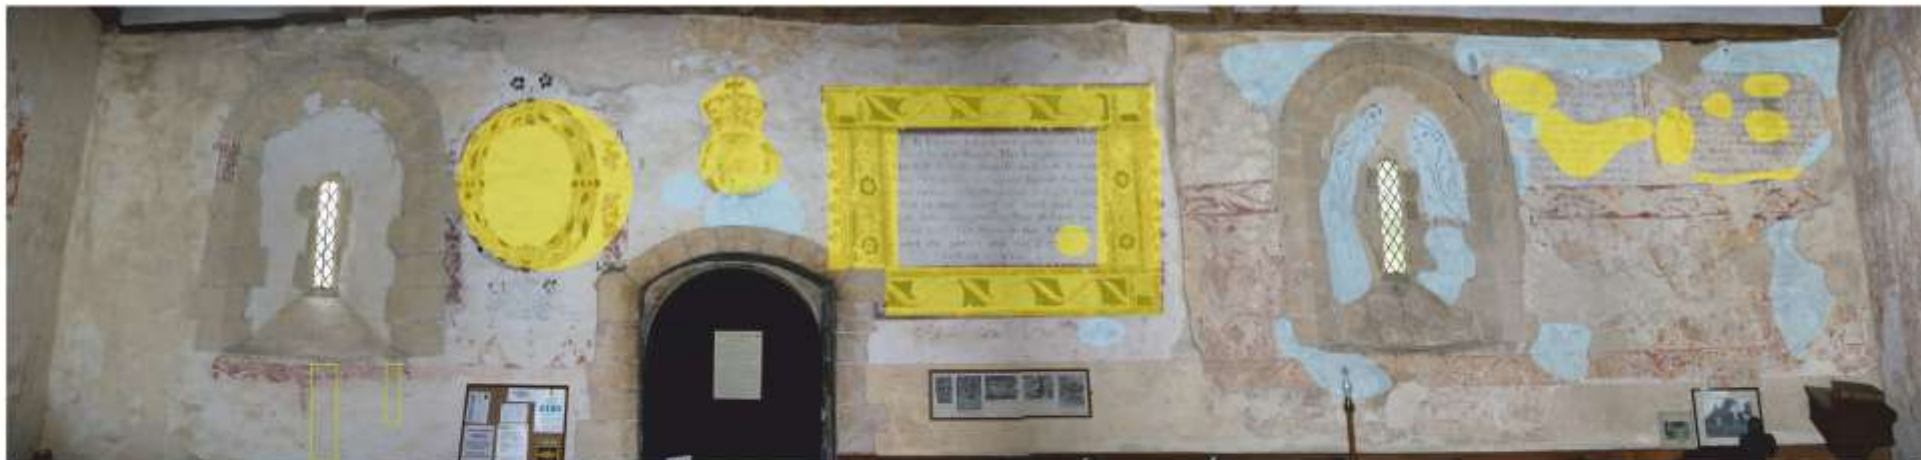
The photographs used as the base for these graphics were taken before treatment

KEY       Unstable paint & ground (treated)       Unstable plaster (treated)       Water/wax drips (treated)

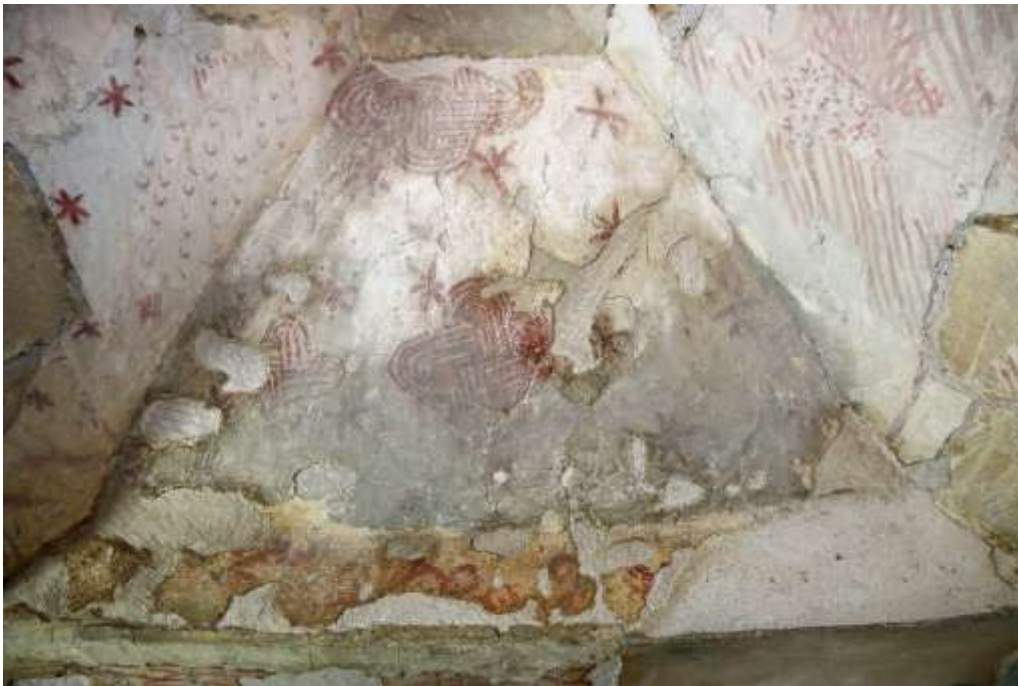
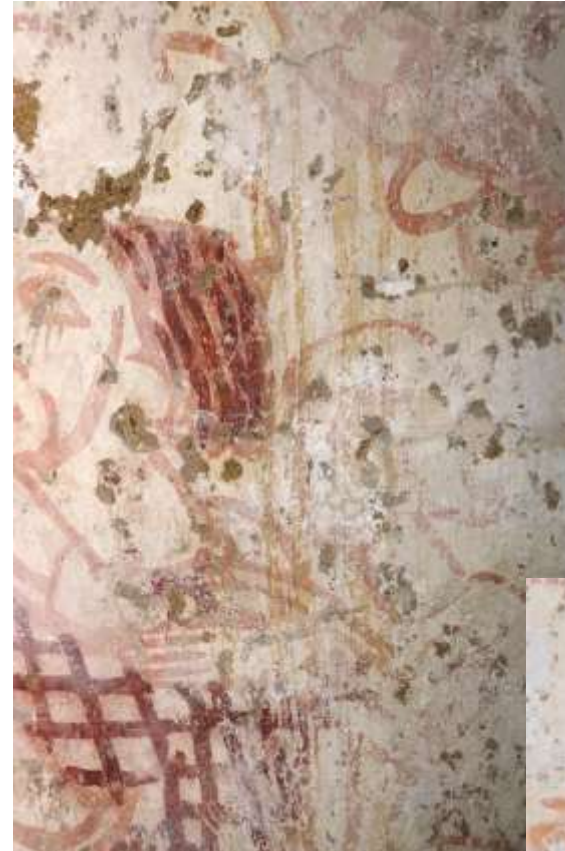
South wall, centre area – before & after dirt & staining removal

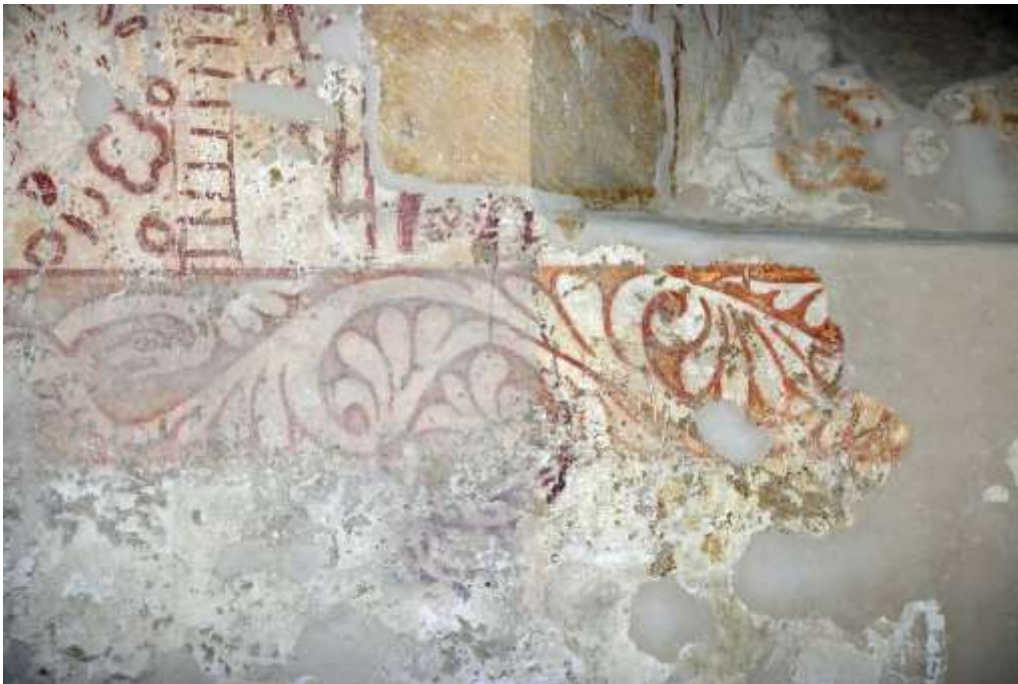
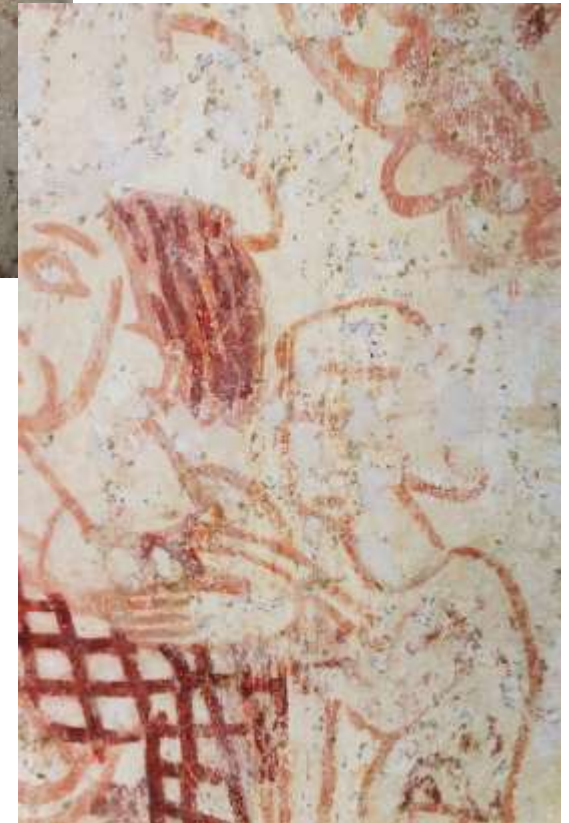
Examples of dirt removal – during treatment

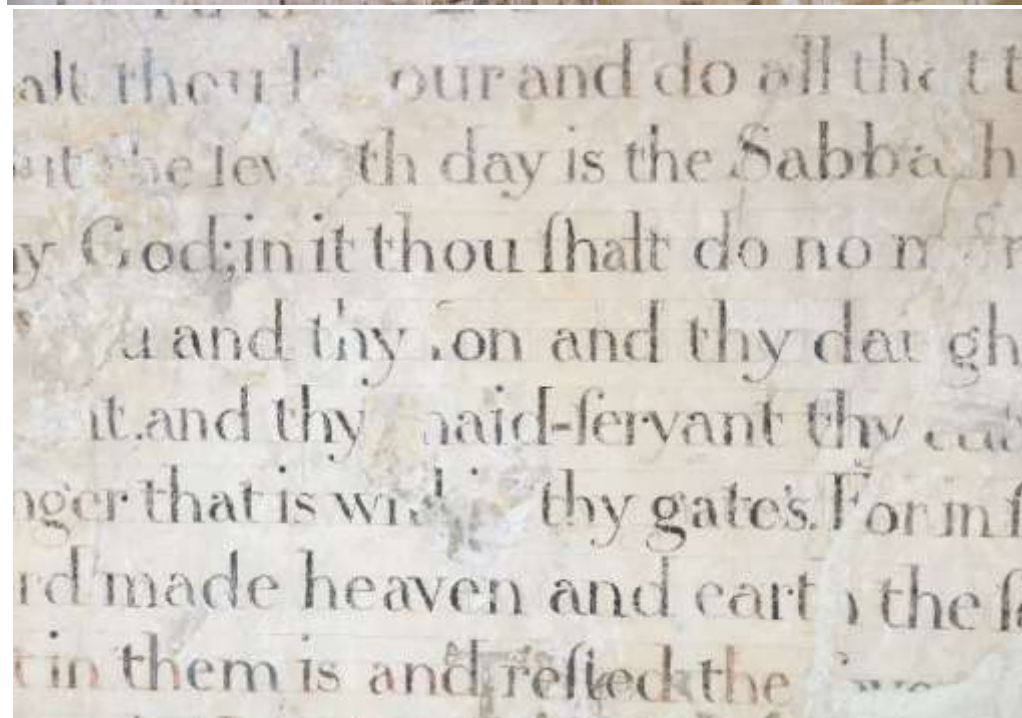
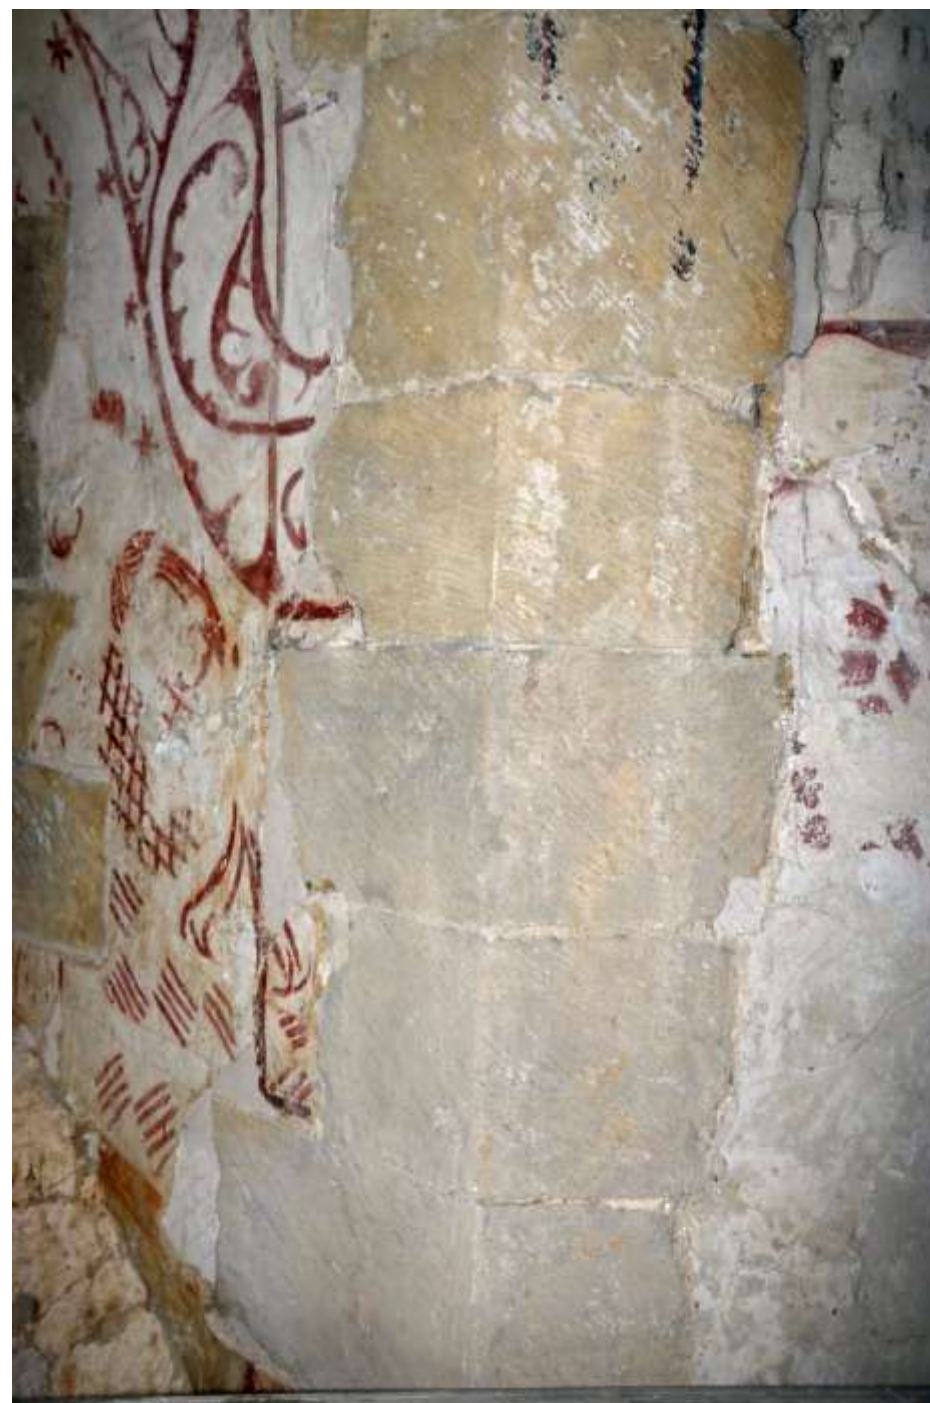
Examples of before and after dirt removal from the 10 Commandments (above left) and during cleaning the exposed stone work on the north window voussoirs (above right)

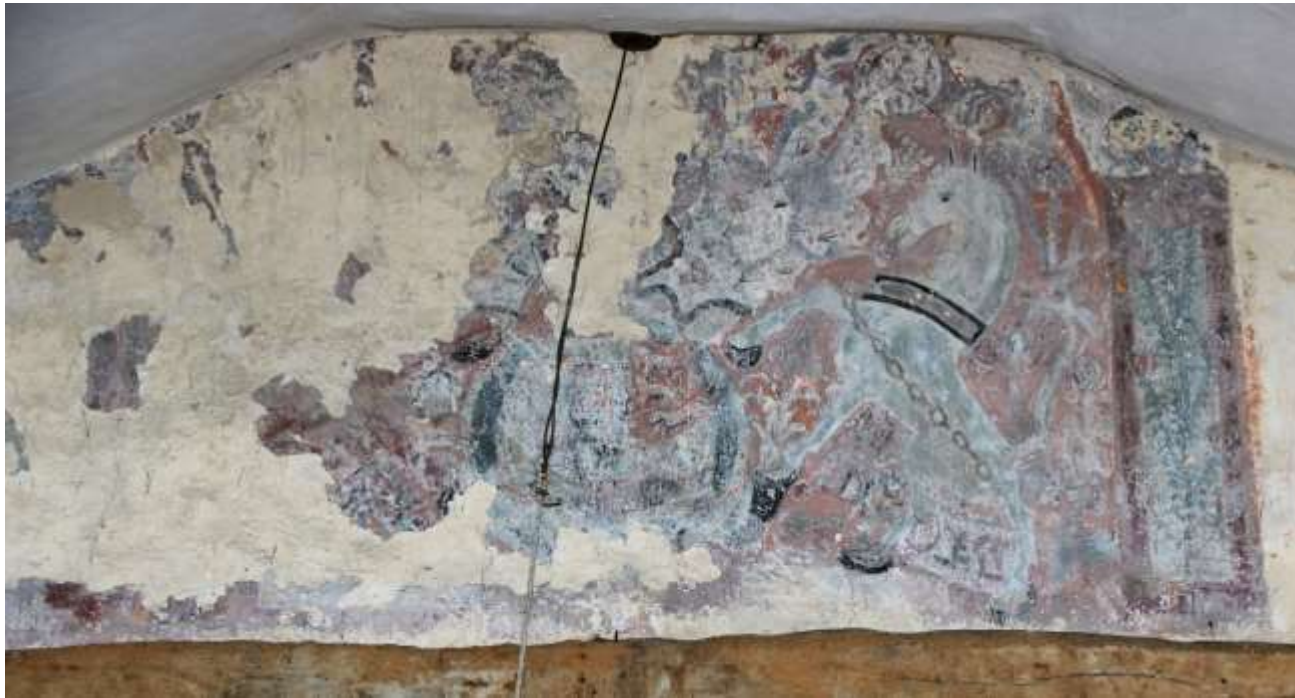
Upper east wall. - The Hanoverian Arms, context & detail  
before & after treatment

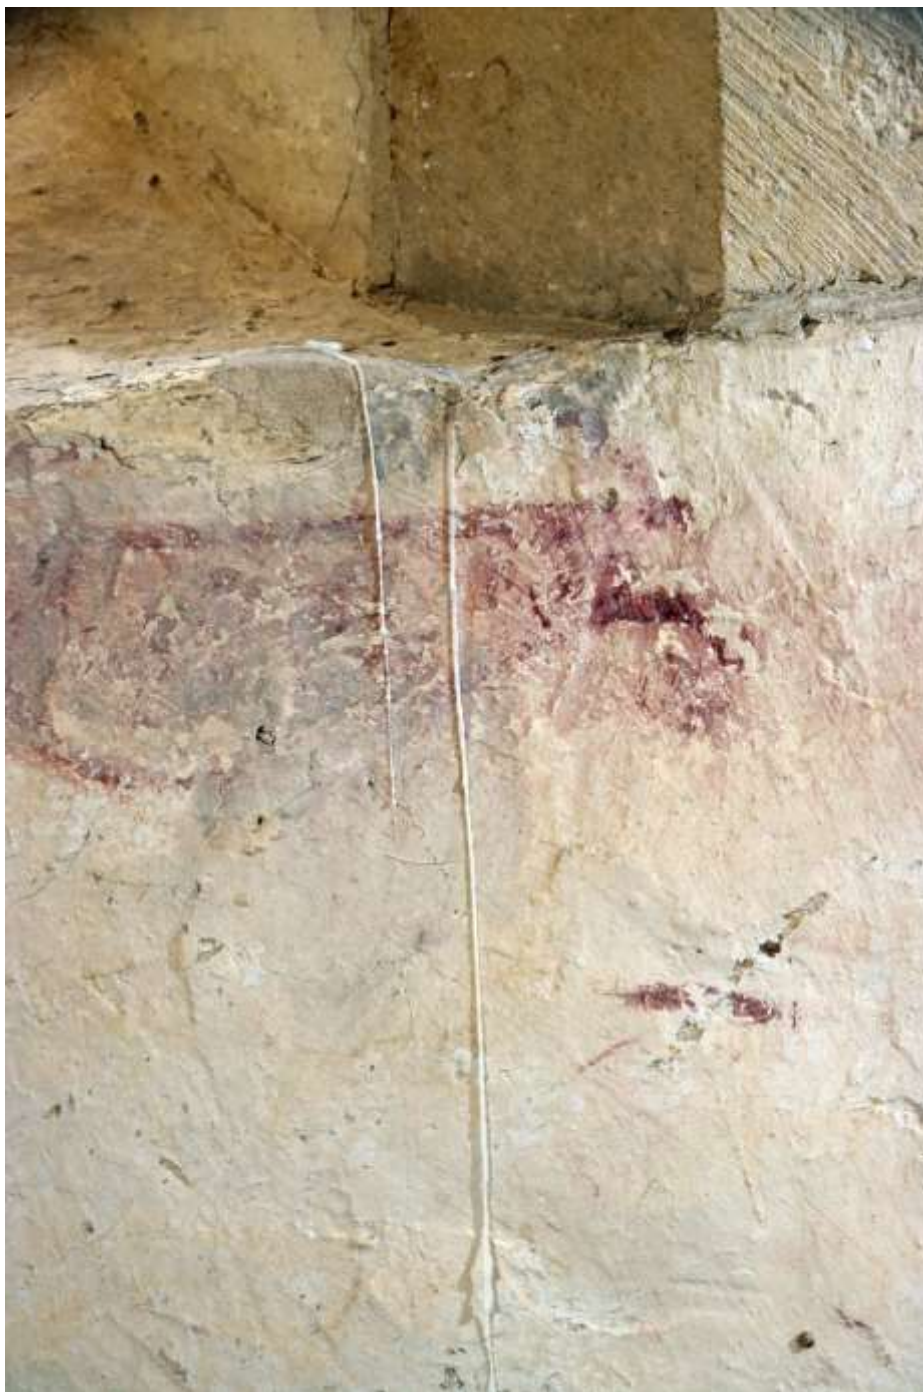
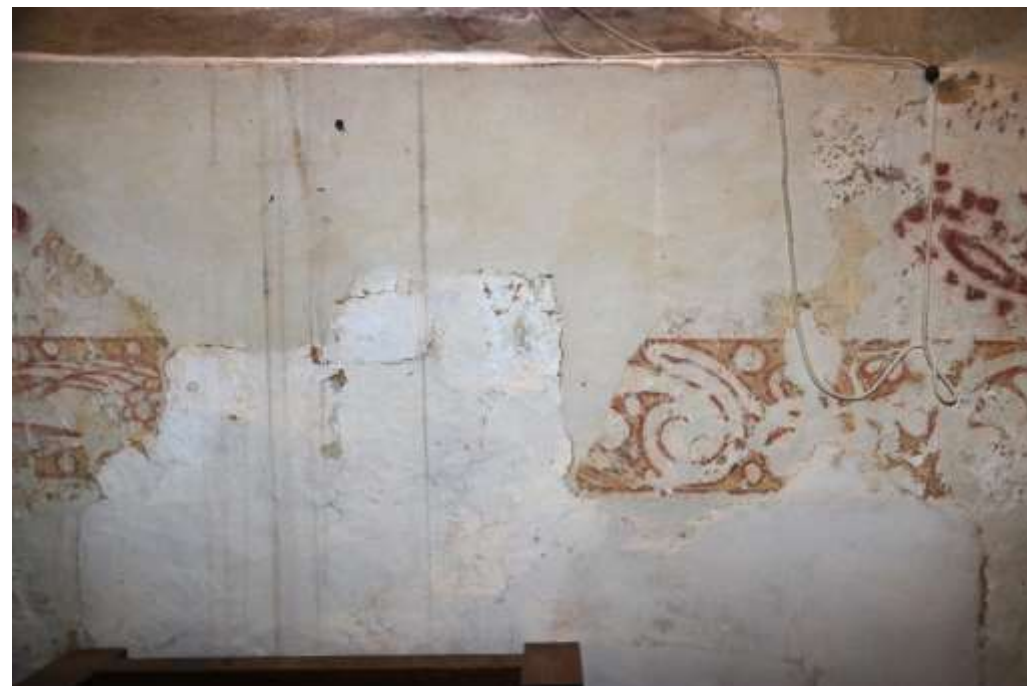
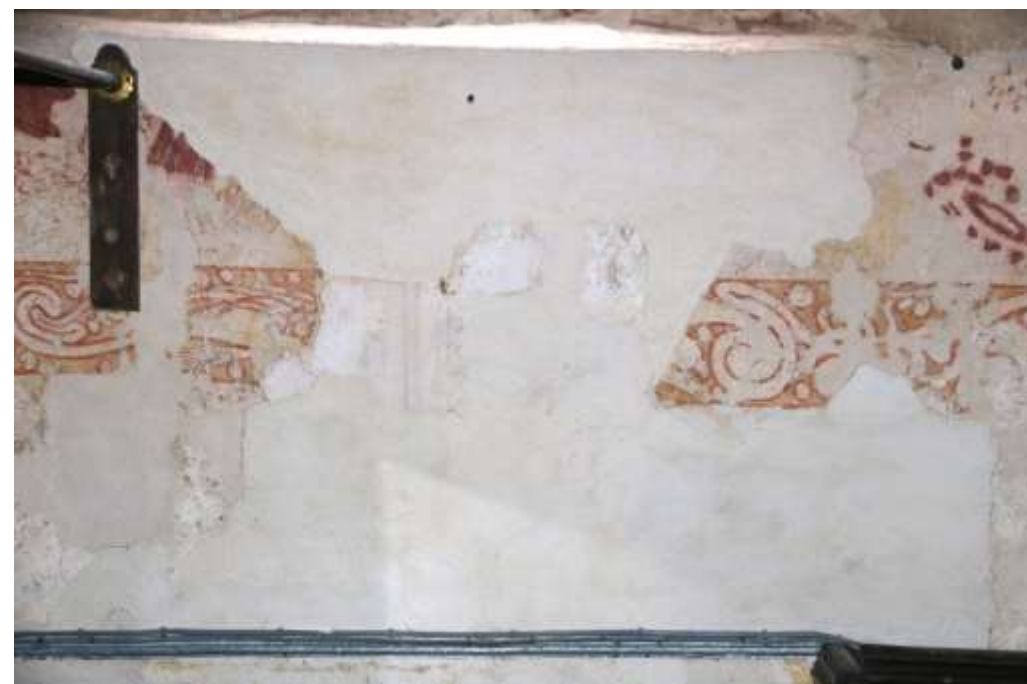
Examples of wax drips from candles & historic staining on window sill areas – before & after treatment

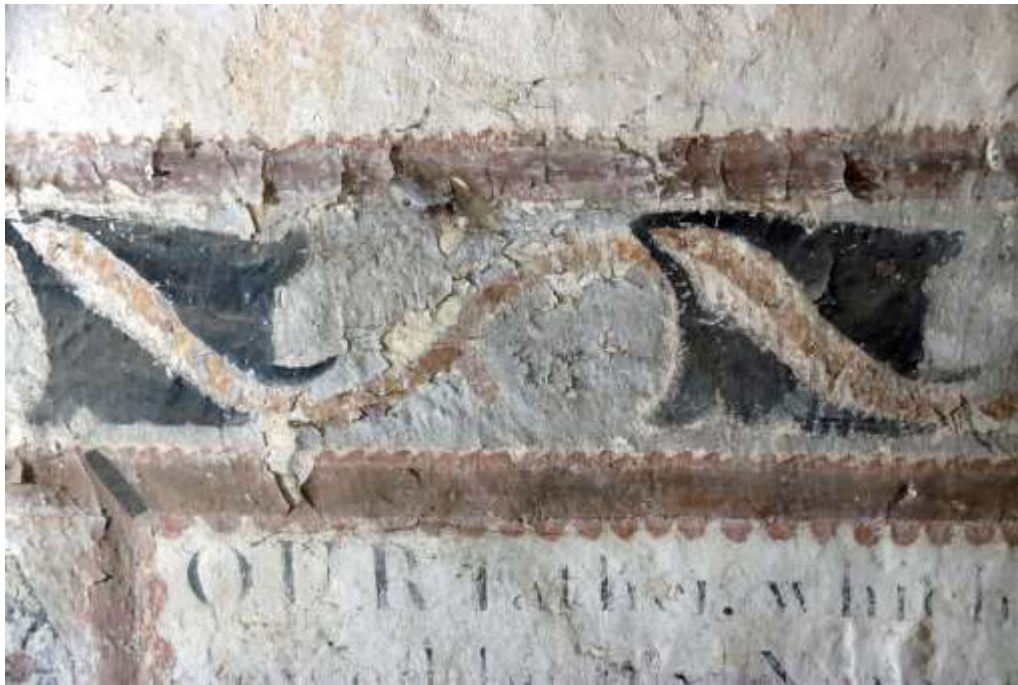
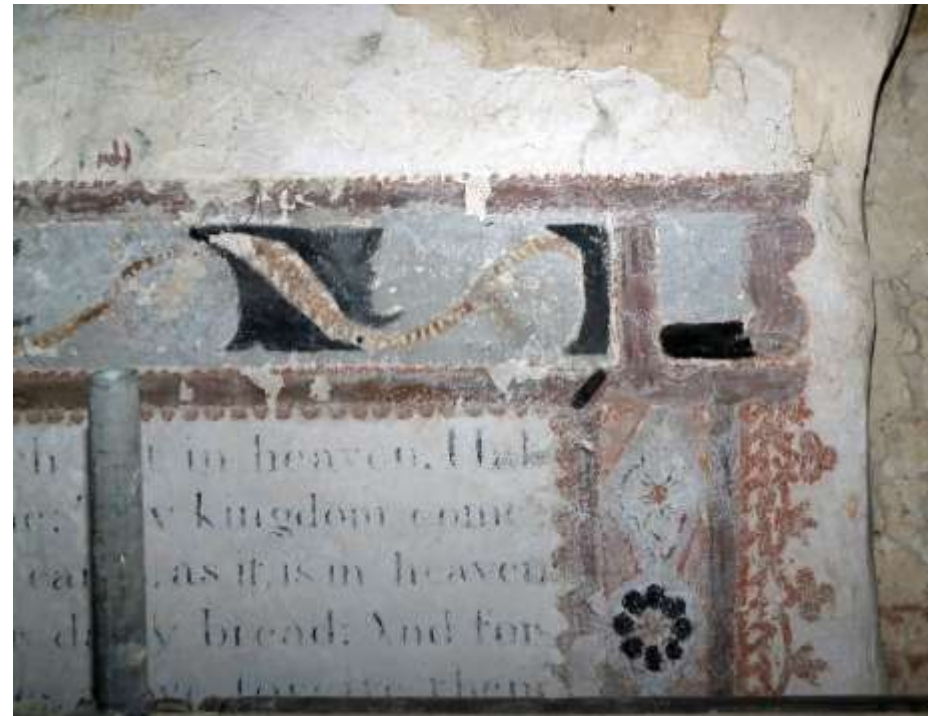
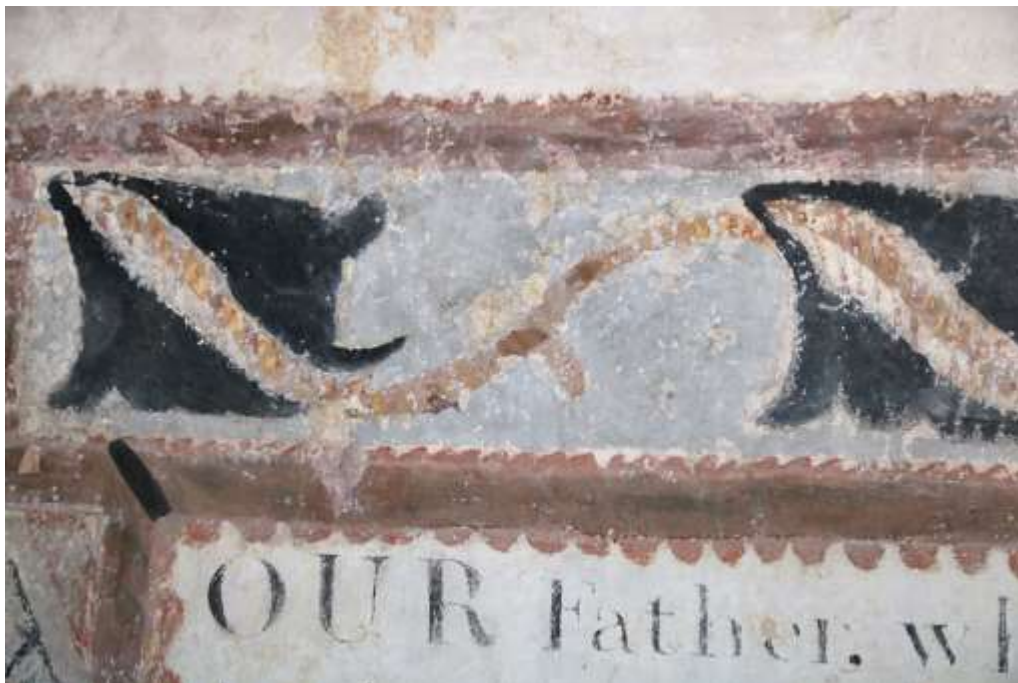
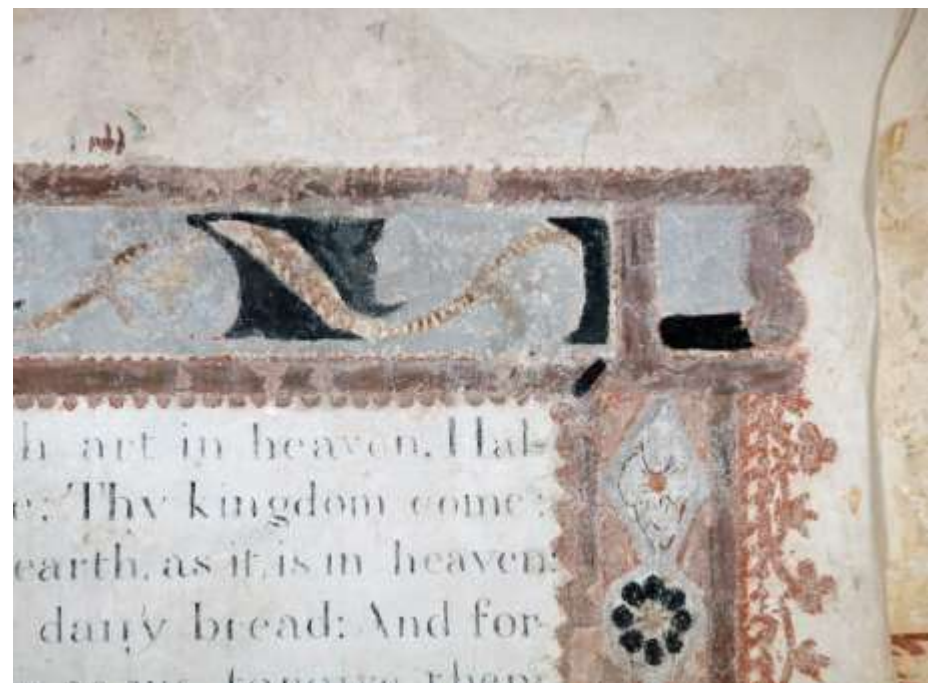
North wall, central area – The Lord's Prayer, details before &amp; after treatment
