## **The Church of St James the Great, Stoke Orchard, Glos**

### **2020 Wall Painting Conservation Project**

**Mark Perry ACR**  
**Adam Klups FIIC**

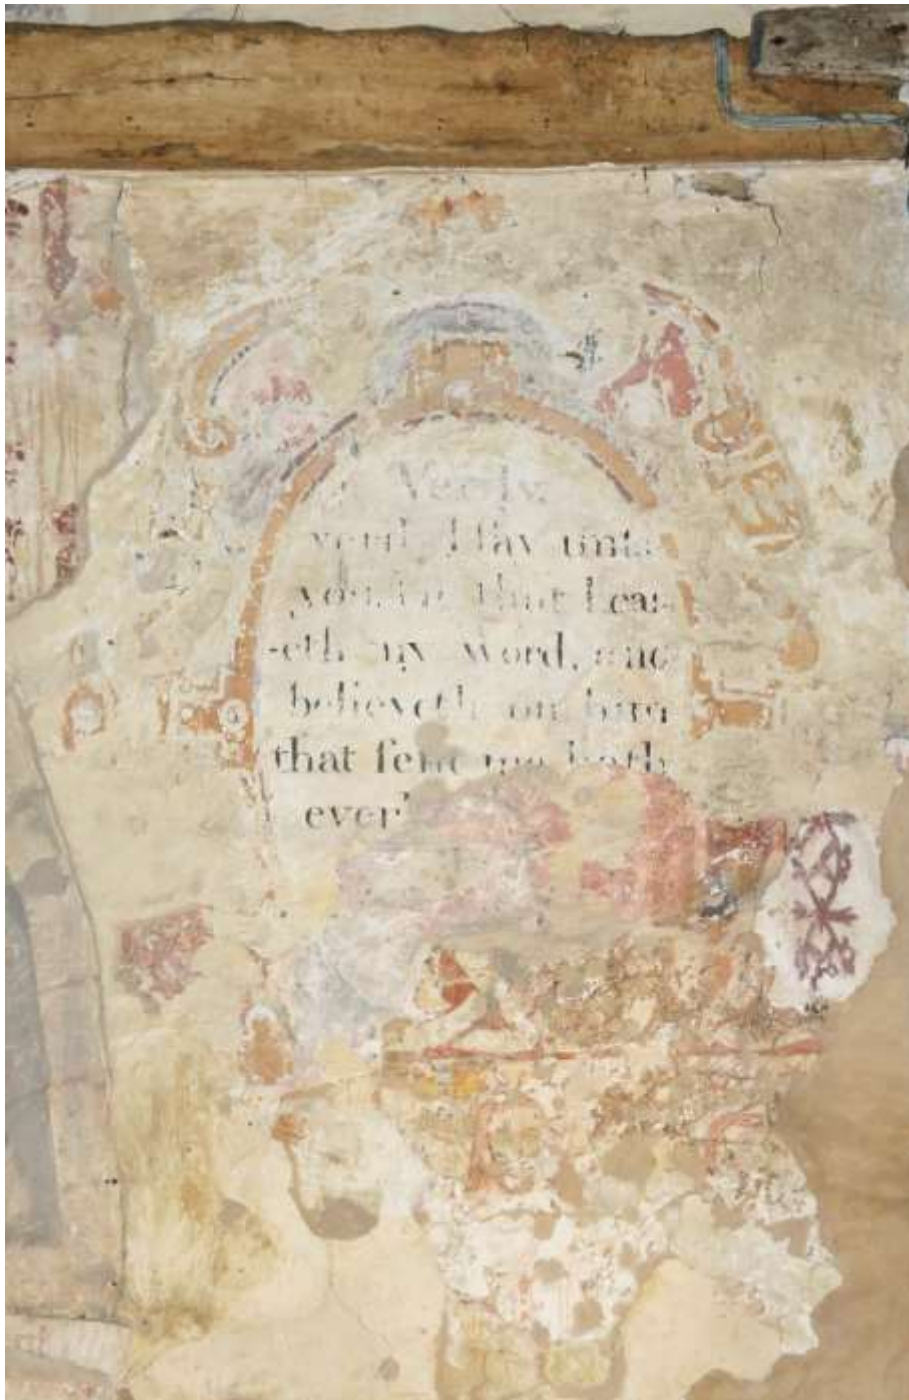
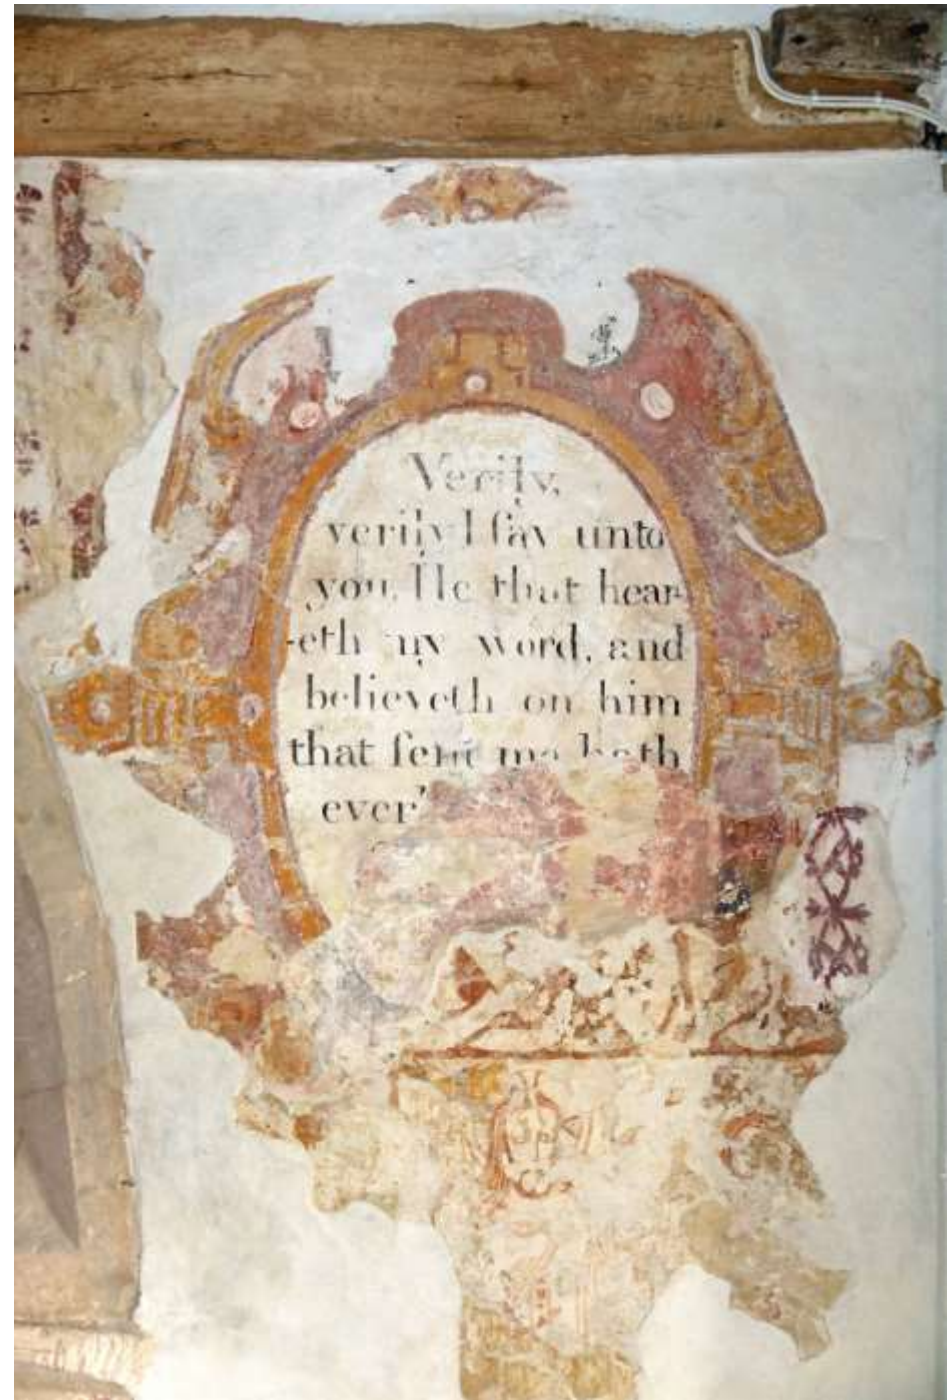
Removal of the unpainted covering limewash layers has exposed and clarified large areas of the 18<sup>th</sup> century text and frame on the south side of the chancel arch (before & after treatment)

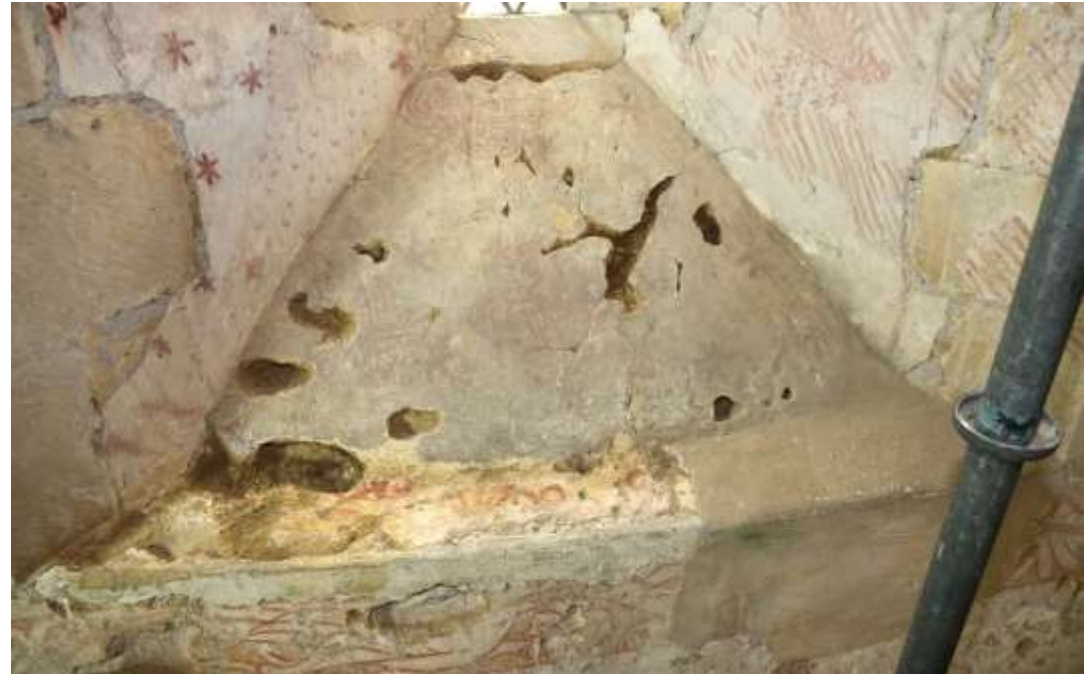
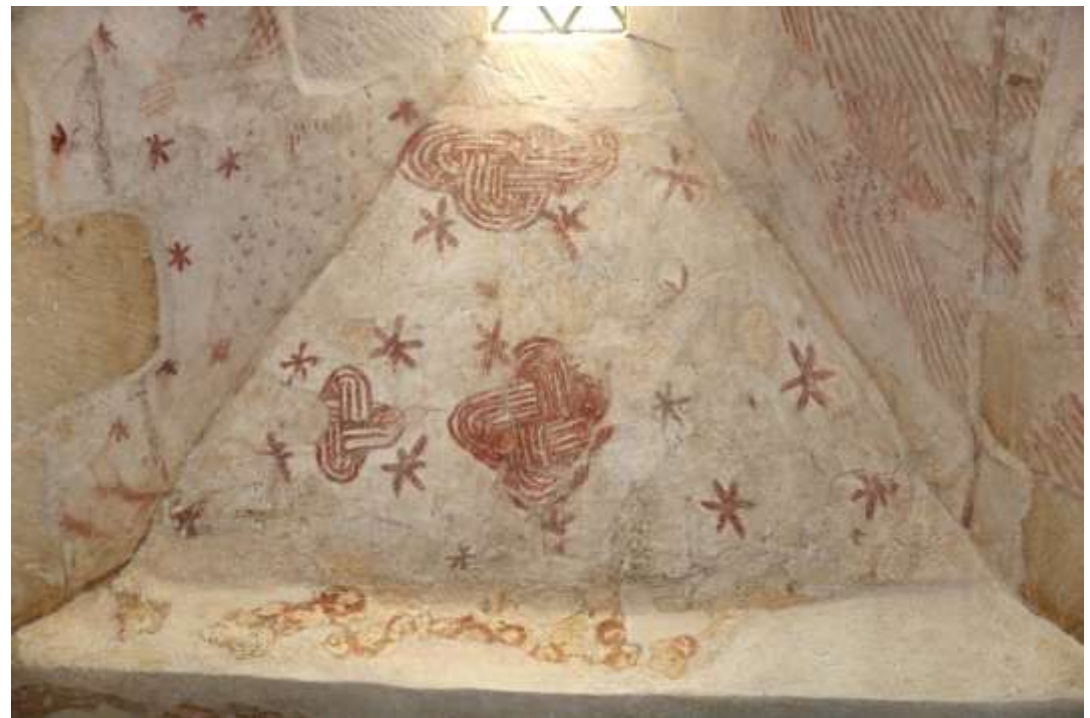
South window, east end – the sill, before, during & after treatment

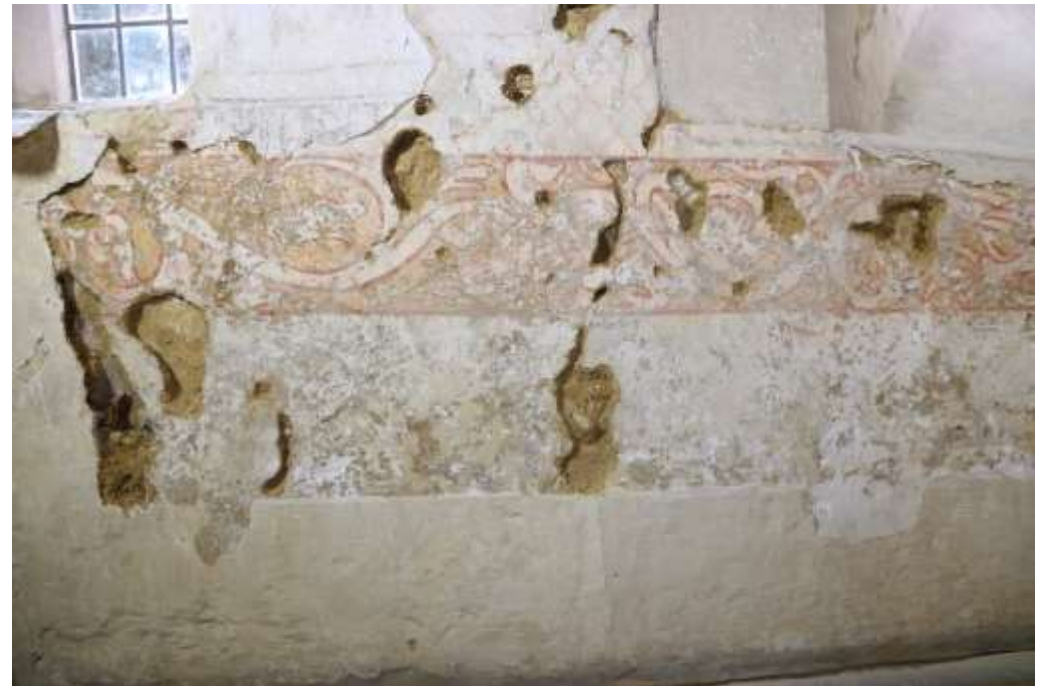
South wall, eastern end– details of the lower border, before, during & after treatment

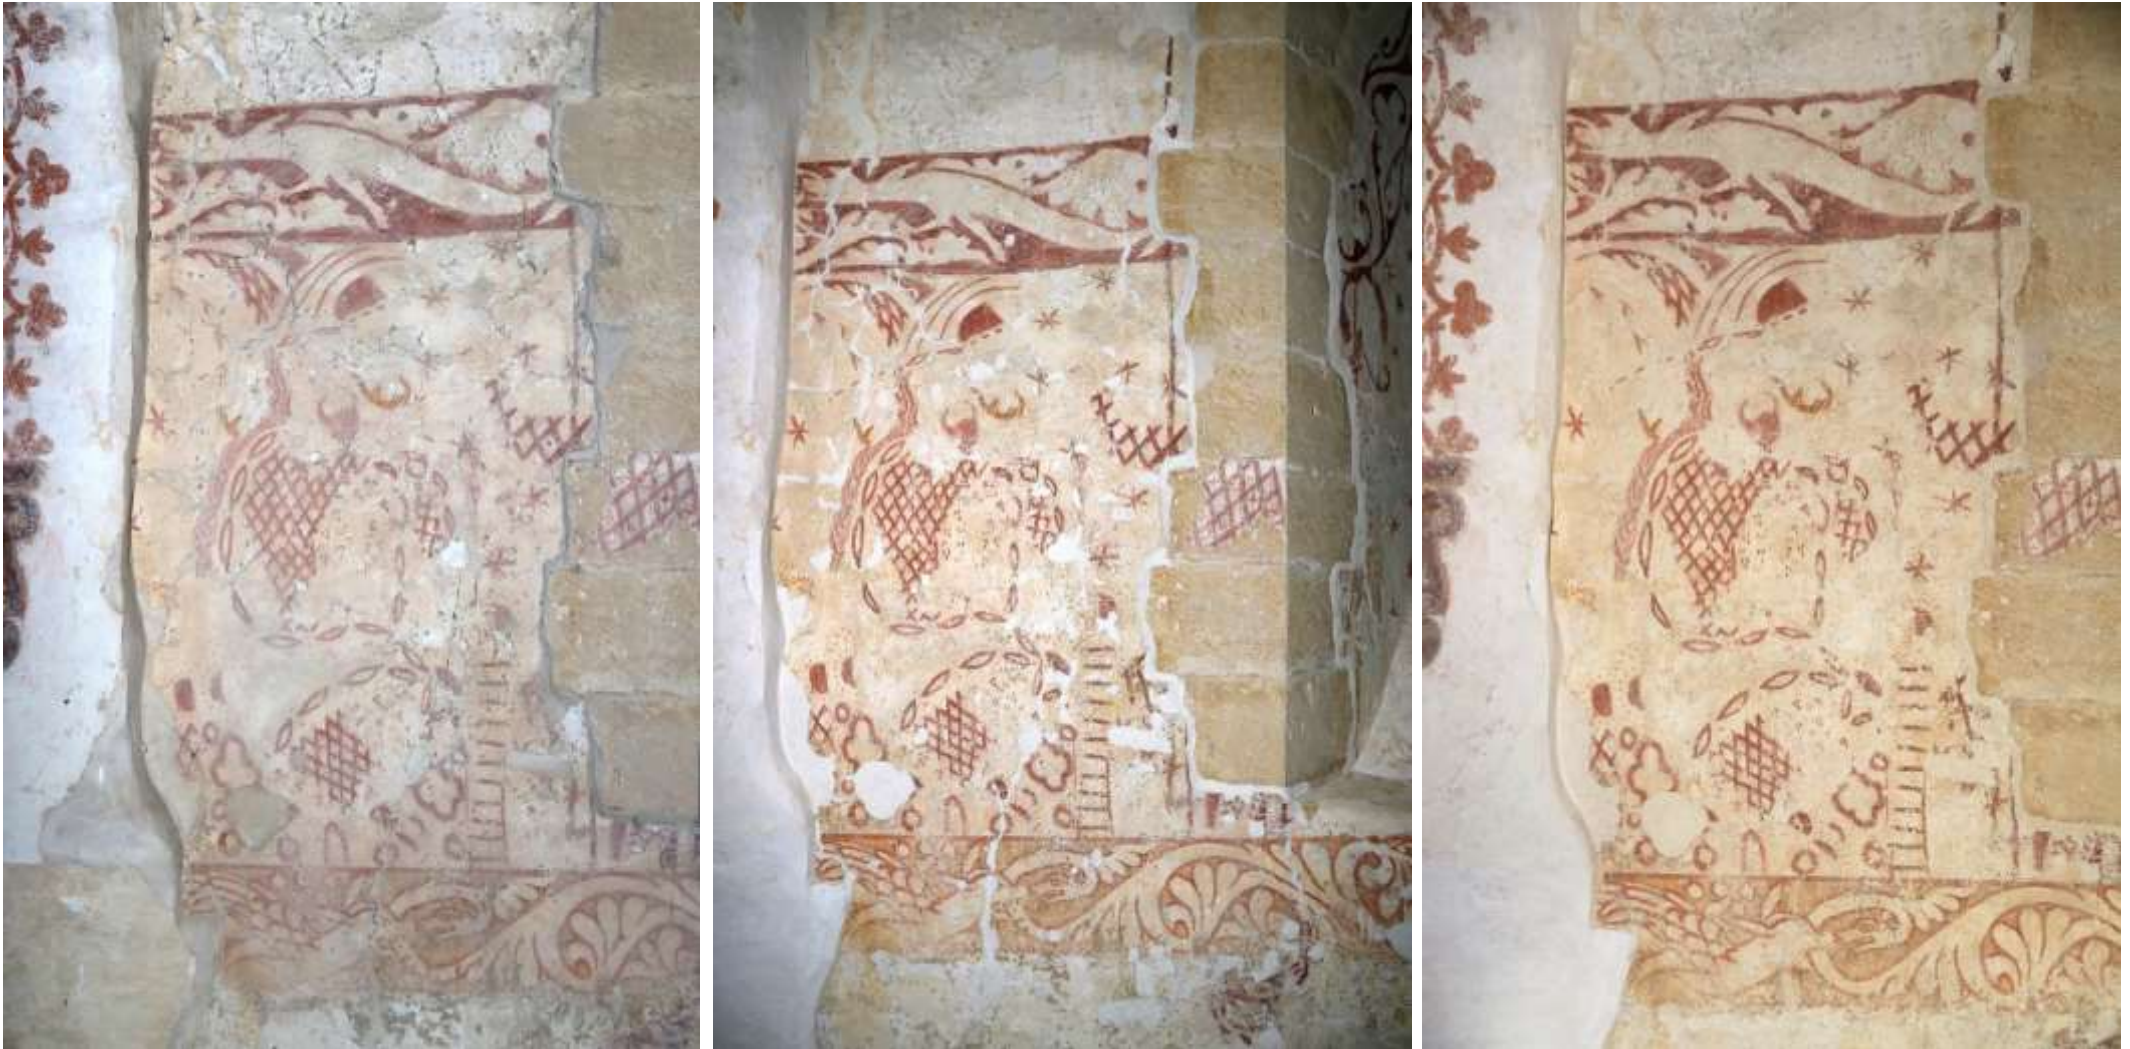
North wall, east end – The Scourging of St James, before, during & after treatment

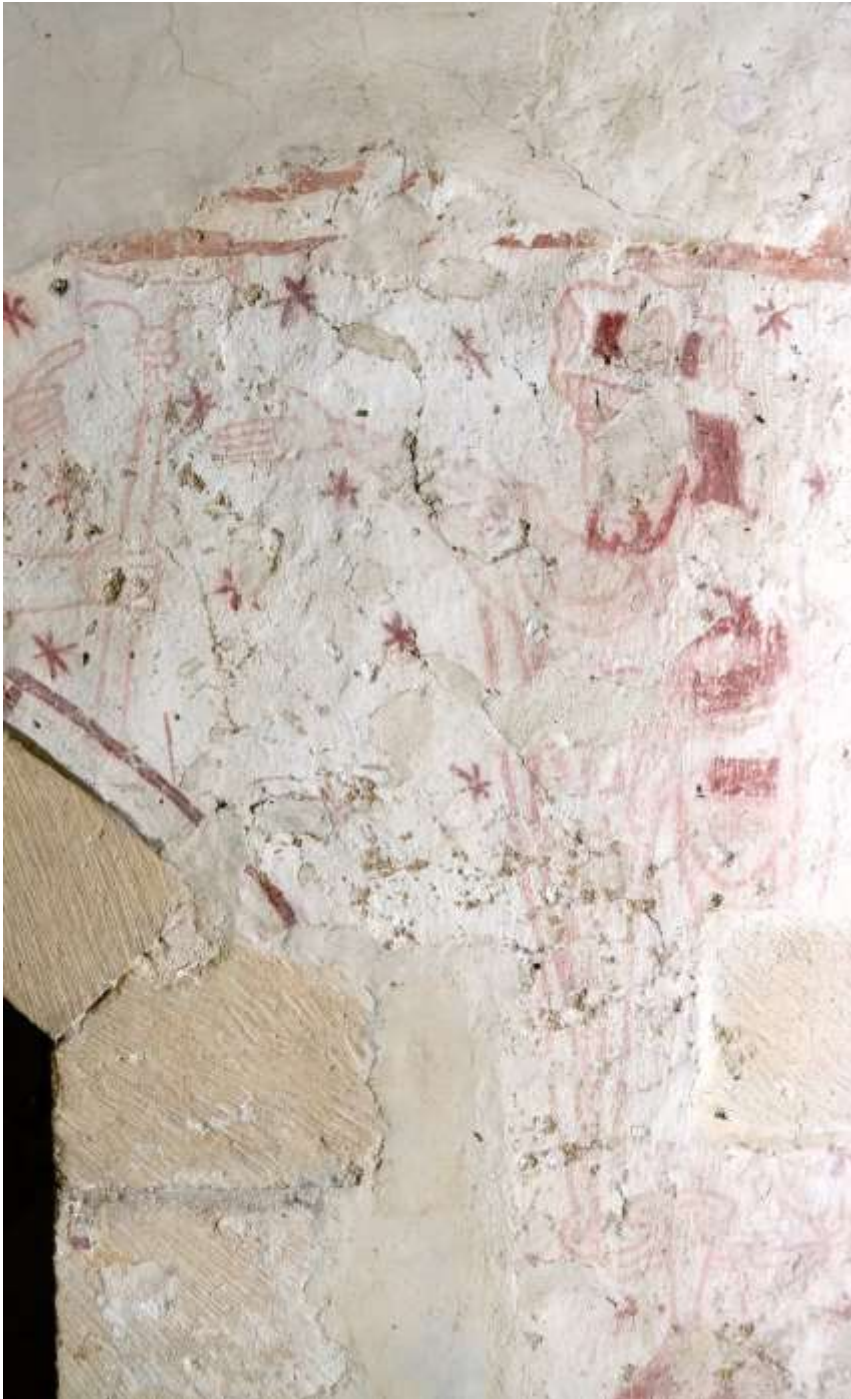
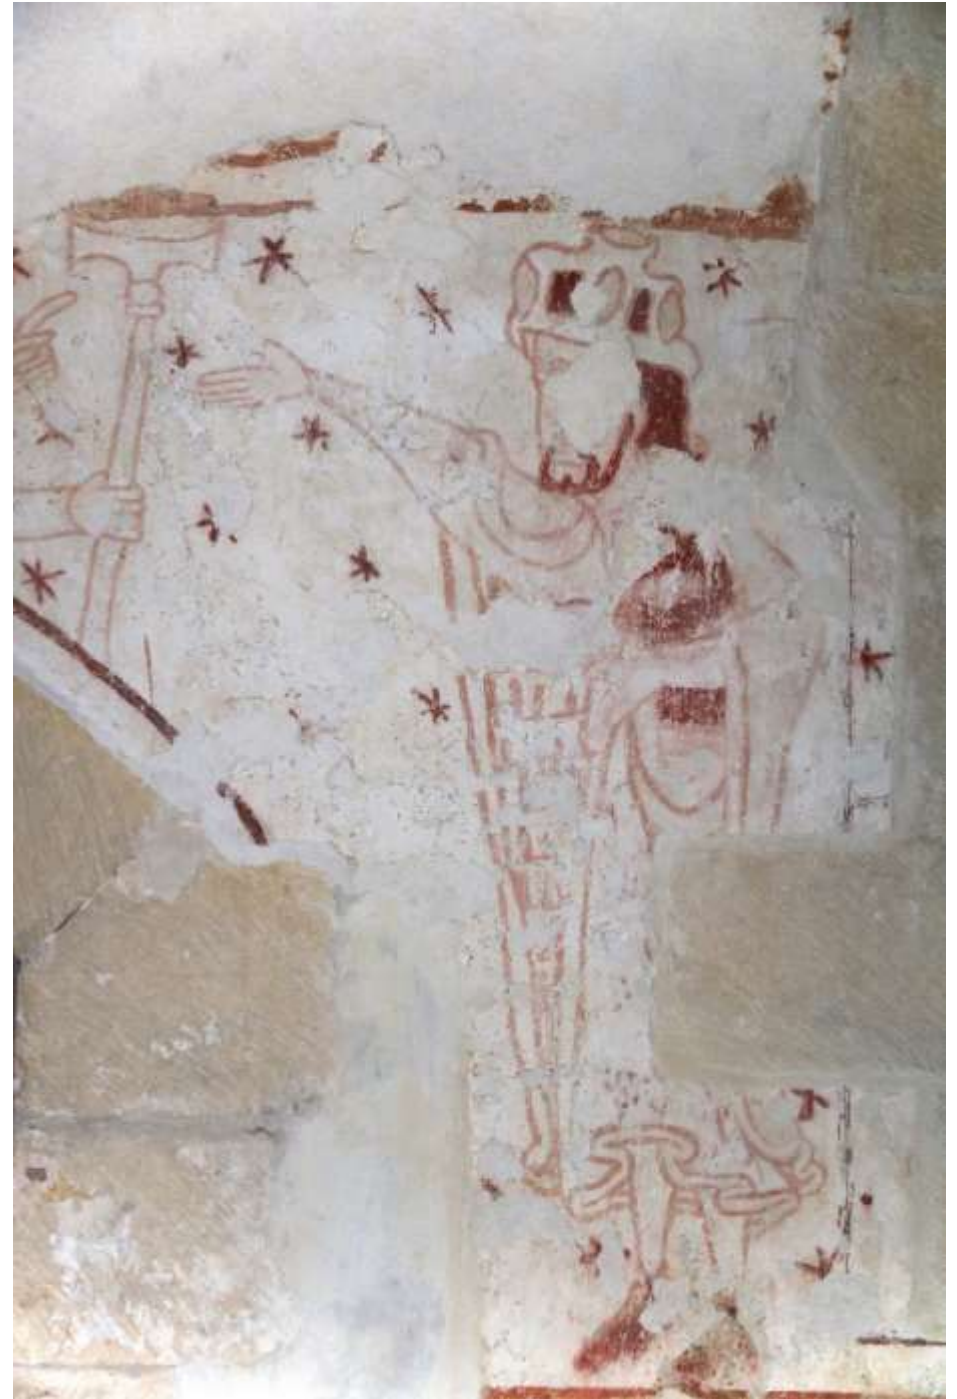
South wall, west end— detail of Hermogenes receiving St James' staff, before & after treatment

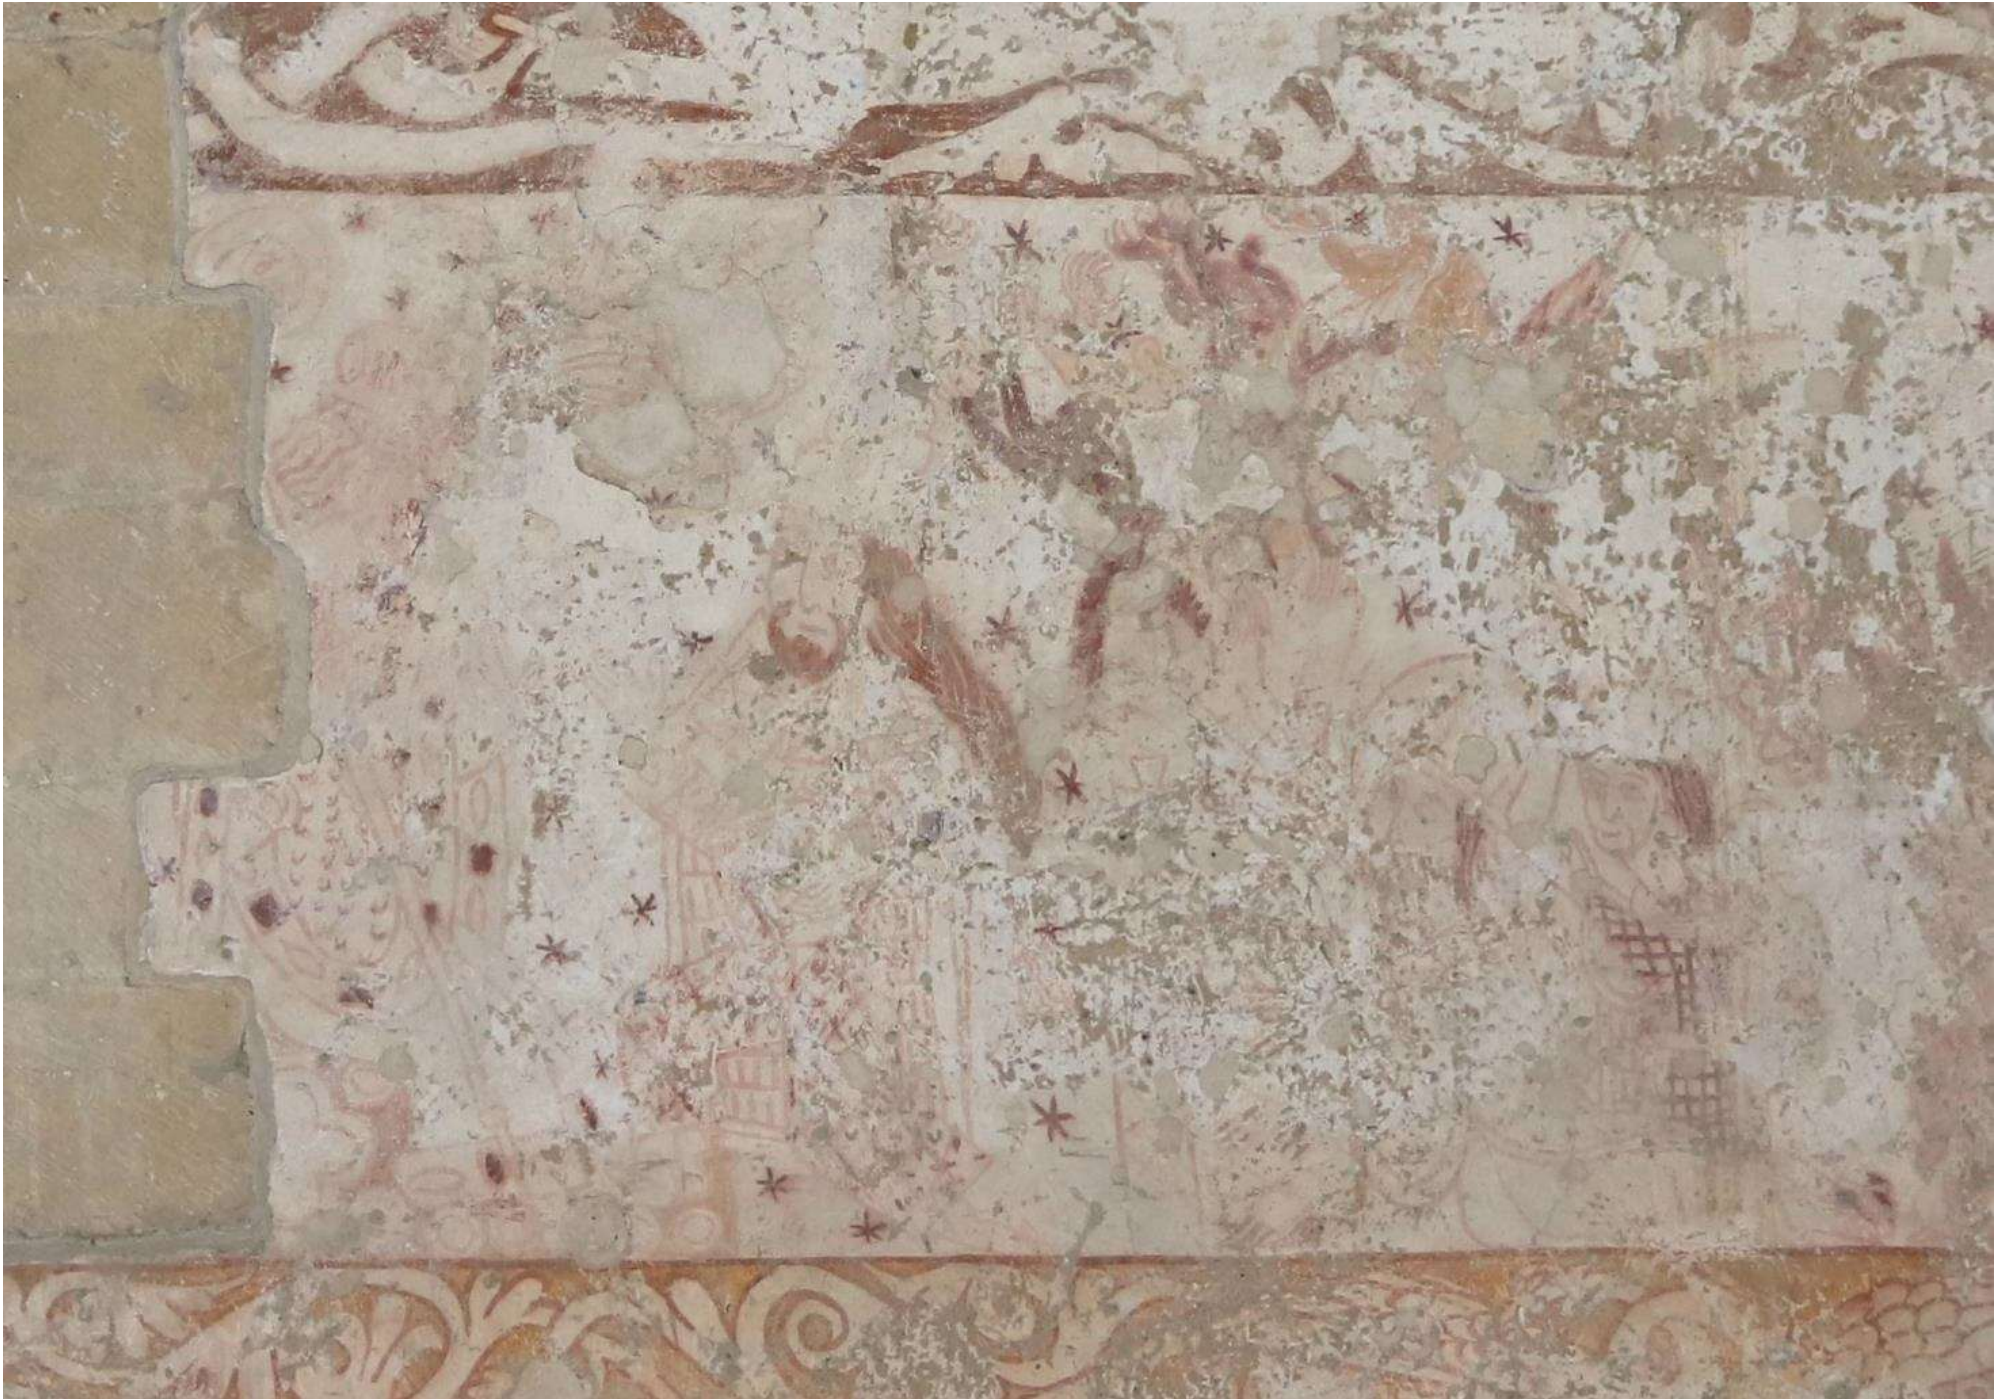
South wall, central area – detail of the St James cycle, before treatment

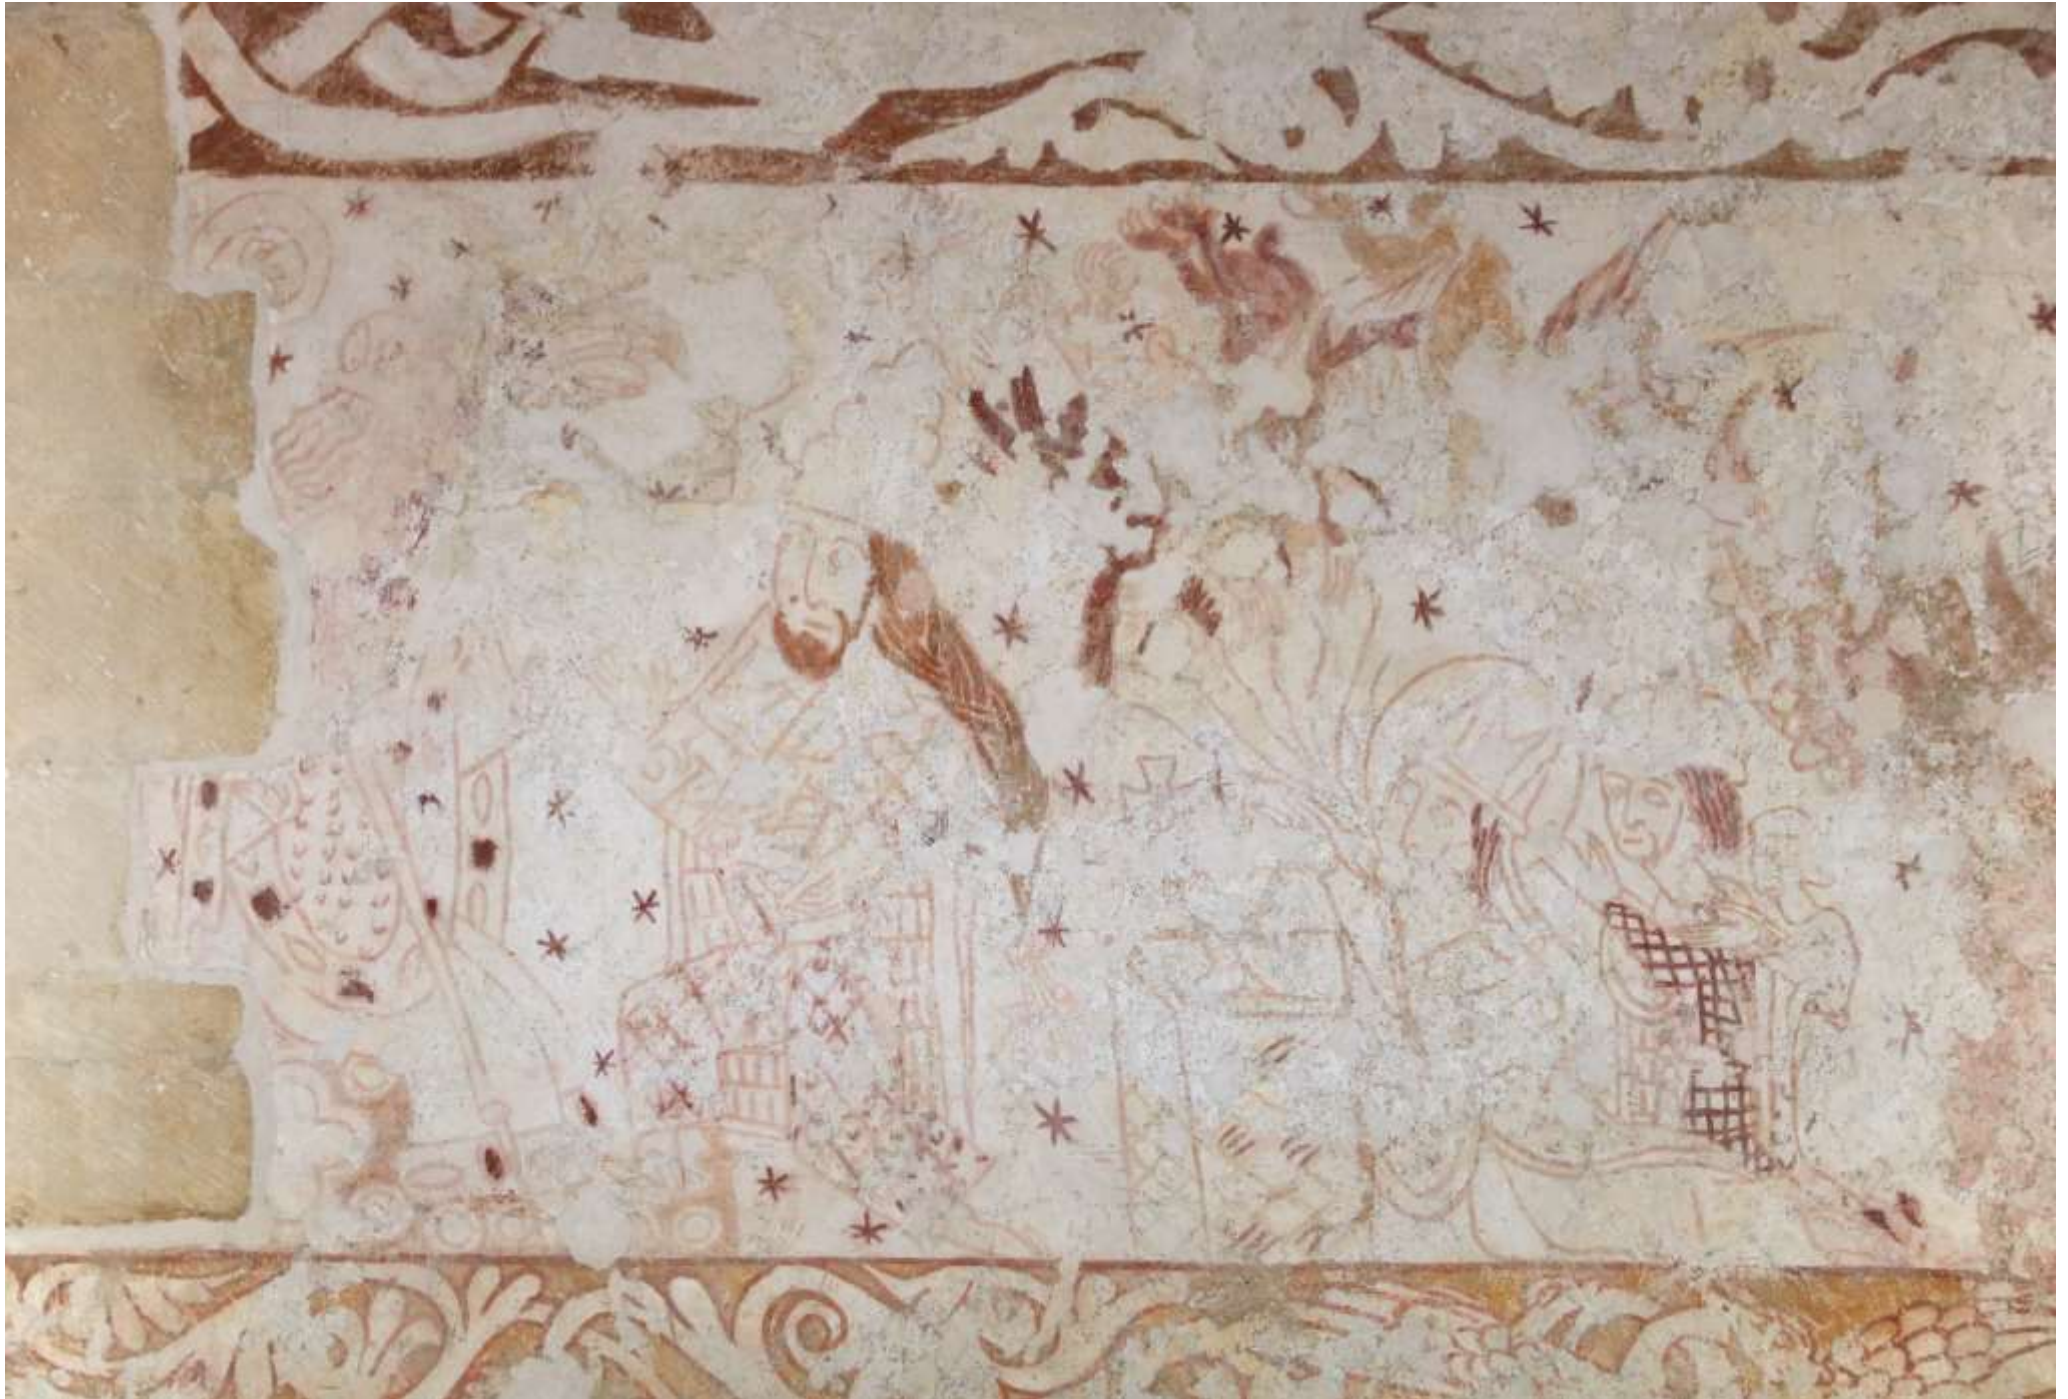
North-west corner, before & after treatment

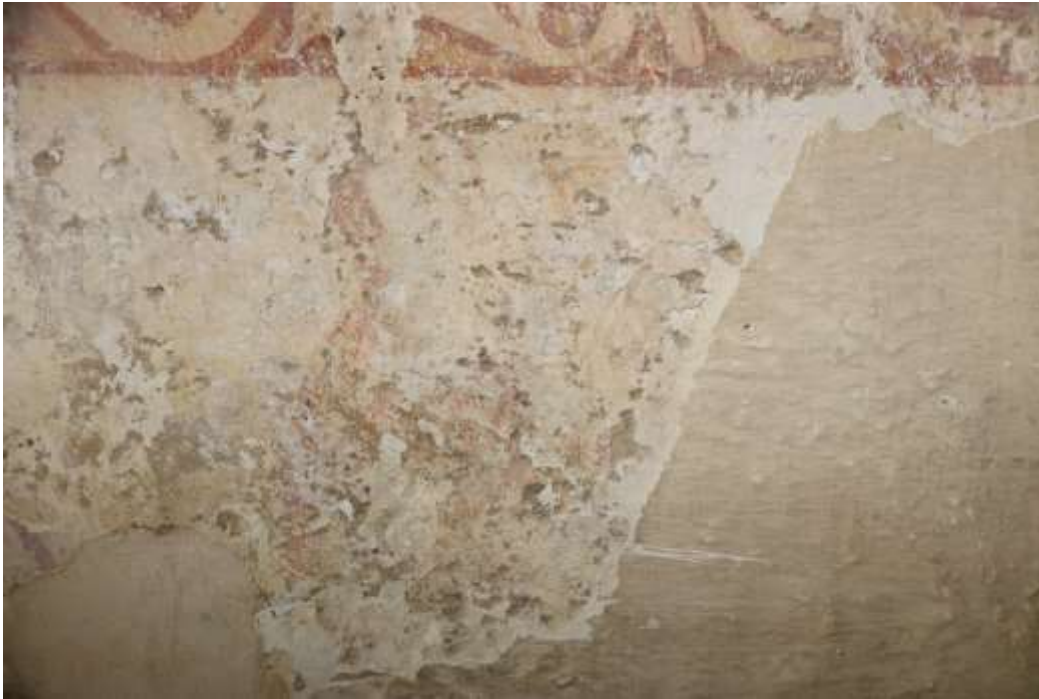
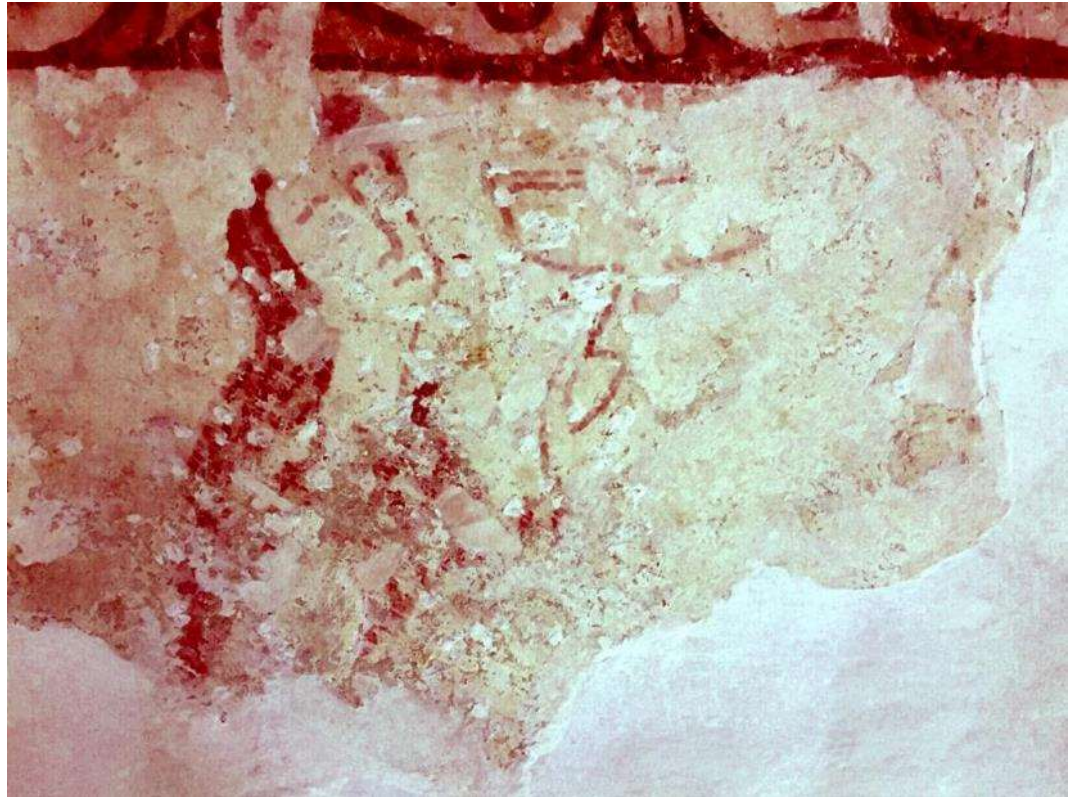
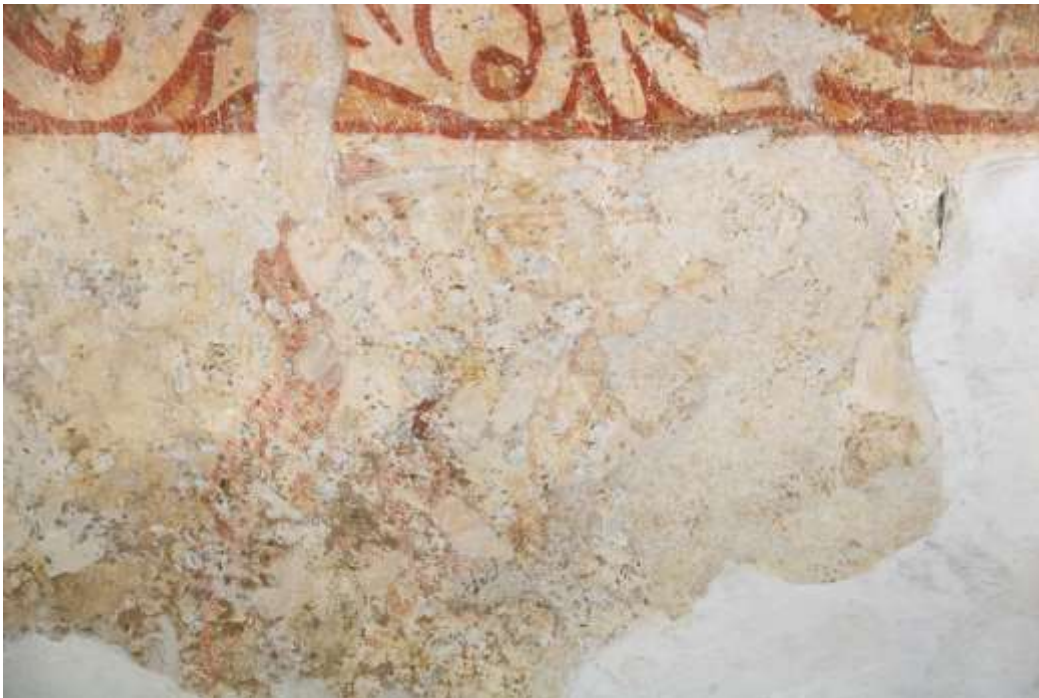
North wall, east end — St James cycle. Detail of possible donor figure below the border before & after treatment  
Plus a detail taken using D-Stretch imaging software (above)

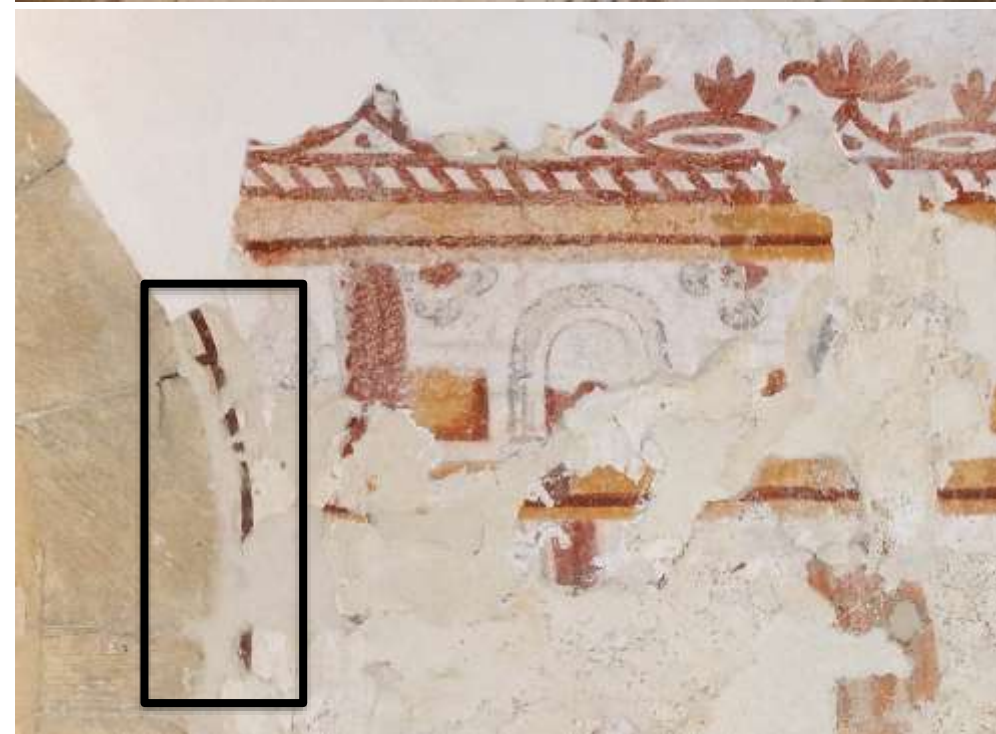
South east window – newly exposed masonry pattern, before (top) & after treatment

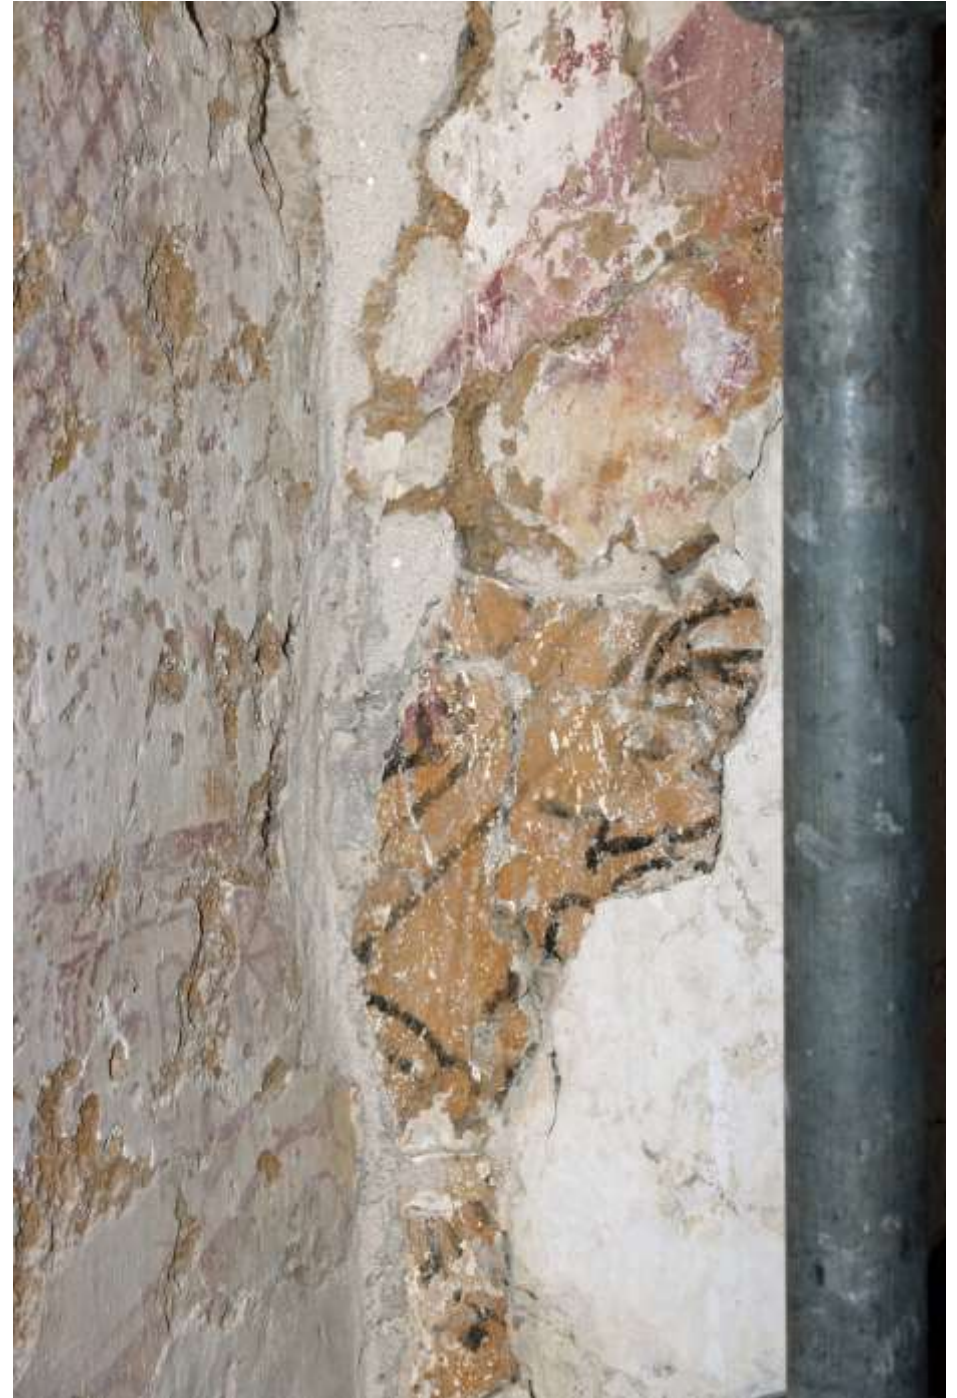
South east window sill – newly exposed foliate scroll pattern , before, during) & after treatment

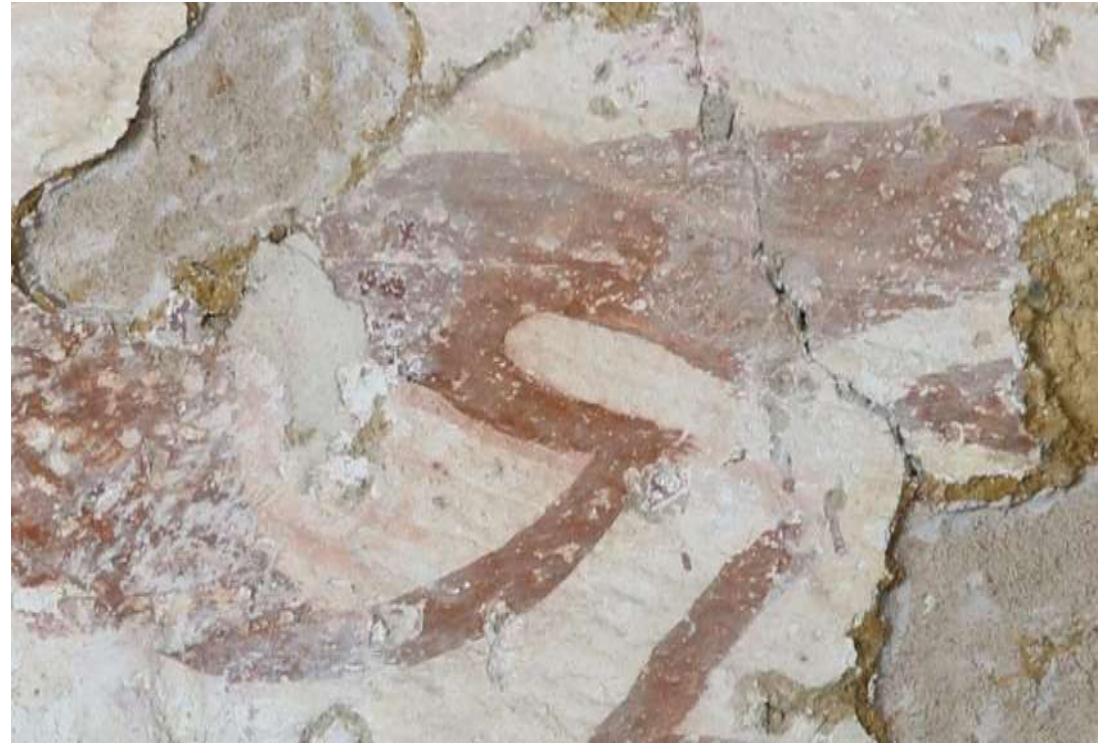
Examples of incised lines used to lay out the scheme – lower east wall, south side , details of Christ's robe & nimbus (top left and left) & south wall centre, border, detail of fingers (above)

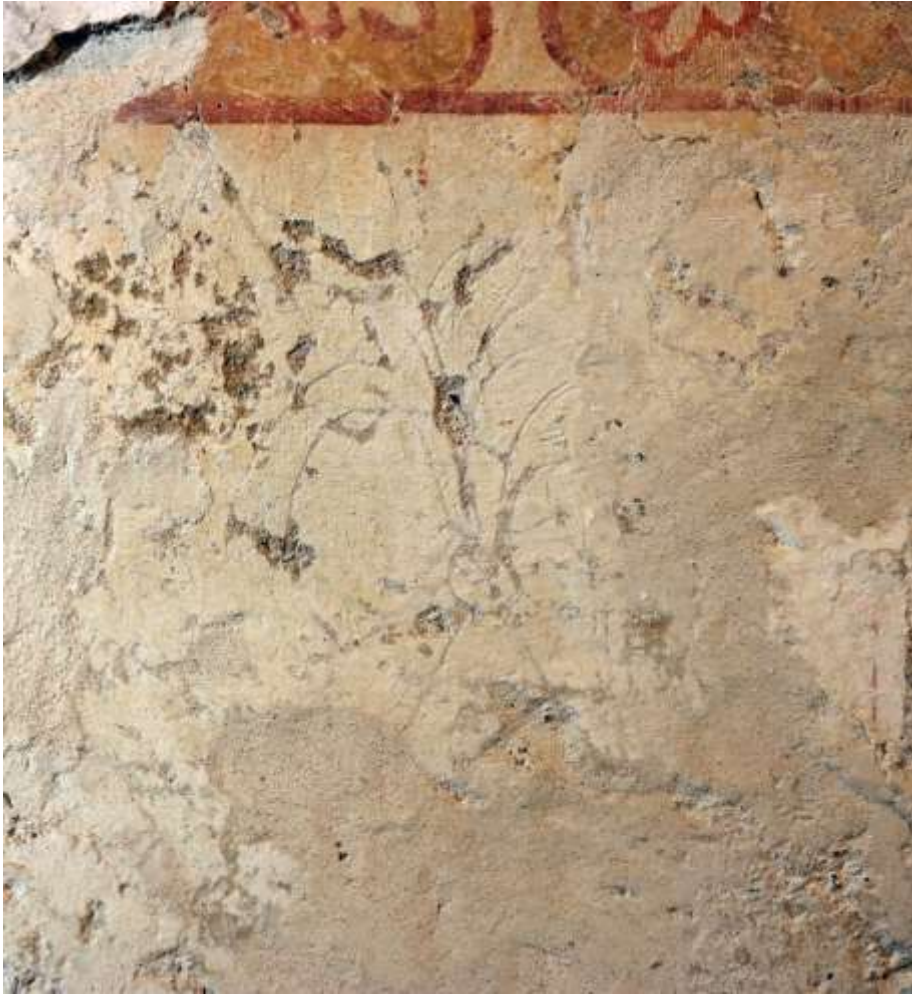
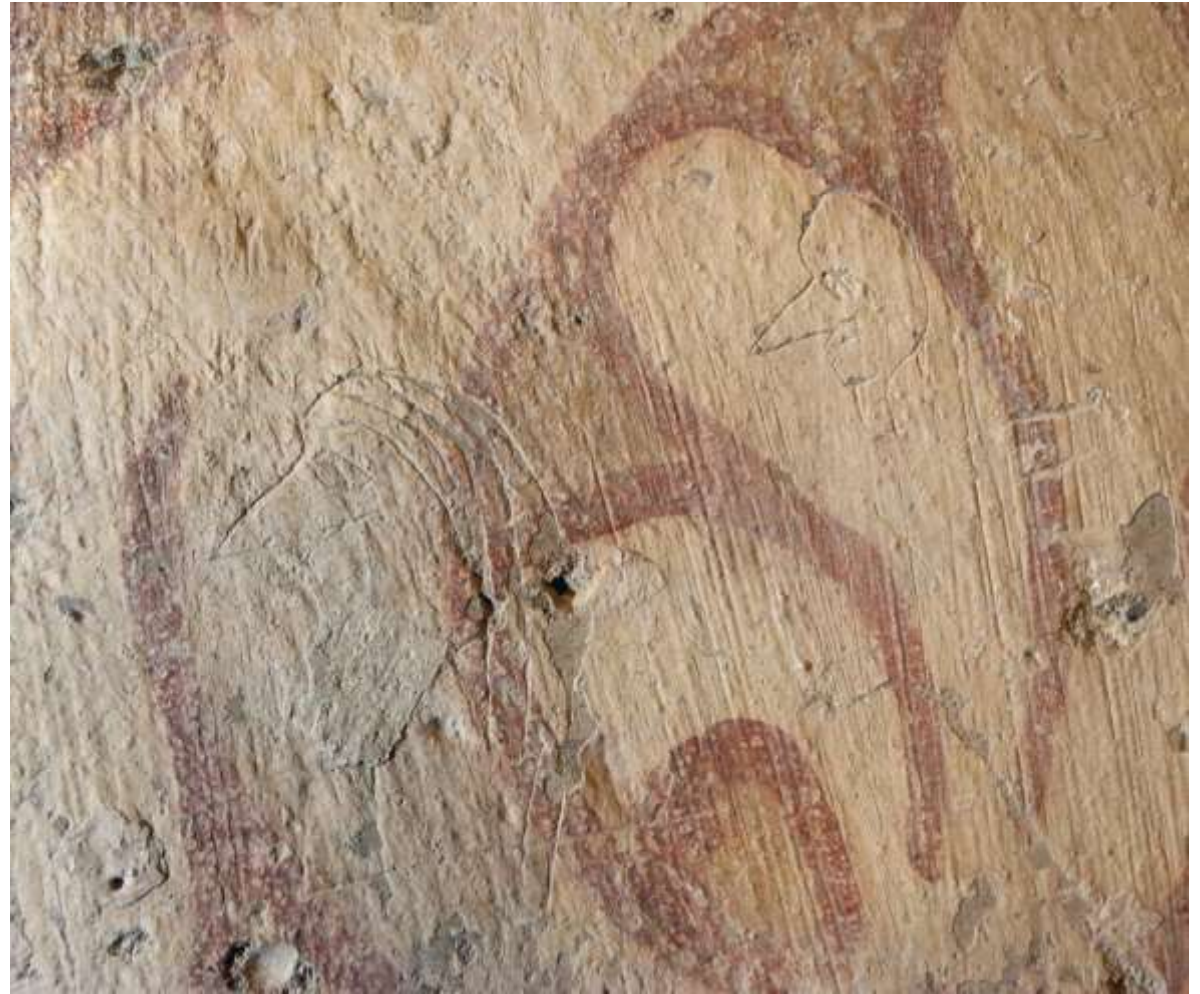
Example of incised drawing possibly intended as a sketch for the border scheme below the western window, south wall (above left) and graffiti of two heads on the border below the easternmost window, north wall (above right)
