CASE STUDY RECOVERING FROM FLOODS ALONGSIDE THE COMMUNITY

- The Parish Church of St Mary, Radcliffe was flooded severely in the boxing day floods of 2015, causing extensive damage throughout the church building.
- The restoration of the church building was a focal point of the recovery for the wider community.
- When threatened again with flooding in 2020, community volunteers and donations of protective equipment protected the church from the majority of water ingress resulting in very minimal damage.

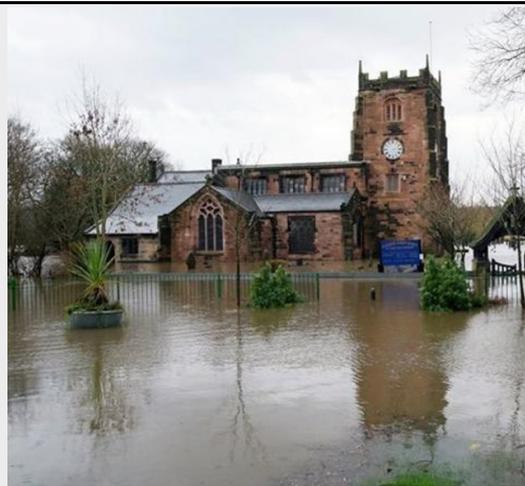
1 The exterior of the Parish Church of St Mary during the 2015 floods.

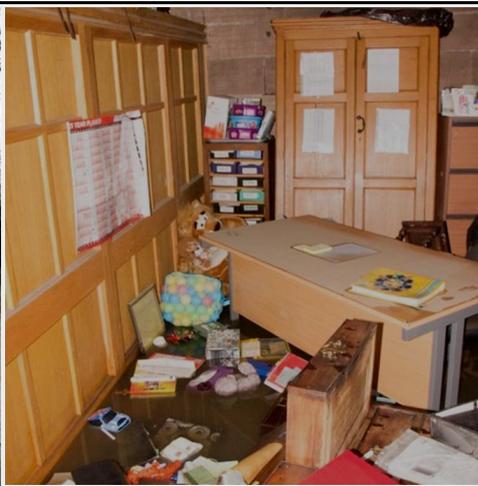
2 Interior damage to the vestry caused by the 2015 flood.

- Drying out the building. For a period of approximately 2 months the church was home to huge industrial dehumidifiers to remove the remainder of the damp.
- An extensive period of deep cleaning as on the other side of the park to the church is a sewage works the product of which flowed into the church with the flood water
- Draining the cellar around the burnt out sump pump was, and remains, a challenge for the church
- The pews were able to be salvaged and remain in the church but much of the interior, particularly the office area in the vestry was completely destroyed (including valuable historical record) and had to be completely renovated

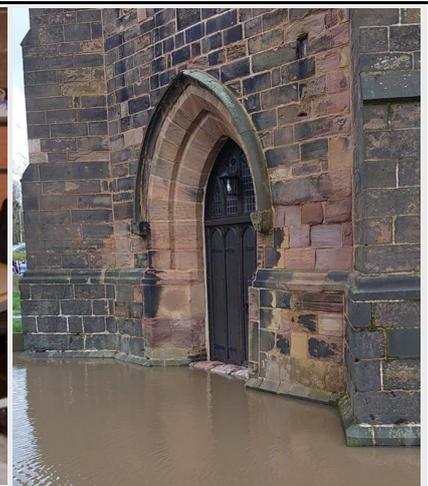
3 Sandbags preventing water ingress in 2020.

- Filled sandbags
- A water snake inflatable flood barrier
