**THE CHURCH OF  
ST. GEORGE THE MARTYR  
BOROUGH  
SOUTHWARK**

**A LEVEL 1 RECORD OF THE BELL FRAME**

**DECEMBER 2011**

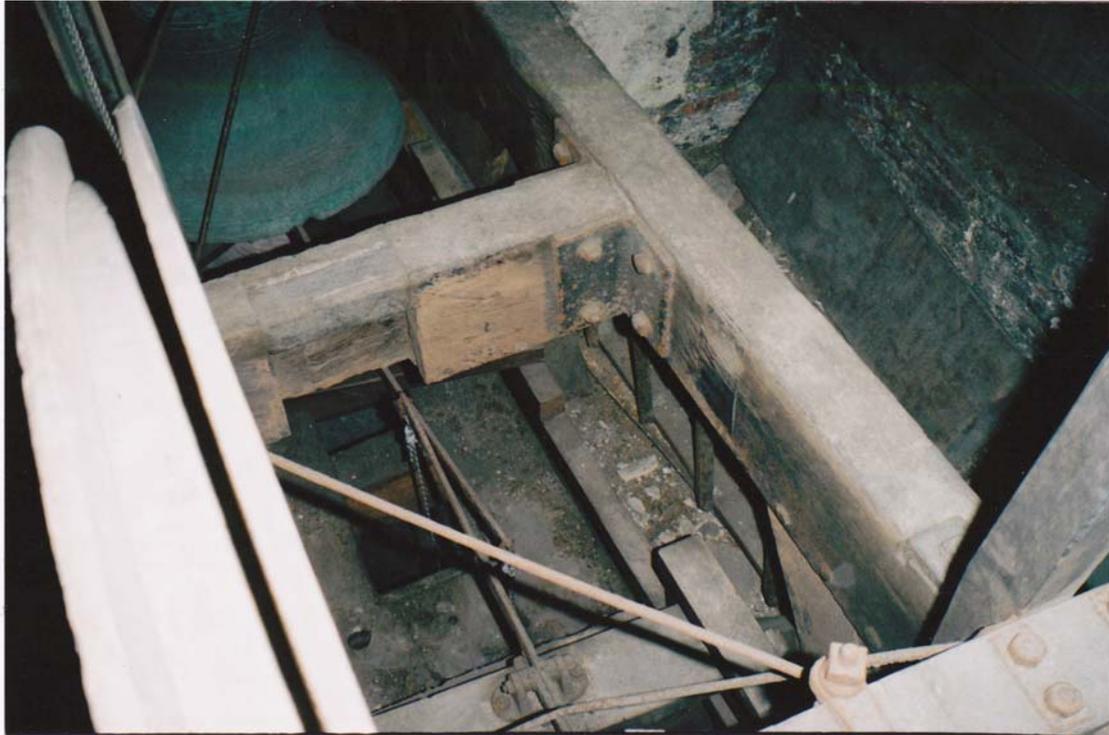
Cut-off tenons in the frame-heads indicate that the timber which divides the treble and second bell pits was repositioned slightly further to the south, to make a pit long enough for the second bell to swing in. (Fig. 1) However, there is no evidence of a bearing indent corresponding to the initial position of the dividing timber.

**The dividing timber between the pits for the treble and second bells. The cut-off tenon shows as a dark rectangle on the side of the frame head.**

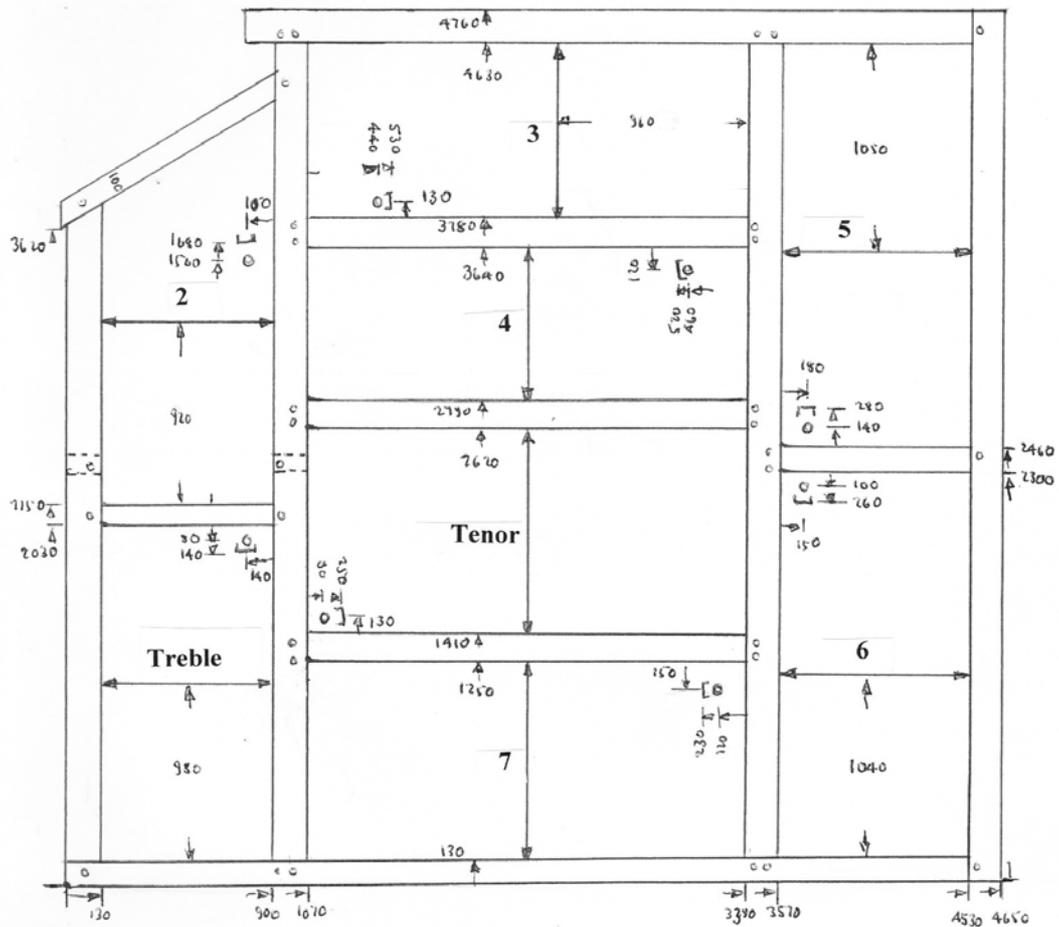
Fig. 1. Plan at frame-head level.

The bell frame is of conventional layout (Pickford Type 8.3), and is approximately square, except for the north-west corner, which is angled, owing to the provision for a spiral staircase. (Fig. 1) Apart from that, the frame sits well within the tower, with a similar clearance of about 10 mm between the frame heads and walls on each side. Because of the offset frame heads, the outer sills are immediately adjacent to the walls. The position of each bell is marked on the sketch of the layout at frame-head

level, as well as the position of the wheel and the rope-fall at pulley level, the latter indicating to what extent the rope is drawn between the wheel and pulley.

Figure 1. Sketch plan of the bell frame at frame-head level, with running dimensions, site north to top. Hanging positions are indicated, as are the positions of the wheels and rope drop pulley level.

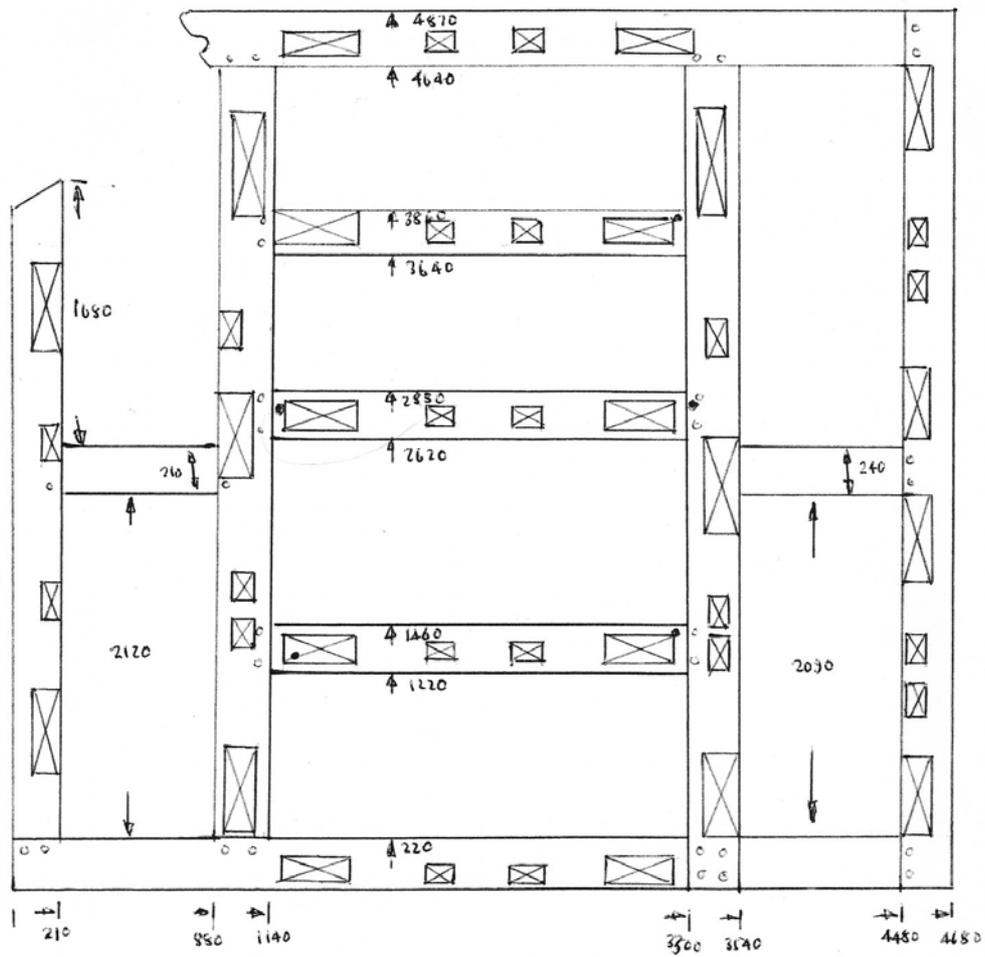
Fig. 2. Plan at sill level.

The form of the trusses can be deduced from the sketch of the frame at sill level, illustrated in Figs. 4 and 5. The truss form used is of a pair of inclined braces, with jack-braces above and below, i.e. to sill and frame-head. In general, the bells hang symmetrically between the braces. This truss form is found in all the trusses of the four parallel pits, and in the east elevation of the frame, where there are two pairs of braces. Because of reduced space, the trusses which close the four parallel pits only have one pair of braces, and one single one on the north side inclined towards the centre of the frame. The west elevation has only one pair of braces, wider apart and necessarily at a lower rake, with the result that neither the treble nor second bell hang at the centre of a truss. (Fig. 2)

Figure 2. Sketch plan of the bell frame at sill level, with running dimensions, site north to top. The positioning of the braces and jack braces is approximate only

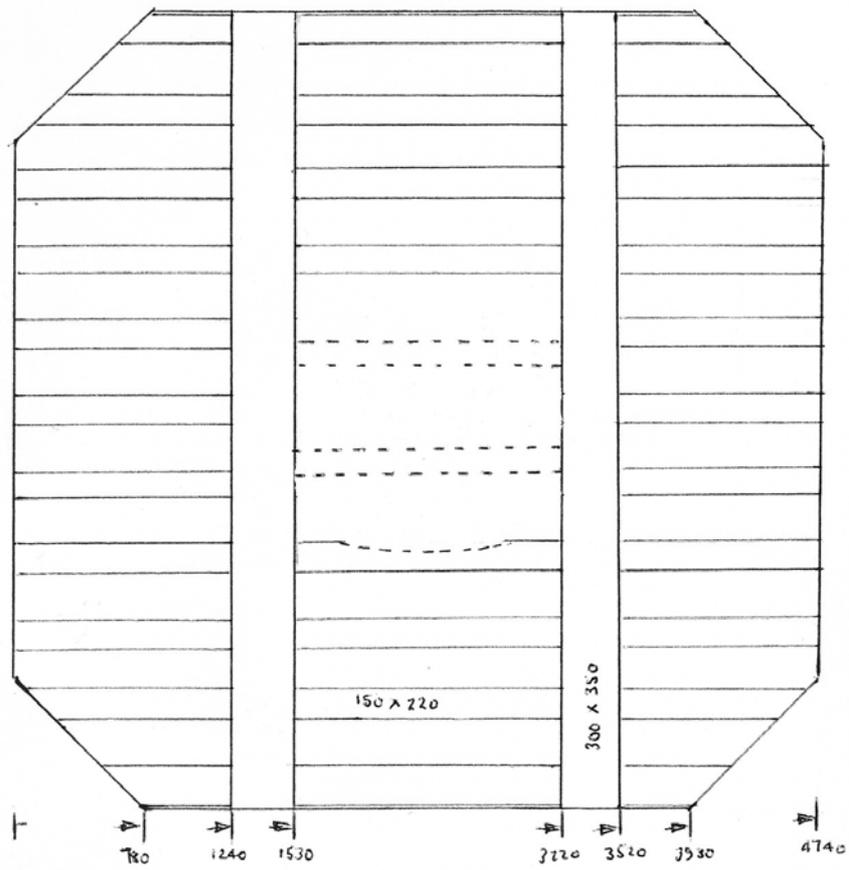
Fig. 3. Sketch of supporting timbers.

Figure 3. Sketch plan of the supporting floor on which the frame rests, with running dimensions, site north to top.

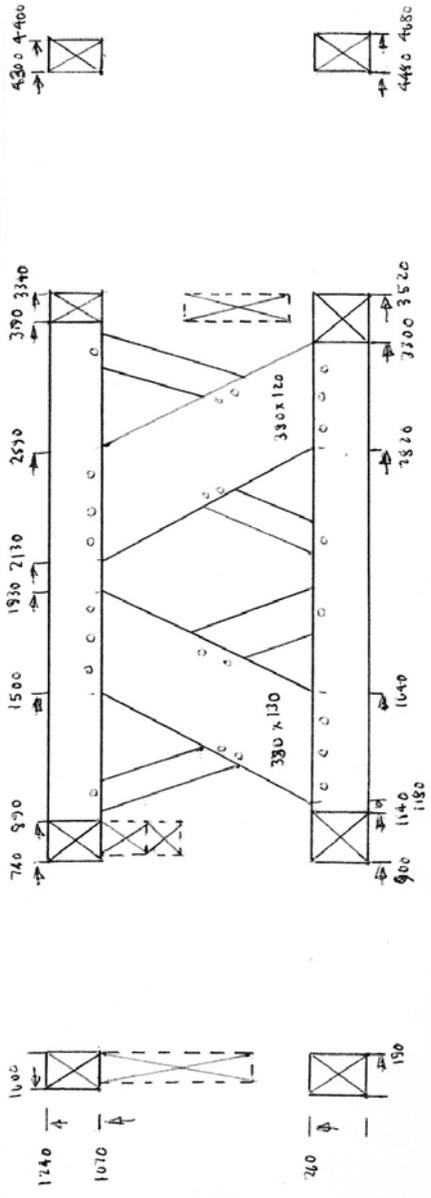
Fig. 4. E-W section.

Figure 4. Dimensioned sketch of E-W section of frame, showing south elevation of the truss between the seventh and tenor bells.

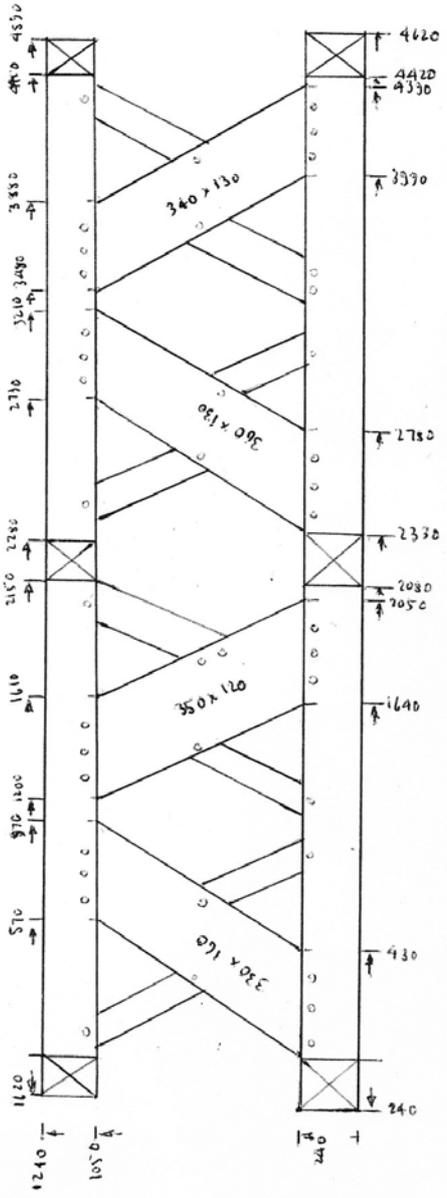
Fig. 5. N-S section.

Figure 5. Dimensioned sketch of west elevation of the easternmost truss of frame.
