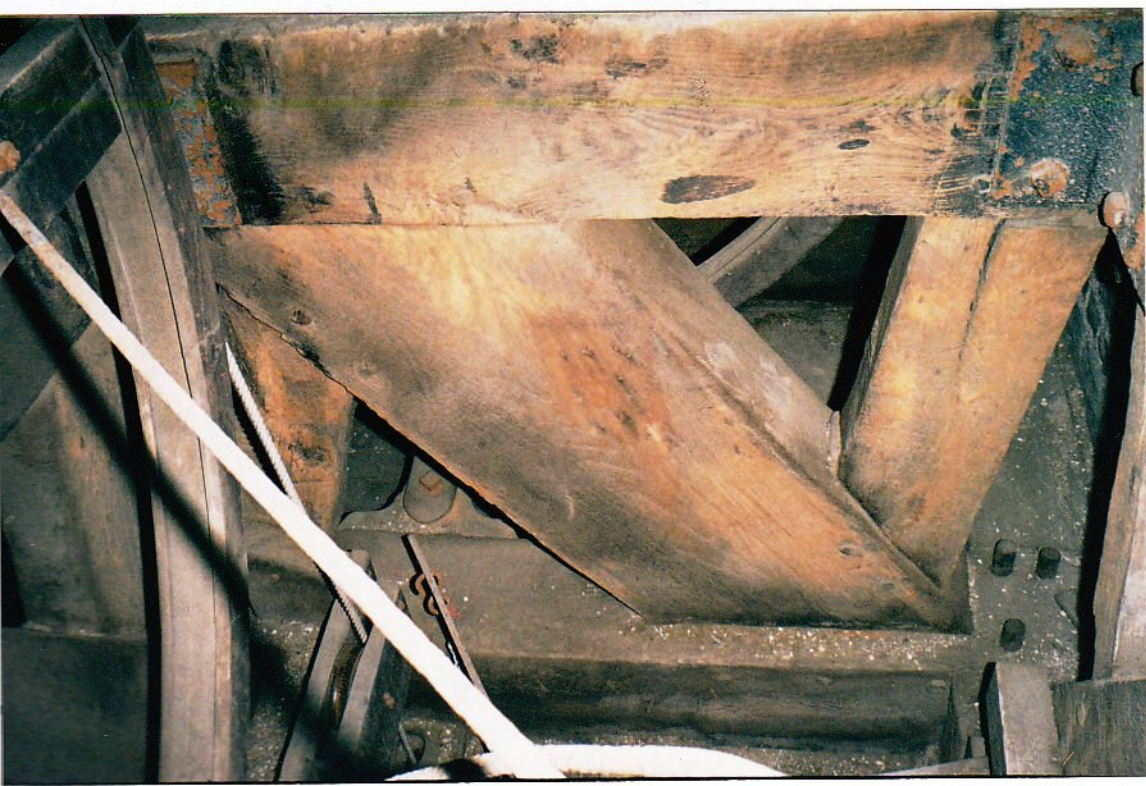
Plate 1

(Below) A massive brace at the east end of the seventh bell pit, with the upper jack brace being clearly seen. The pegs visible on the right secure a halving joint.

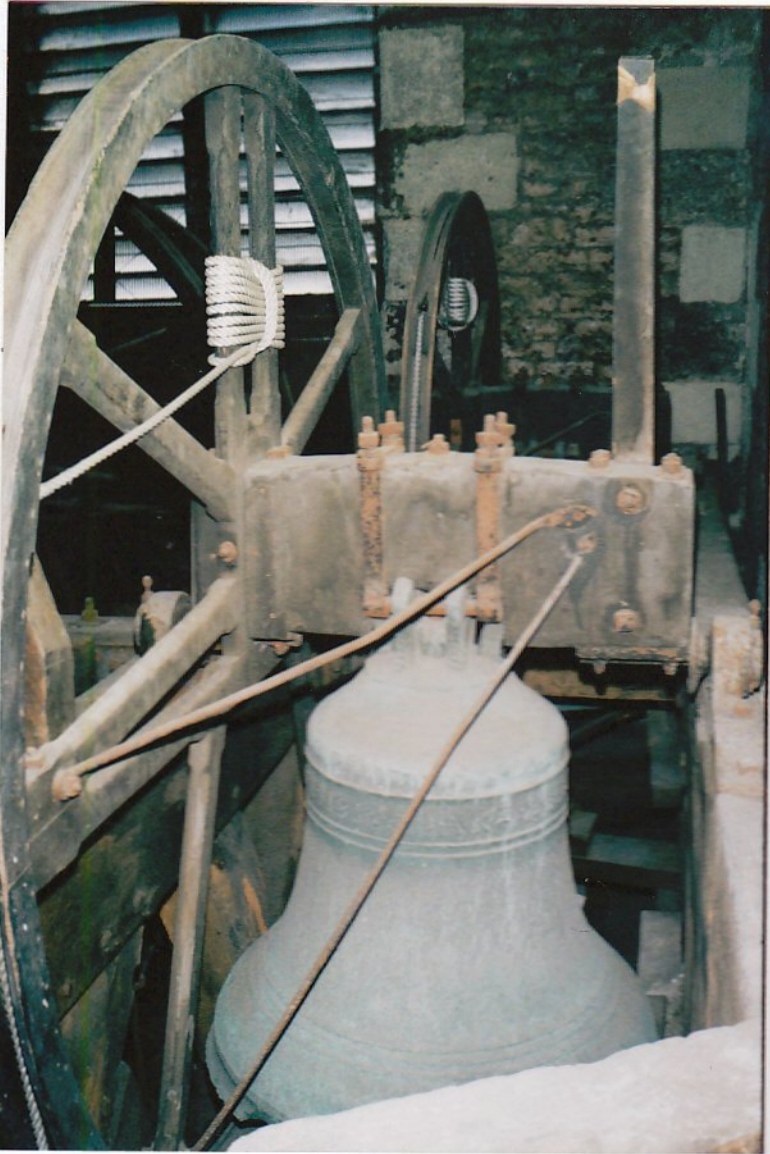
Plate 2

(Left) The high crown on the second bell is clearly seen, as is the traditional ironwork securing the bell to its stock.

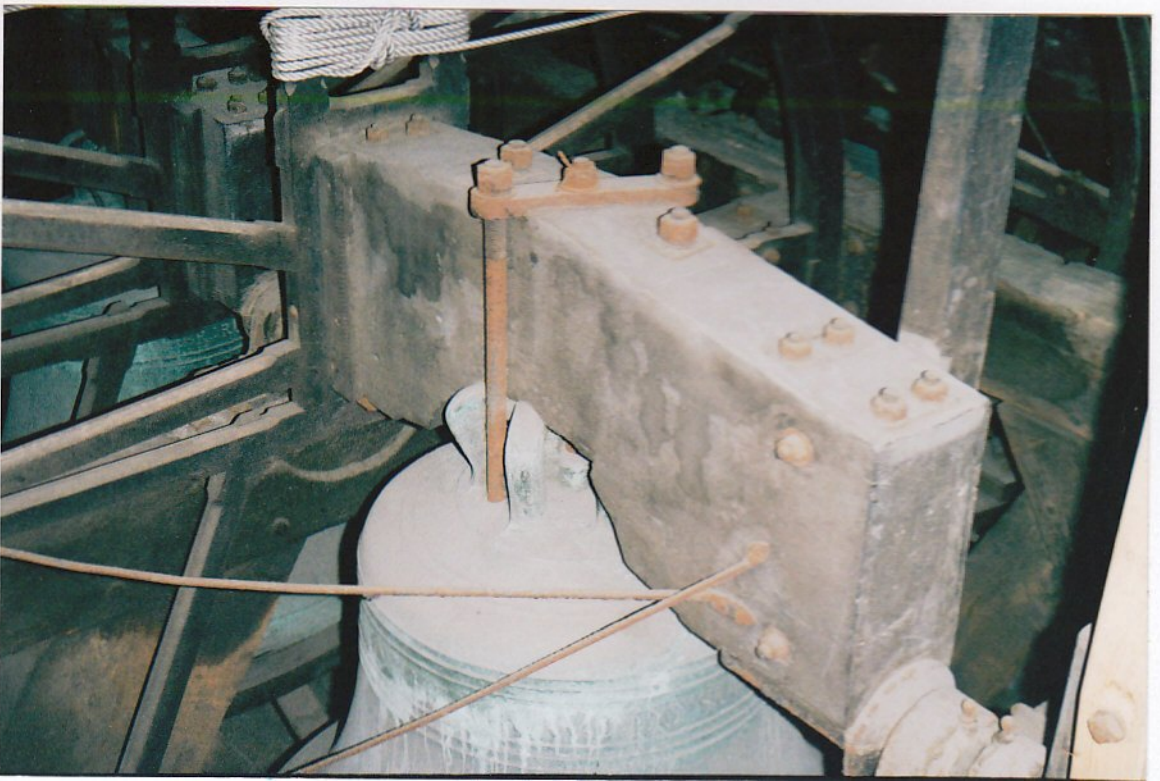
(Below) Hexagonal nuts indicate the work done in 1936, when the tenor bell was eighth turned on the stock.

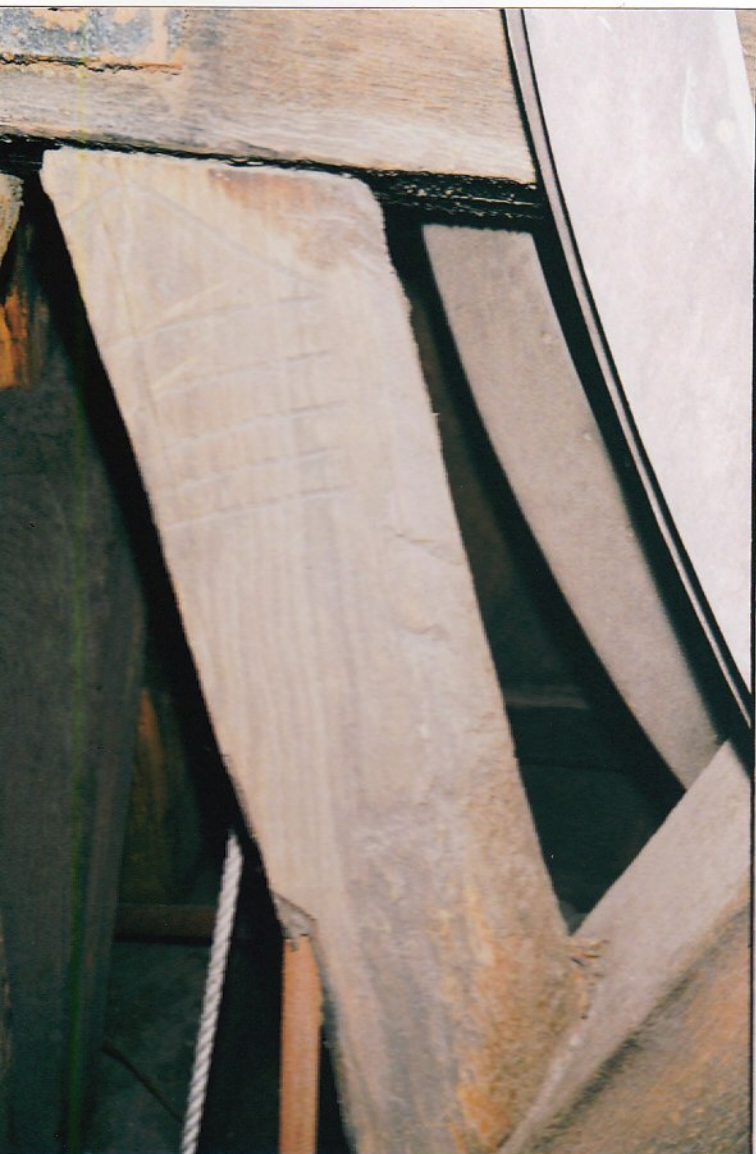
Plate 3

(Left) Long scratch carpenter's marks indicate that this piece of timber was first used *c.*1600.

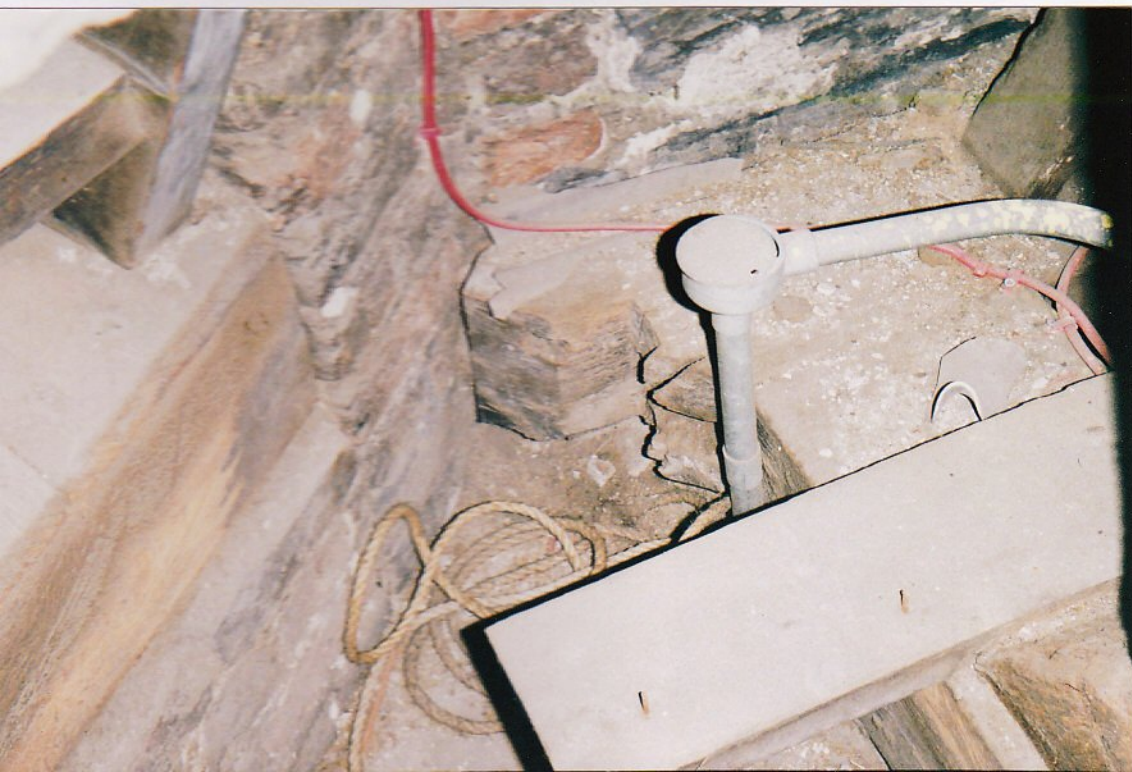
(Below) The slot in which the tenon engages to close the sills of the four-bell unit is visible in the centre, behind the conduit.

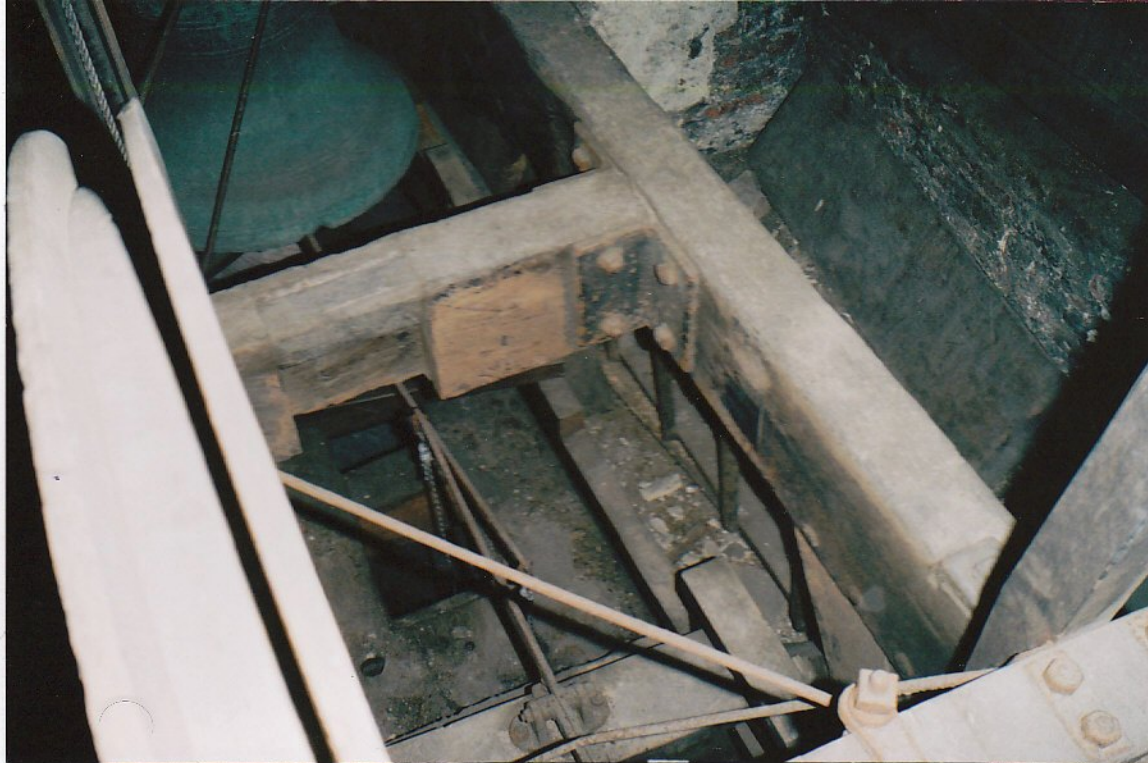
Plate 4

(Above) Just visible in the frame head are the cut-off tenons where a mistake was made in setting out the frame.

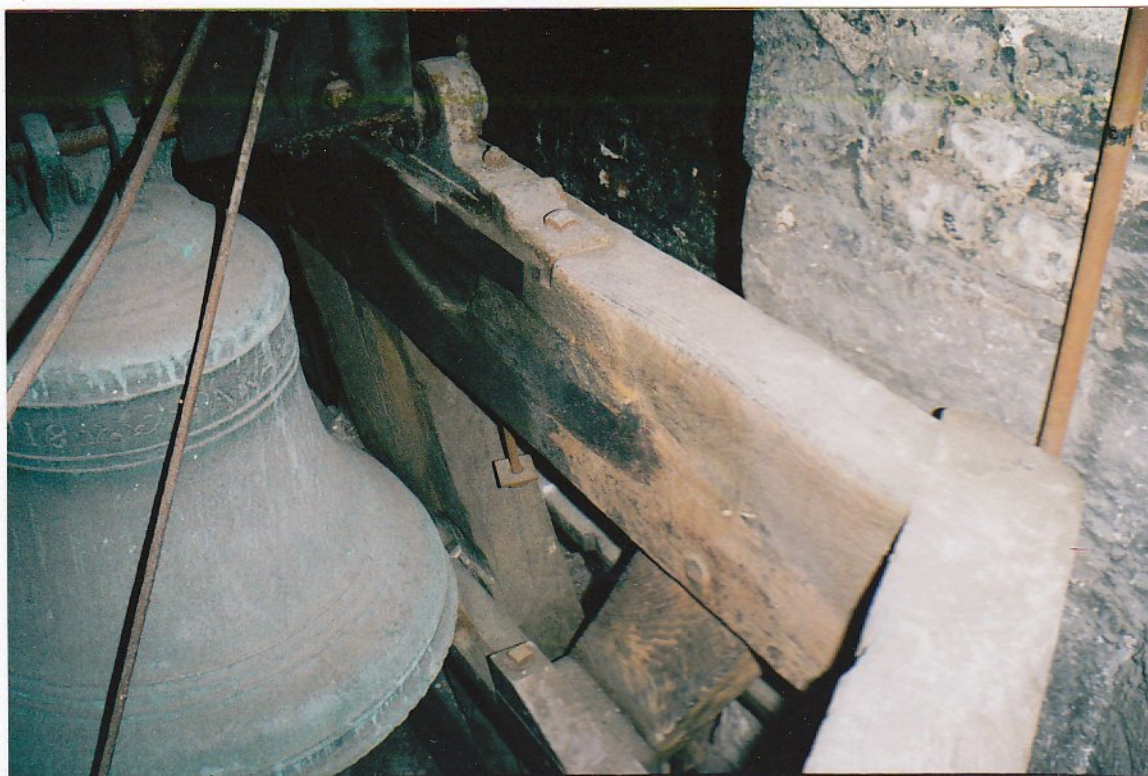
(Below) Below the present bearing can be seen a clearance mark where, prior to 1899, the stock hoop of the bell cleared the frame head.

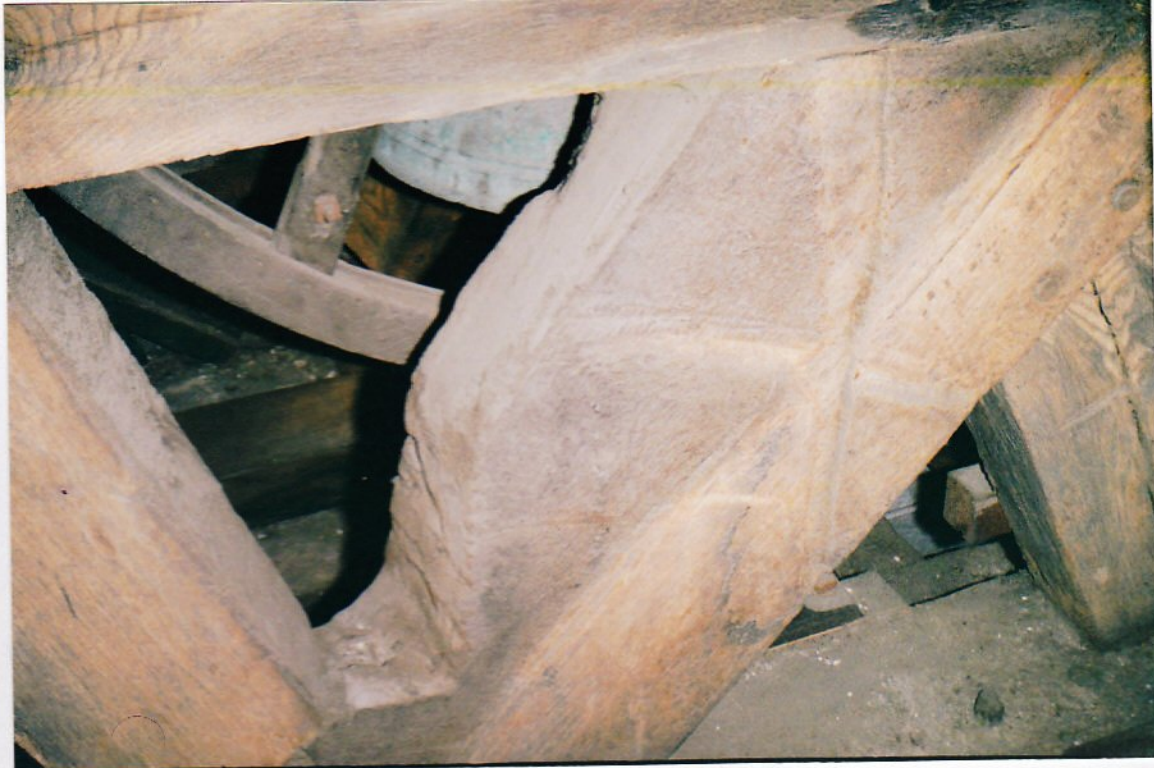
Plate 5

(Above) The mark where a bell formerly swung on this brace at the west end of the seventh bell pit indicates that this brace was reused from a former frame.

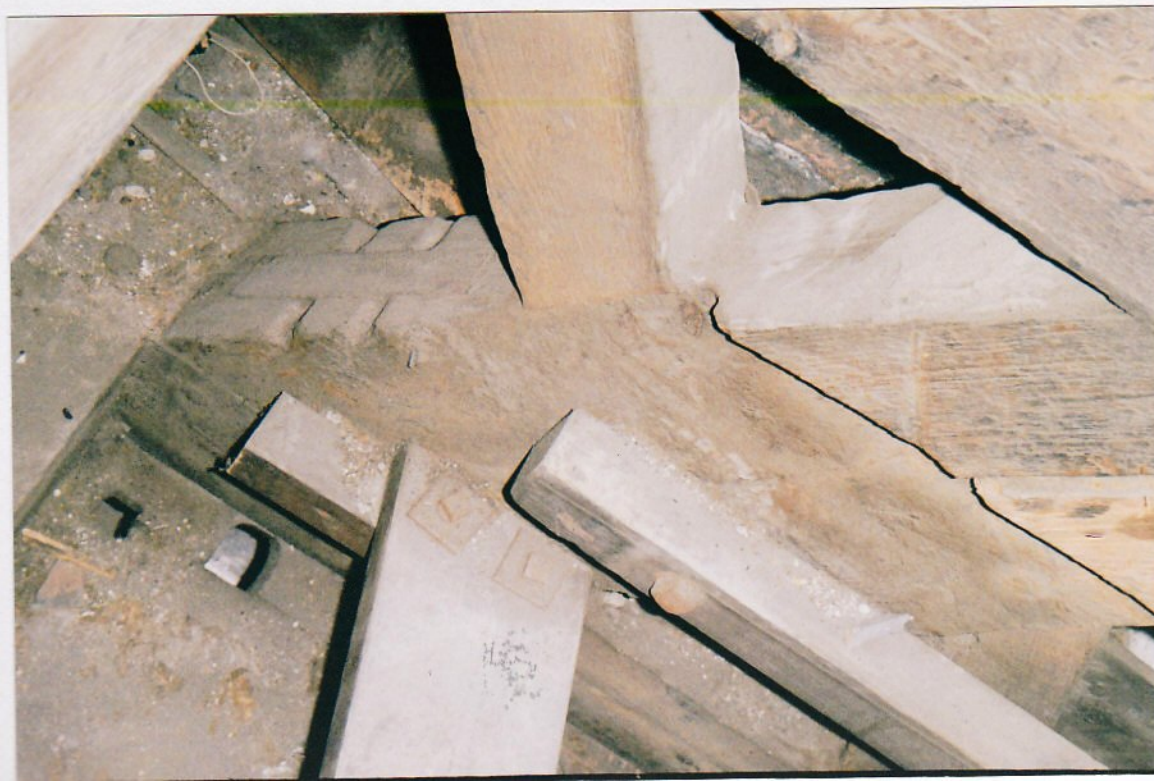
(Below) Reuse is also indicated on the northernmost brace of the east truss supporting the sixth bell. The tenon from the former use was left in situ.

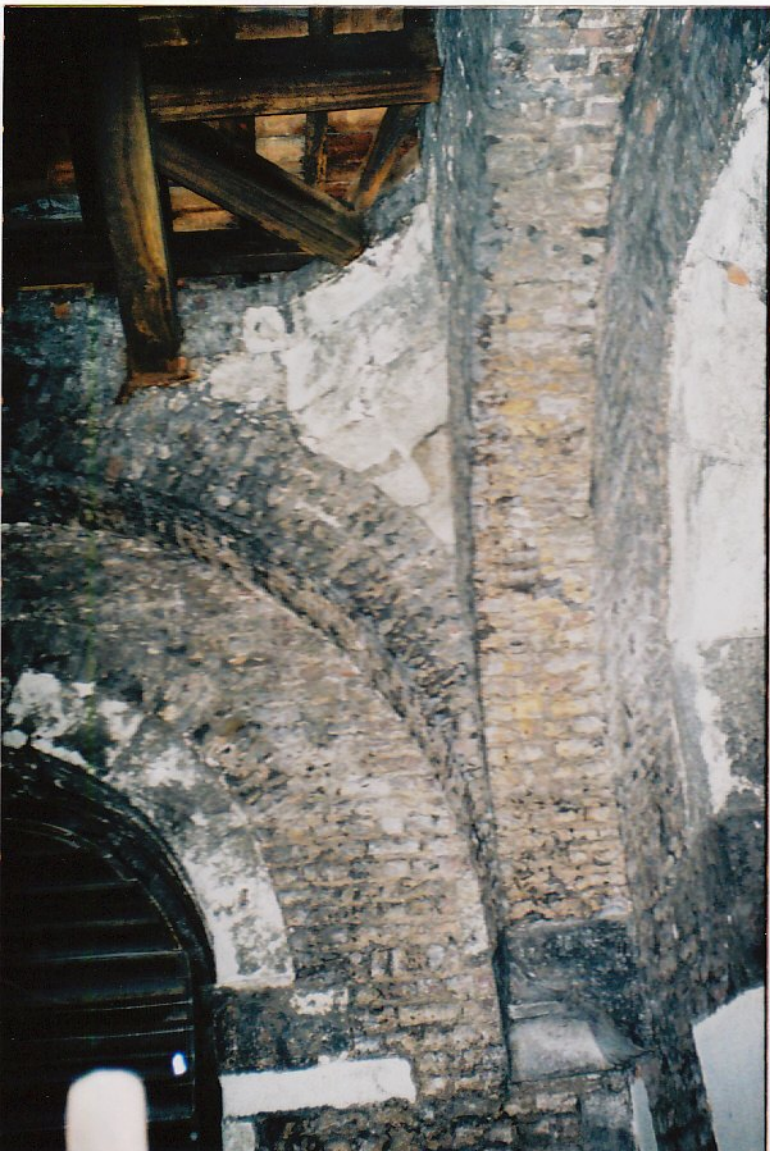
Plate 6

(Left) To support the octagonal stage above the belfry, squinches are built out at the four corners.

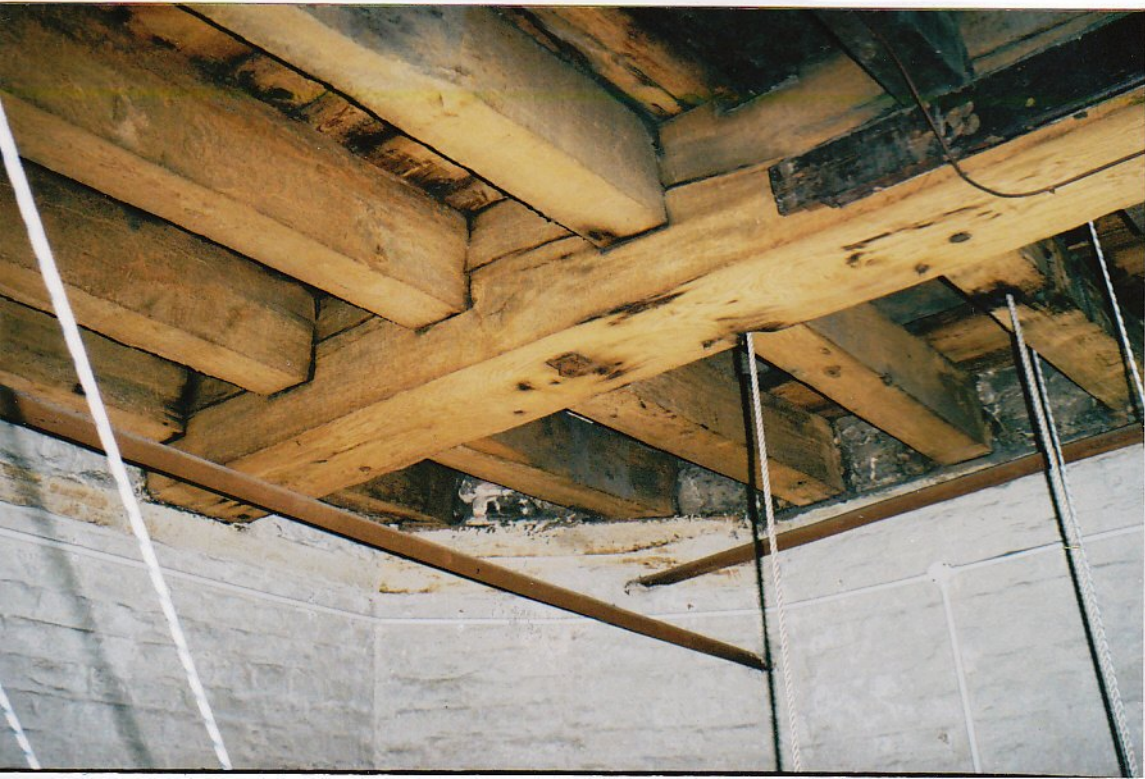
(Below) Looking at the timbers supporting the frame towards the south west. In the centre is the end of one of the tie rods that secure the frame to the floor.
