Exeter Cathedral: Repairs to cresting of high roofs (1 of 5 projects funded)

Exeter Cathedral: Chapel of St Andrew repairs (2 of 5 projects funded)

Exeter Cathedral: East End conservation (3 of 5 projects funded)

Exeter Cathedral: North side drainage (4 of 5 projects funded)

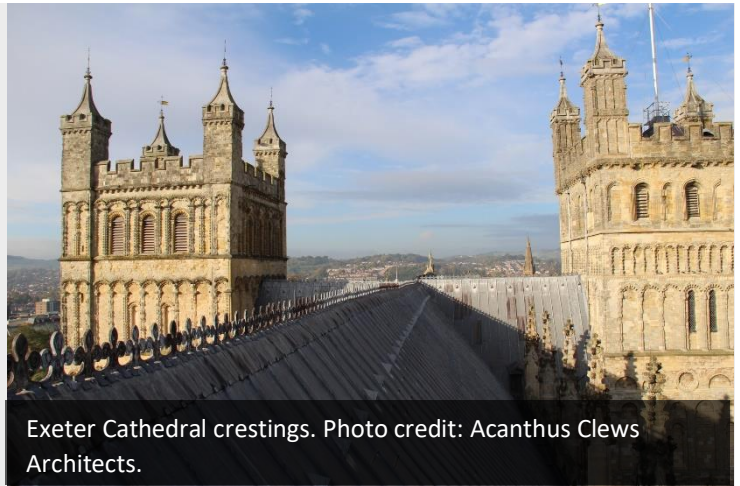
Repairing the lead crestings on the high nave, quire and transept roofs had been identified as an urgent need by the cathedral architect. The crestings have formed a significant feature of the roofs since the medieval period and are made of lead in a fleur-de-lys design. Each piece of cresting is substantial, being approximately 30cm in length and weighing about 6 kilos. Defects in their re-fixing during a previous phase of roof repairs commenced in the 1980s meant that many had already fallen, creating a health and safety risk as well as damaging the lead roofs below. The collapsed cresting was clearly visible from the Close and all the long views of the cathedral. The application was to re-fix all the crestings and take preventative measures to prevent those which were still in-situ from falling.

Exeter Cathedral crestings. Photo credit: Acanthus Clews Architects.

The work was carried out by contractors Mike Light Leadworks. It began in late May 2015 and was complete by July 2015. The work included crestings, timber and stonemasonry. Changes to the scaffolding design to achieve a safe working platform increased the original costings, with the balance being met by the Friends of Exeter Cathedral.

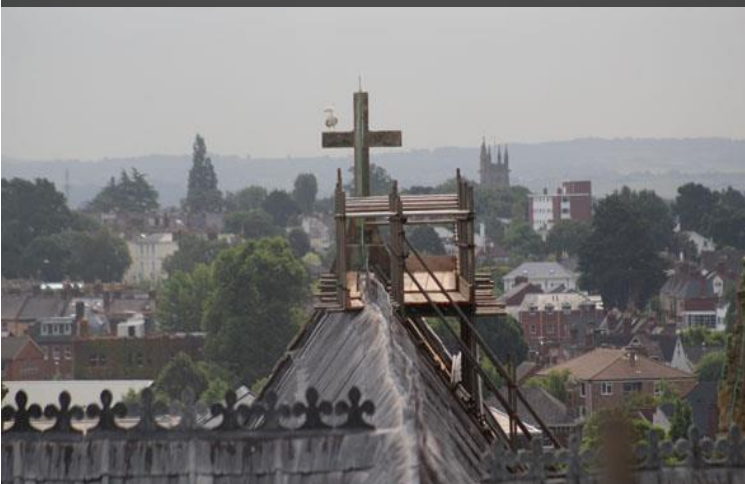
The working platform. Photo credit: Acanthus Clews Architects.

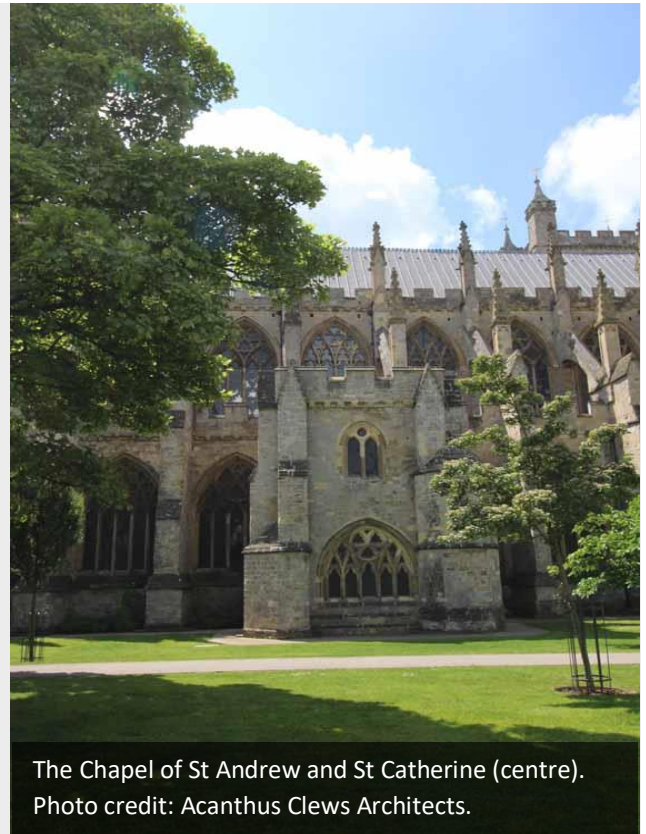
Essential work was required to conserve masonry and medieval stained glass in the Chapel of St Andrew and St Catherine, which were under threat from water ingress and damp caused by poor drainage. The Chapel is a good example of part of a medieval chantry, with an unusual triple canopy and remains of original paint. The problem with rainwater disposal and water ingress was raised in the 2012 Quinquennial Inspection and was linked to the poor condition of the roof over the Chapel. This was being exacerbated by rising damp thought to be caused by failures in the below-ground water drainage system and confirmed by imagery taken as part of wider environmental monitoring. Loss of fabric due to water and salts penetrating the walls had been occurring over the previous 40 years.

The Chapel of St Andrew and St Catherine (centre).
Photo credit: Acanthus Clews Architects.

Repair work, recording and conservation was carried out to the Chapel and the associated clerestory window (left). The works included general security, access and protection, stone cleaning, external drainage, flashings, waterproofing, timber repairs, and stonemasonry repairs.

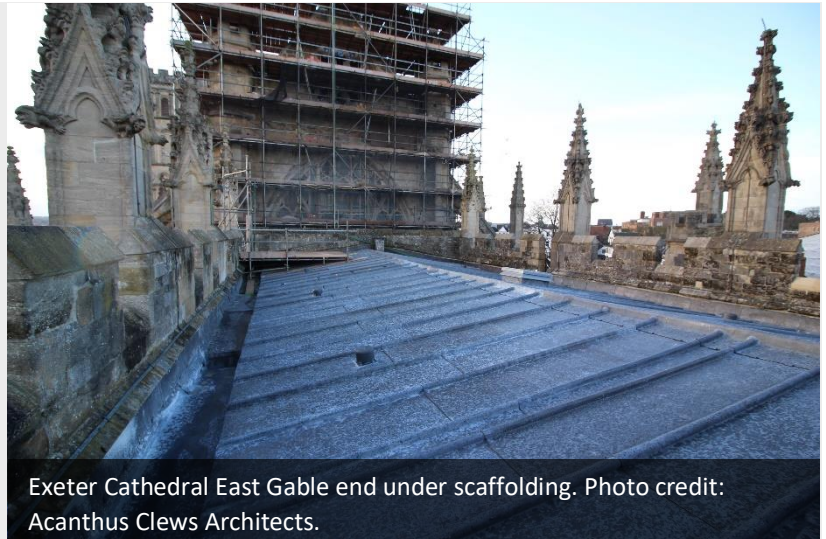
The Great East Window, c.1300, is of national significance, incorporating important examples of early 14th and 15th century craftsmanship. The existing 1980s polycarbonate protection system was damaged and discoloured, allowing damage from salts and damp penetration. There was also a range of critical work required to the stonework and structures of the East Gable end, where vertical cracks in the north and south stairs turrets were visible and being monitored, and to the lead roofing of the Lady Chapel.

Exeter Cathedral East Gable end under scaffolding. Photo credit: Acanthus Clews Architects.

The failing 1980s polycarbonate projection system on the Great East Window was removed and replaced with an externally ventilated isothermal protection system. The external face of the glass was inspected, recorded, cleaned and repaired. On the East Gable end, stonework was repointed, sections of decayed masonry conserved, the diamond leaded lights restored, high-level working access to the east wall and associated turrets provided and bird mesh and netting installed. At high level in the Lady Chapel, rainwater drainage was improved, roof voids were cleared for safer maintenance in future, ventilation to the lead roof was improved, and damaged and decayed weathering coping stones were replaced.

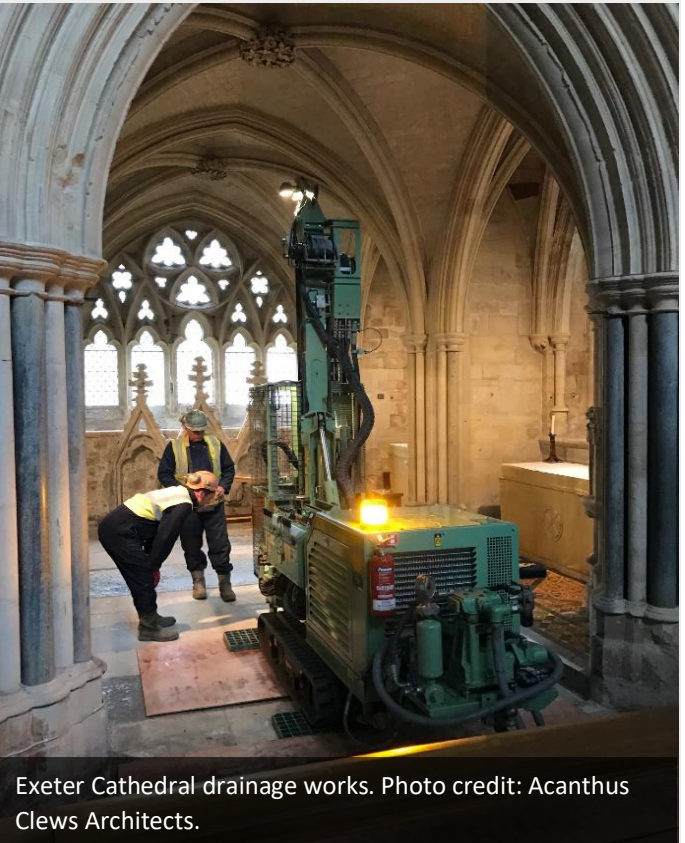
Critical repair work was required to the drainage to the northwest side of the cathedral and to fill a related void below the West Front apron that had been discovered during earlier drainage repairs in 2014. This posed a high risk to visitors, staff, vehicles, business and the cathedral fabric should it collapse: access for fire engines would have been restricted in an emergency, such as occurred soon after the application with the major fire at the nearby Royal Clarence Hotel fire in October 2016, and the fire strategy for the cathedral would have been seriously compromised. The work was therefore felt to be key to keeping the cathedral safe and open.

Exeter Cathedral drainage works. Photo credit: Acanthus Clews Architects.

The works included drainage repairs, grouting to the West Front apron, and installation of a ground water

monitoring system to provide data to evaluate the water table and its effect on the building. This project was the final piece of work needed to address significant underground drainage problems which threatened the cathedral fabric.

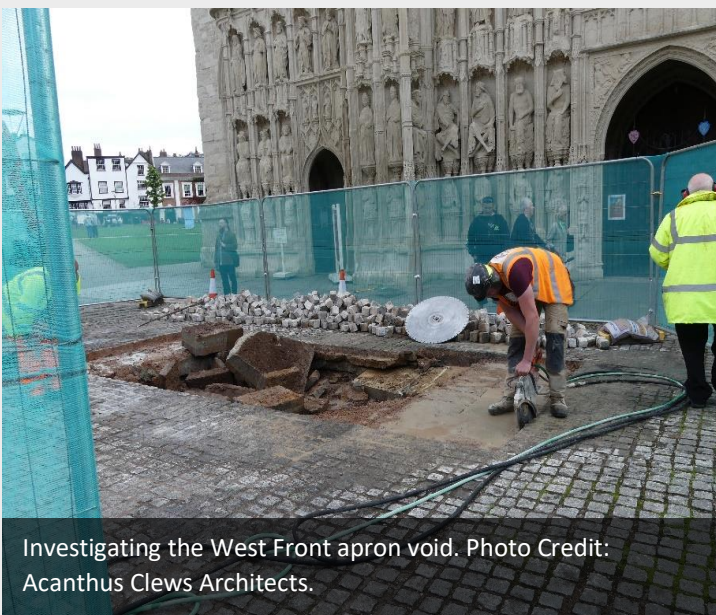
Investigating the West Front apron void. Photo Credit: Acanthus Clews Architects.

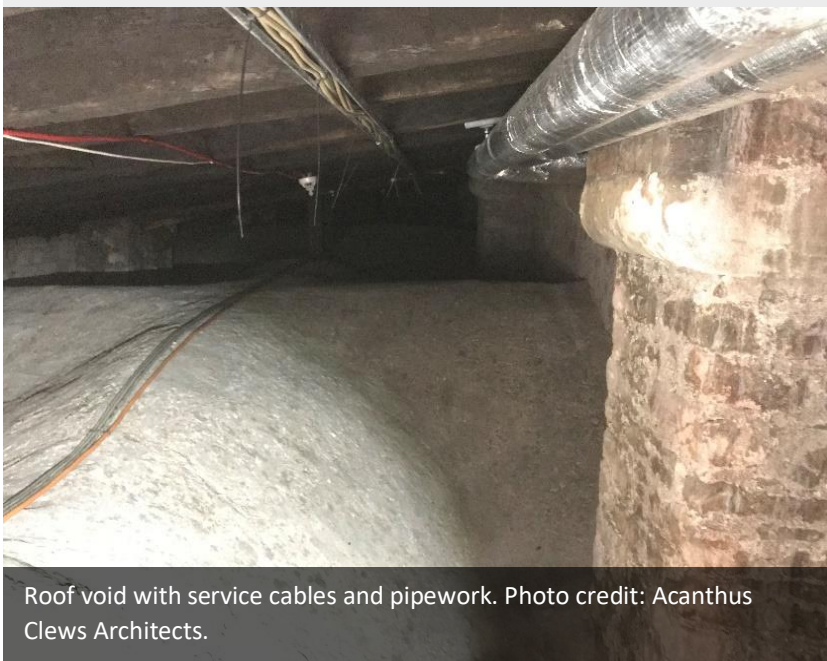
The highest priority element of the application was the removal of asbestos to enable safe access to various roof voids for maintenance and repair. A comprehensive survey had taken more than 200 samples of suspected asbestos-containing materials: key areas were inaccessible without full asbestos protection measures. As a result the condition of the fabric and associated heating systems could not be properly inspected or maintained. This created a significant risk of damage through late detection of water ingress through roof coverings and gutters or through faults and failures to the heating system pipework.

Roof void with service cables and pipework. Photo credit: Acanthus Clews Architects.

The works included leading, masonry repairs, asbestos removal and further remedial repairs.
