# Leicester Cathedral: North Side Project (1 of 2 projects funded)

## Leicester Cathedral: South Face Stonework (2 of 2 projects funded)

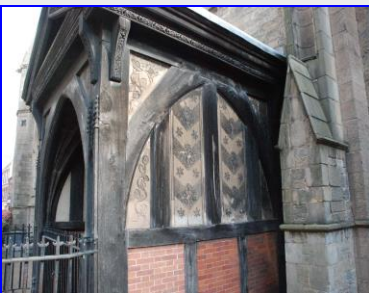
North Porch before repairs. Photo credit: Ian Salisbury, Cathedral Architect.

These works were carried out by Midland Stonemasonry Ltd under the supervision of the cathedral architect. The works included masonry repairs to the high level north transept, timber repairs to the north porch, replacing corroded saddle bars to the north window of the north transept with bronze, refurbishment of rainwater goods,

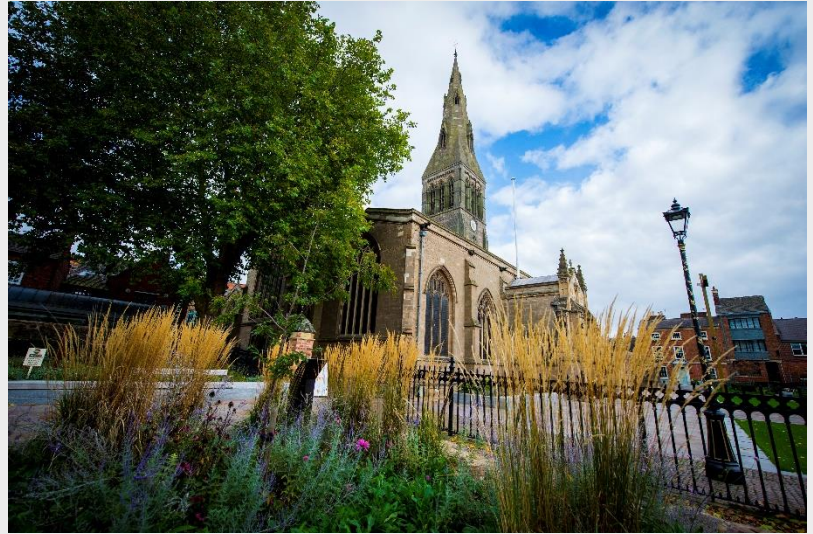
The 2016 Quinquennial Inspection identified an urgent need for significant external stone repairs on the south side of the building, to address risks of falling stone in public areas and of inadequate support for the roof. The walls consisted of a very shallow layer of ashlar, with much face-bedding and spalling, and with no useful ties to the rubble behind. The sandstone in places appeared to have lost nearly all of its strength; it was easily broken into powder between the fingers. A particular feature of the deterioration of this stone is that it turns to powder behind a deceptively hard but thin crust. When the crust falls off, all that remains is the powdery material. The weakness was in the poor quality of the facing stone, the thinness of the external layer and inadequate tying-in.

Works commencing in January 2018, carried out by Midland Stonemasonry Ltd under the supervision of Van Heyningen & Haward Architects, and included major repairs to the great south aisle wall and the south nave clerestory. The repairs were due for completion in June 2018. The repair works included the replacement of two badly deteriorated stone gargoyles with new grotesques in the forms of a Fox and a Tiger.
