Portsmouth Cathedral: Tower & South Transept (1 of 3 projects funded)

Portsmouth Cathedral: Repointing of Chapel (2 of 3 projects funded)

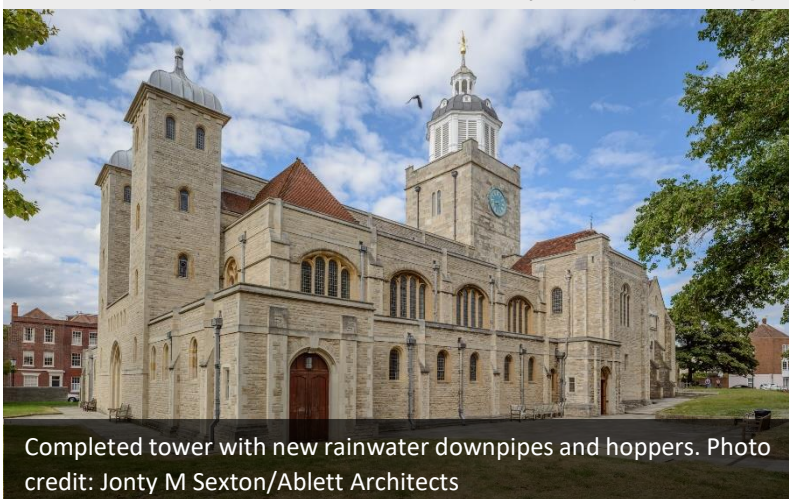
Completed tower with new rainwater downpipes and hoppers. Photo credit: Jonty M Sexton/Ablett Architects

The transept works involved the removal of the internal plaster to the end transept wall and re-pointing. Tower lead was renewed, rotten timber cut out and decayed steelwork replaced and new rainwater goods installed. Costs increased and timescales were extended because of the discovery of extensive rot and corrosion at high level in the tower belfry, risking its collapse in a storm; the fund's Expert Panel allocated an additional sum from underspend elsewhere towards the c. £100,000 extra required.

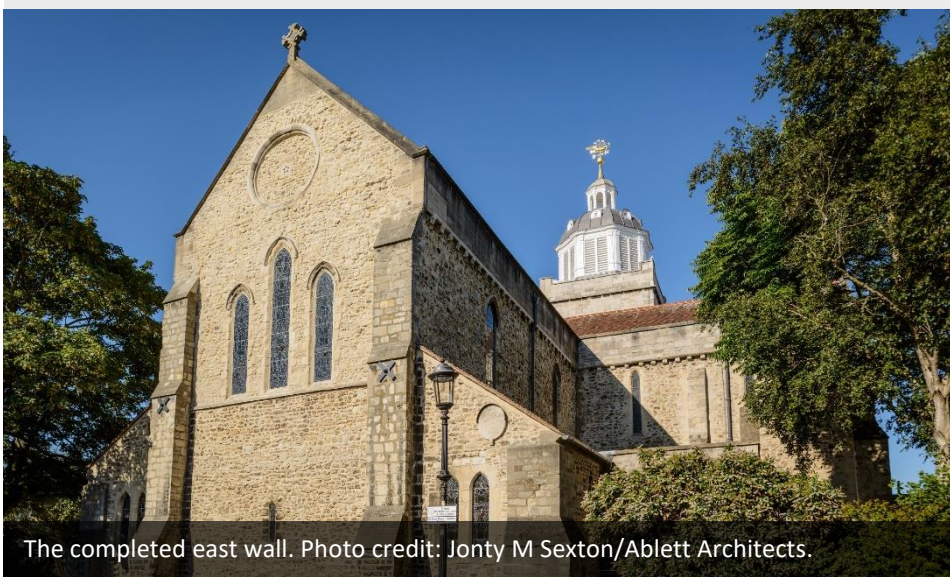
The completed east wall. Photo credit: Jonty M Sexton/Ablett Architects.

The works consisted of the repair and renewal of damaged exterior stonework to the Chapel and the removal of the 'crazy paving' wide and hard cement pointing to the whole elevation, as well as to the south elevation of the aisle. It also involved the refurbishment of the plain clay roof tiles and repair of the rainwater goods. It completes the repointing of the exterior of the cathedral, funding for which had not been obtainable in recent years.

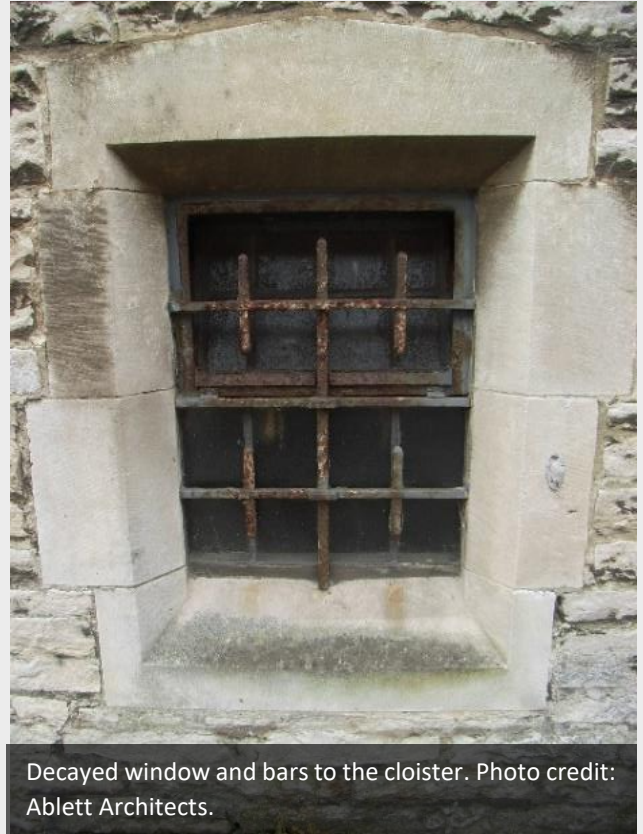
The poor condition of the metal-framed windows on the north side and their ferramenta (metal bars) had been noted in the 2011 Quinquennial Inspection and again in 2016; the location of the cathedral by the sea ensures that ferrous metal corrodes very quickly, expanding and causing splits and fractures to the stonemasonry into which the metal is fixed.

Decayed window and bars to the cloister. Photo credit: Ablett Architects.

The project consisted of the repair of the nine stained-glass windows to the north quire aisle, the windows of the north tower transept, all the remaining leaded light windows of the cloister and the cloister garth and

their corroding window bars. It also address various other north side repairs: repointing of open joints to the stonework and the parapet coping stones, new lead cover flashings to the cloister roof and a lead cover flashing and pointing to help protect the fine 17th-century north doorcase. Lead rainwater pipe fixings were inspected and some renewed. There were also some works to the nave flooring, which required repointing.

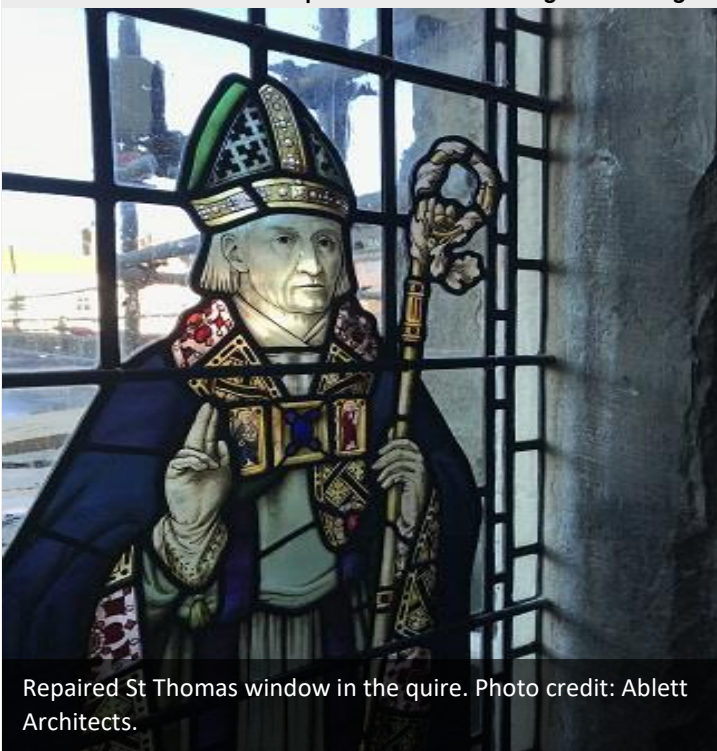
Repaired St Thomas window in the quire. Photo credit: Ablett Architects.
