Ripon Cathedral: North Transept and East Elevation Repairs (1 of 3 projects funded)

Ripon Cathedral: Glazing Repairs (2 of 3 projects funded)

Ripon Cathedral: Presbytery Stonework Repairs (3 of 3 projects funded)

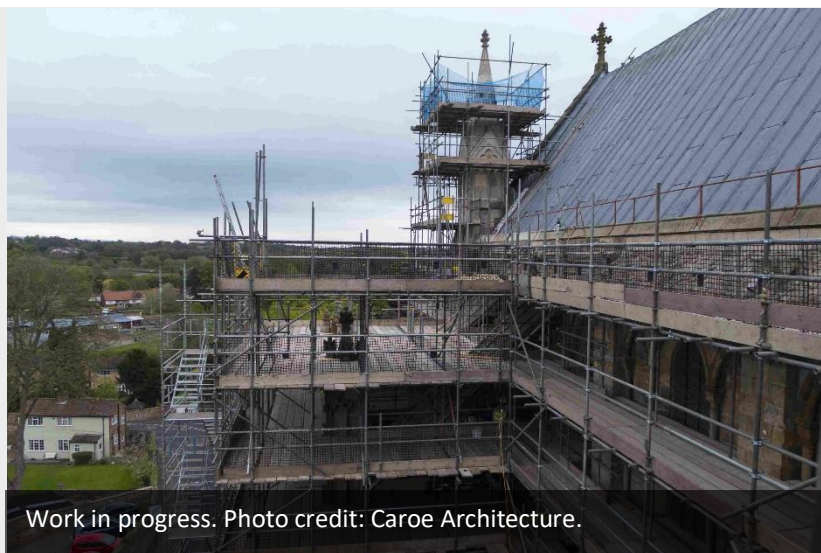
Work in progress. Photo credit: Caroe Architecture.

The work was carried out by in-house stonemasons. This saved time and money across this and the third project which involved work in the same area of the cathedral. The works are now successfully complete and will not need any further work for at least 25 years.

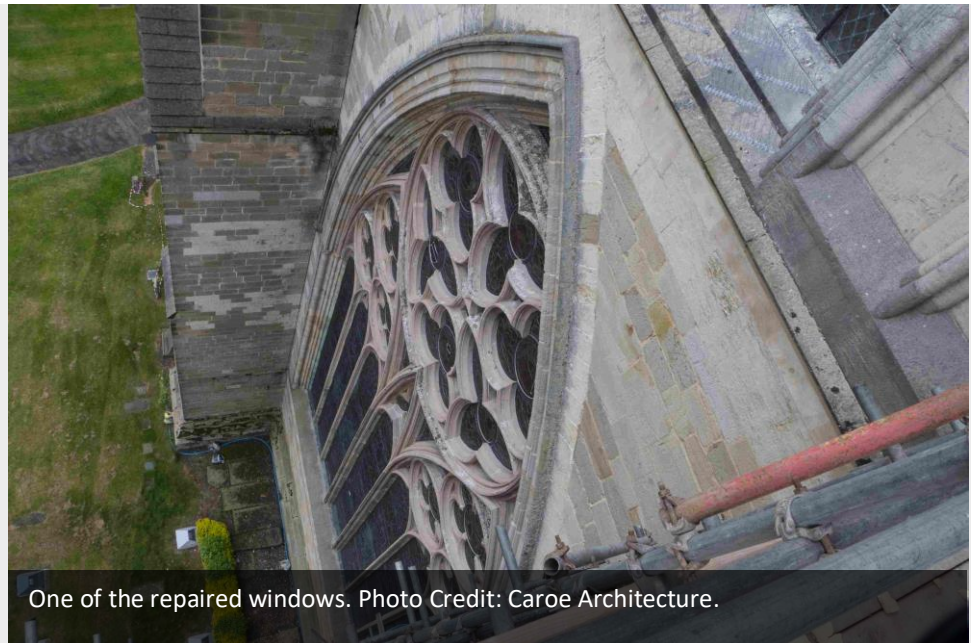
One of the repaired windows. Photo Credit: Caroe Architecture.

The funding enabled the cathedral to address the most urgent repair needs of some of their stained-glass windows. One of these, the highly significant nave west window was at risk of imminent collapse, as was a library window just above the Chapter House door, one of the busiest parts of the cathedral. Much of original £19,208 grant had to be directed to these windows, which turned out to be in much poorer condition than anticipated. As a result part of the original proposed work, to re-lead a window in the nave clerestory, was going to be omitted, but the fund's Expert Panel was able to re-allocate £12,000 from underspend elsewhere to reinstate it to the work programme.

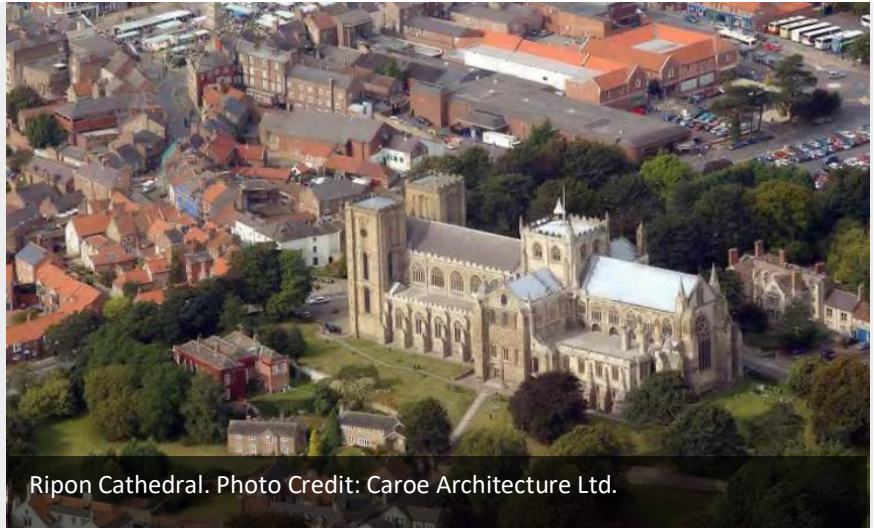
Ripon Cathedral. Photo Credit: Caroe Architecture Ltd.

The work involved a programme of stonework stabilisation, repair and renewal to the walls and flying buttresses to the North Choir clerestory, as well as to pinnacles and window tracery. The Cathedral brought the stonemasons in-house which saved time and money across their two stonework projects in the same area of the Cathedral. The works are now successfully complete and will not need any further work for at least 25 years.
