Salisbury Cathedral: SE Transept and Clerestory Repairs (1 of 3 projects funded)

Salisbury Cathedral: External Repairs (2 of 3 projects funded)

Salisbury Cathedral: Trinity Chapel Stonework Repairs (3 of 3 projects funded)

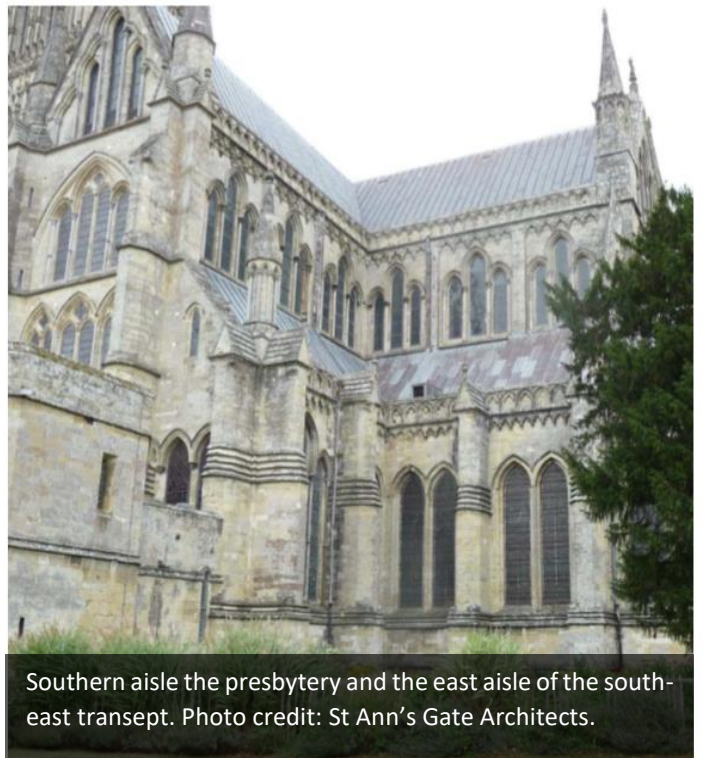
Southern aisle the presbytery and the east aisle of the south-east transept. Photo credit: St Ann's Gate Architects.

The works comprised of stone conservation, in line with the established cathedral policy, inspection and mitigation of decay to the parapet, replacement of Purbeck marble as needed to the corbel table, repair to window mouldings at high level, and reinstatement of features such as carved decoration and carved capitals.

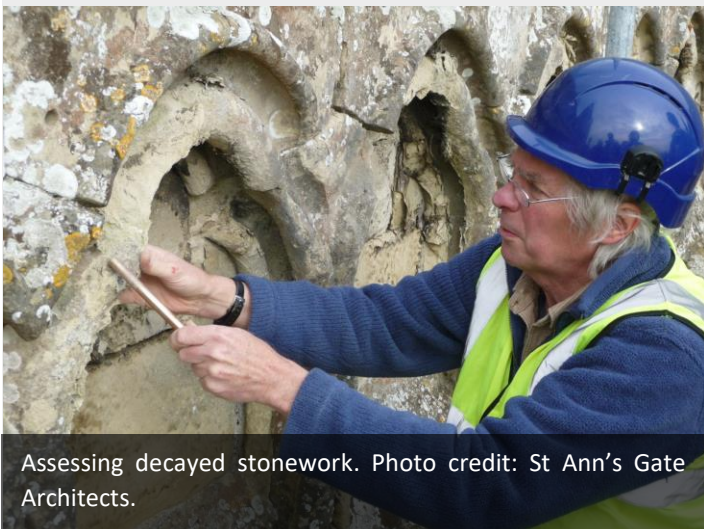
Assessing decayed stonework. Photo credit: St Ann's Gate Architects.

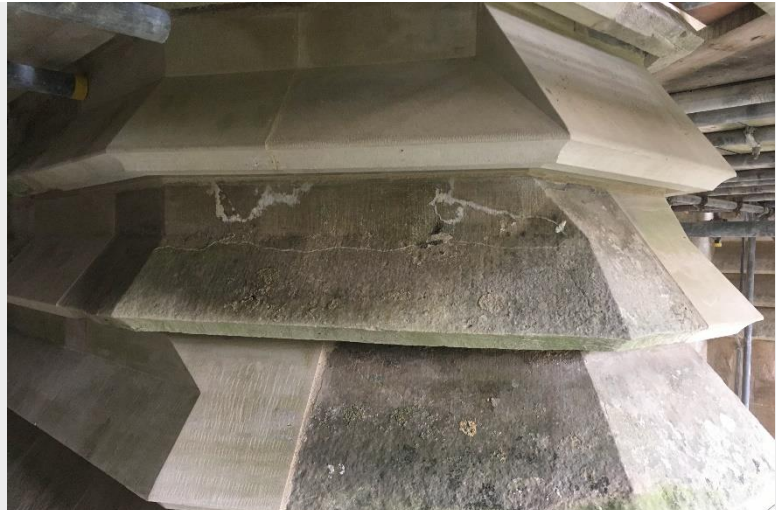
Buttress repairs. Photo Credit: Dittrich Hudson Vasetti Architects .

Following on from the previous project, the work focused on stonework repairs (masonry replacement and repair, and shelter coating) on the south presbytery aisle and the east aisle of the south-east transept.

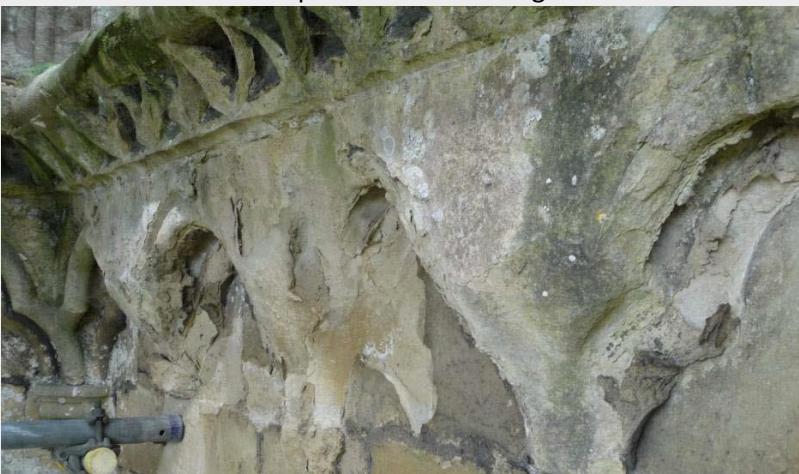
Soot crusts beneath the parapet string courses caused severe sulphate damage locally. Photo credit: St Ann's Gate Architects.

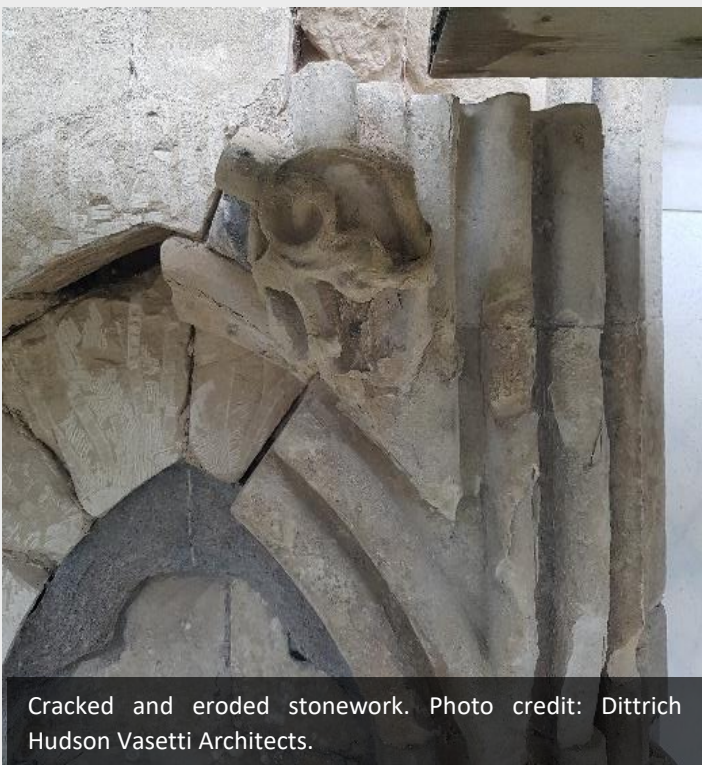
Cracked and eroded stonework. Photo credit: Dittrich Hudson Vasetti Architects.

Masonry, conservation and leadwork repairs took place between 2016 and 2017.
