Wakefield Cathedral: Nave and Quire Roof Repairs (1 of 3 projects funded)

Wakefield Cathedral: Stained Glass Repairs (2 of 3 projects funded)

Wakefield Cathedral: Nave Window Repairs (3 of 3 projects funded)

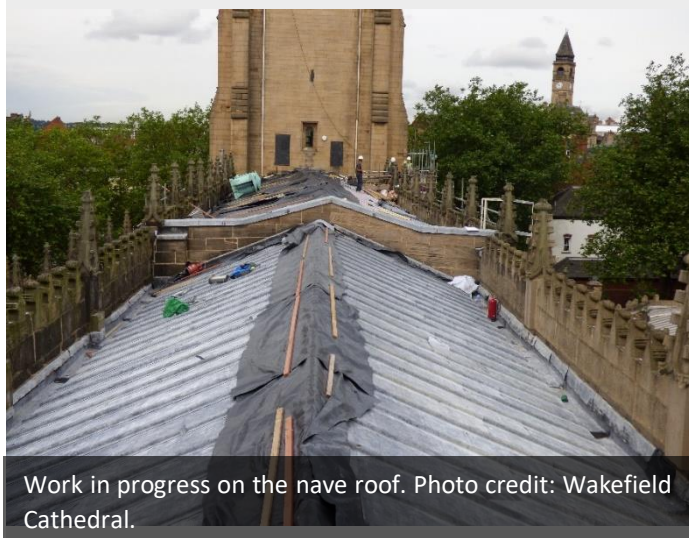
Work in progress on the nave roof. Photo credit: Wakefield Cathedral.

The works involved the removal of existing lead and parapet gutters, repairs to timber cored rolls and boards and re-leading to fix leaks. It also involved repairing and reinstating ventilators and some associated urgent masonry repairs to the parapets of the nave and quire.

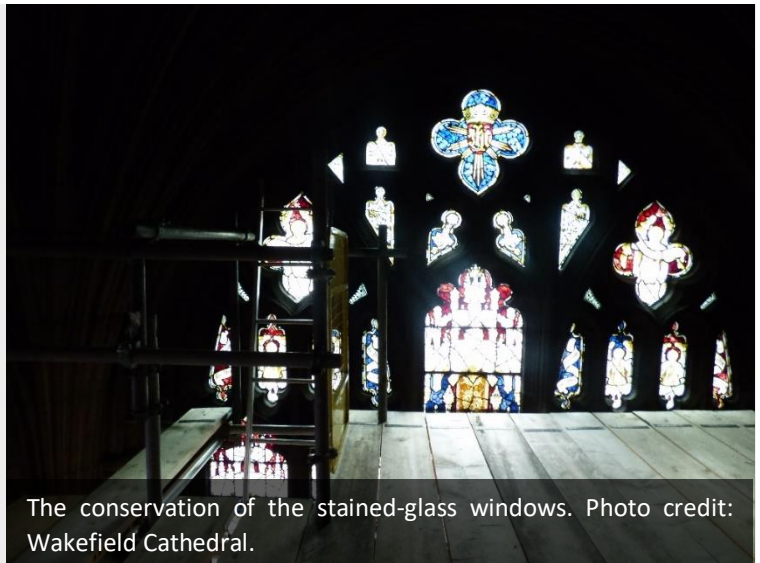
The conservation of the stained-glass windows. Photo credit: Wakefield Cathedral.

The conservation of the three 19th-century stained glass windows involved conservation cleaning by York Glaziers Trust to remove harmful deposits which were attacking the fired detail. There were also repairs to the glass and some stabilisation of painted detail. In addition, one of the windows required re-leading to some lights and the application of protective glazing.

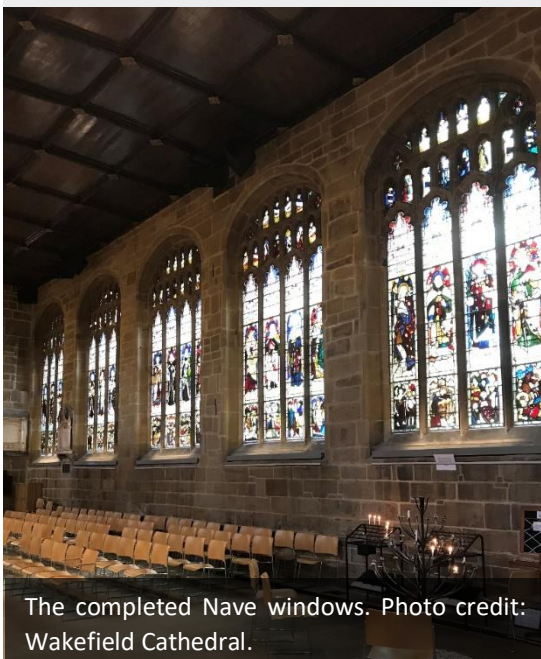
The completed Nave windows. Photo credit: Wakefield Cathedral.

The works consisted of the repair and conservation of the windows in the nave aisles and the western tower that were deteriorating rapidly and allowing water penetration. This involved re-leading, cleaning and the application of protective glazing.
