Worcester Cathedral: Library Ceiling Repairs (1 of 5 projects funded)

Worcester Cathedral: Great East Window Repairs (2 of 5 projects funded)

Worcester Cathedral: Roof Repairs (3 of 5 projects funded)

Worcester Cathedral: Great West Window Repairs (4 of 5 projects funded)

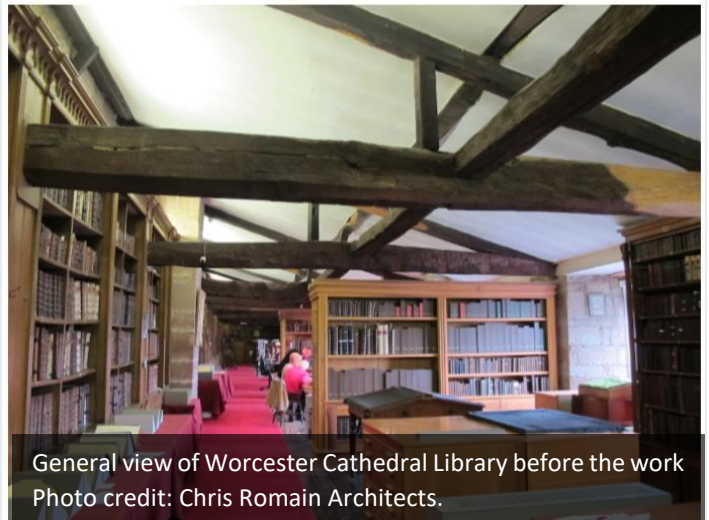
The Cathedral Library, a working library used by academic researchers and scholars, sits directly above the full length of the south nave aisle and houses rare documents and manuscripts which had until recently been at risk from leaks and plaster falls. The water was entering around the flying buttresses which pierce the roof vault. This fault had already been remedied at the time the fund was launched, but the cathedral had no funding for the repairs to the plaster ceiling needed to complete the project. Several sections had collapsed and full replacement was required as others could have fallen at any time.

General view of Worcester Cathedral Library before the work
Photo credit: Chris Romain Architects.

The replacement ceiling was like-for-like work, with traditional oak laths and three coats of lime plaster, finished with three coats of limewash.

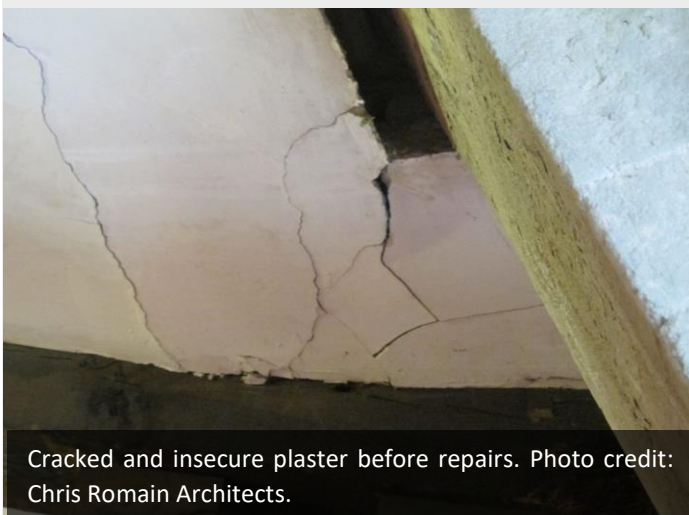
Cracked and insecure plaster before repairs. Photo credit: Chris Romain Architects.

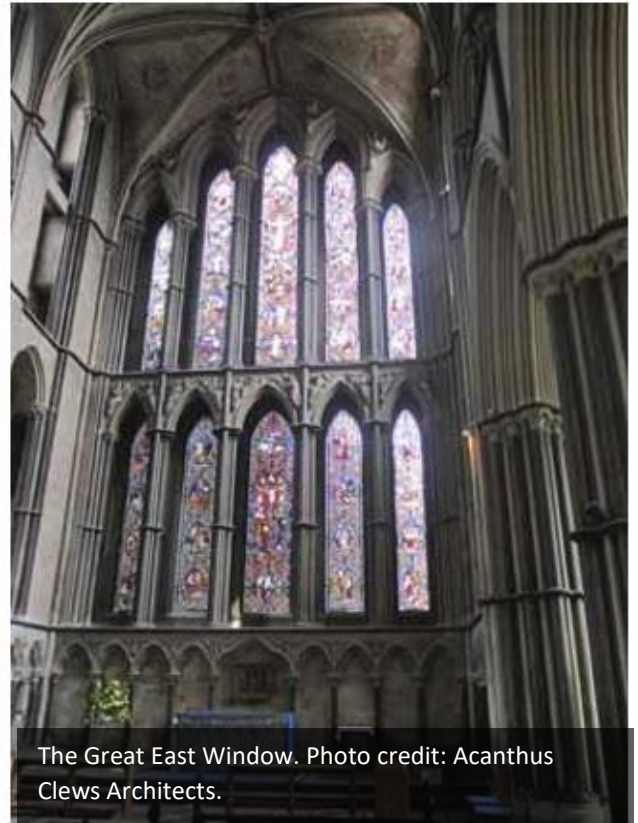
Great East window, a ten-light arrangement by John Hardman and Co, installed in the 1854/75 restoration campaign and set in 19th stonework, was showing structural instability and letting water in. Its lead was deteriorating resulting in numerous areas where panels are bowing. Where the bowing was most severe it had caused some of the ties to snap so that they were no longer offering support. The waterproofing cement had started to become friable, crumbling and pushing its way out from underneath the lead flanges. If allowed to deteriorate further, water ingress and severe paint loss would have become a major problem and could start to affect the internal fabric of the building as well as threatening loss and significant damage to the window.

The Great East Window. Photo credit: Acanthus Clews Architects.

The repairs rectified the issues which had resulted from over a century and a half of weathering. This included, intricate re-detailing to the glass illustrations, repairs to the glass which had become worn, and repairing of the iron fittings which had severely decayed. The window no longer leaks and the window is now more secure.

The restoration of the east window was carried out by the distinguished Holy Well Glass studio, based in Wells, supported by the cathedral's in-house stonemasons. The official unveiling and re-dedication of the window was carried out during the Mothering Sunday service in March 2016.

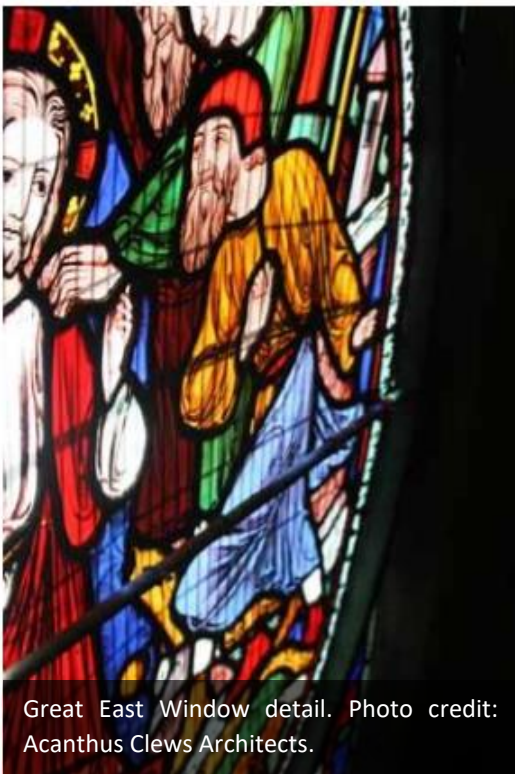
Great East Window detail. Photo credit: Acanthus Clews Architects.

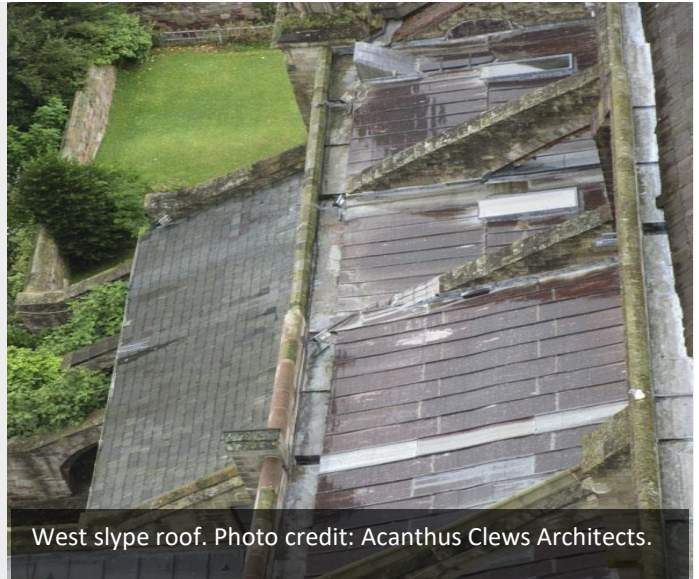
The need for urgent repairs to the roof covering, rainwater goods and structure of the west slype, the late-12th century passage leading from the west end of the cathedral to the cloister, was identified in 2011. A second storey had been added to the slype in the 1370s, and the present roof was in slate. Recent inspections had highlighted a significant deterioration in the condition of the slates and associated rainwater goods. Local failures in roof slates had allowed leaks to occur in multiple locations across the roof. Associated roof timbers were saturated with decay evident, and water was also penetrating the stone vault. The area is important to the functioning of the cathedral: the roof space above the slype was used for storage, including important medieval sculptures, and the ground floor houses the cathedral shop. However due to other urgent repair works elsewhere in the cathedral it had not been financially possible to carry out these repairs to date.

West slype roof. Photo credit: Acanthus Clews Architects.

The works, completed by the main contractor with the support of the cathedral's in-house stonemasons included roof coverings, rainwater goods, restructuring of the west slype roof, timber replacements, leading and roof slate replacements. Improvements to access to allow easier and safer maintenance in future were also carried out.

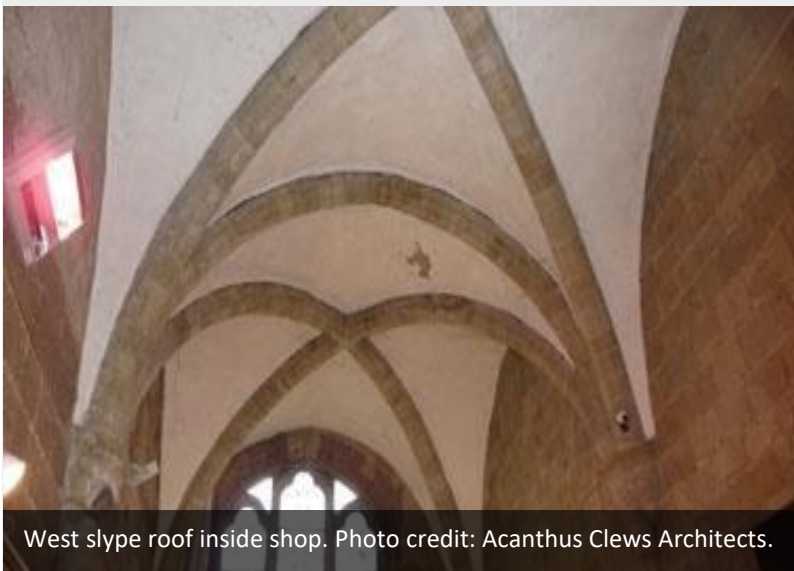
West slype roof inside shop. Photo credit: Acanthus Clews Architects.

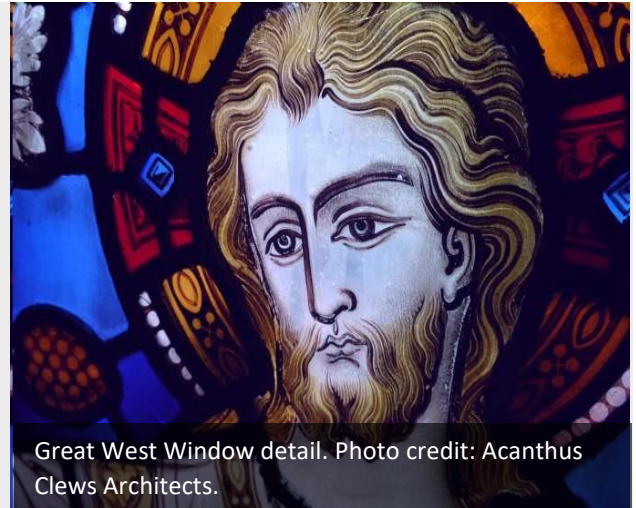
The Great West Window, by John Hardman and Co. of Birmingham, was installed during the restoration between 1854 and 1875. Depicting the Creation story, it is the counterpart of the Great East Window, repaired with the help of a previous grant. An inspection carried out in early 2016 during repairs to damage probably caused by a football concluded that an immediate major programme of repair and conservation was needed. The leadwork was in poor shape, with many cracked solder joints and hundreds of cracks throughout the window. This was caused mainly by buckling of the lead work. All main lights of the window leaked very severely, with water pooling on tie bars, running freely down the inner face of the glazing and forming large pools at sill level. Water was also forced through the leading, soaking areas below the window. This amounted to widespread failure of the window as a weatherproof barrier with implications for the surrounding fabric, and risked loss and significant damage to the window, which is exposed to strong westerly winds and rainstorms. The work was therefore urgent.

Great West Window detail. Photo credit: Acanthus Clews Architects.

The works were carried out by the cathedral's in-house works department and stained glass specialists Holy Well Glass, and covered conservation and repair of the window and adjacent stone repairs. Once high-level access was possible, close inspection highlighted a fundamental design fault in the tracery profile that had not been known about previously: the convoluted profile formed multiple water traps within the tracery, which had accelerated the decay of the associated stonework and caused significant water ingress into the cathedral. It was agreed by the cathedral and all advisory bodies that now, while the scaffolding was up, was the time to address the design fault, but the additional work would have significant cost, programme and resourcing implications. The First World War fund's Expert Panel was able to re-allocate £60,000 from underspend elsewhere to cover most of these extra costs. The conserved glass was in-installed in the cathedral in March 2018.

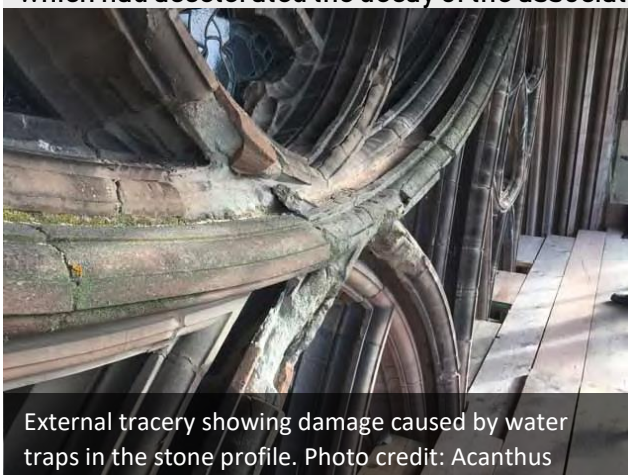
External tracery showing damage caused by water traps in the stone profile. Photo credit: Acanthus

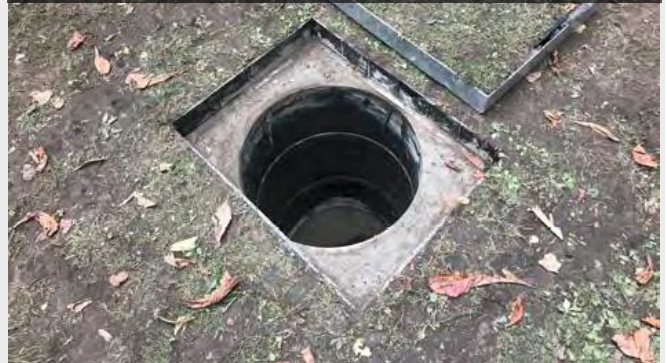
St George's Chapel, the cathedral's Military Chapel, is the setting of the commemorative plaques, standards and stained glass dedicated to those who fought and lost their lives in the First World War. It had a damp problem and the stonework within the chapel was in poor condition, with fractures and loss to the arcade that frames the commemorative plaques. Investigations to the ground conditions were required to inform future projects to address the leaks and poor drainage here and to the north of the cathedral generally, which were causing significant decay and loss to the stonework.

New manhole installed to the north of St George's Chapel to enable clearance of blockages and maintenance. Photo Credit: Acanthus Clews Architects.

Knowledge of the drainage system to this part of the cathedral has improved, it has been cleared of debris, local repairs have cleared blockages, access for maintenance has been improved, and it is free-flowing, which is improving the conditions inside the Chapel. Conservation cleaning techniques have been tested and a package of further works identified as a focus for fundraising. The projects at Worcester Cathedral have generated greater interest in the building and its heritage, catalysing further investment. Without the grant, the cathedral team do not feel they would have been able to raise the necessary funding for the work.

The works included drainage surveys and repairs, conservation cleaning of salt deposits, and window repairs. The project was led by the cathedral works department. Investigations and associated remedial work to the drainage was carried out by Sewer Surveys UK. McNeillage Conservation carried out two phases of cleaning trials to test a 'palette' of conservation techniques that could be effectively used within the Chapel and elsewhere in the cathedral to remedy the effects of water penetration once drainage problems have been solved. It is intended that further fundraising will allow for the full programme to be implemented, including the lining of two culverts to complete the drainage improvements.

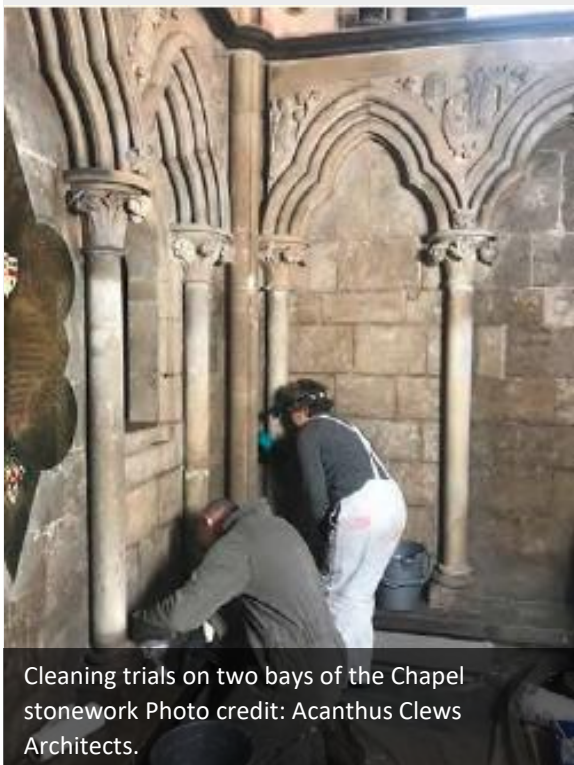
Cleaning trials on two bays of the Chapel stonework Photo credit: Acanthus Clews Architects.
