## York Minster: Camera Cantorum Repairs (1 of 2 projects funded)

# York Minster Cathedral: Quire South Side & Lady Chapel Exterior Repairs (2 of 2 projects funded)

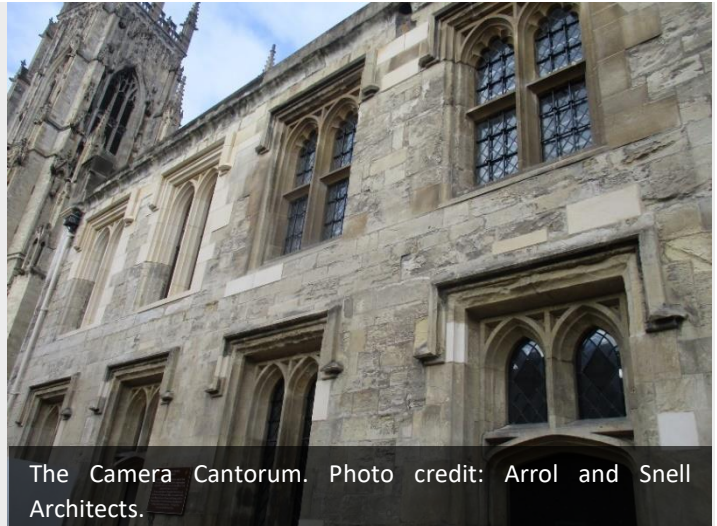
The Camera Cantorum. Photo credit: Arrol and Snell Architects.

Repair work began in March 2015 and was complete by the spring in 2016. It involved renewing stone sections and carrying out mortar repairs to the high-level stonework. The in-house Minster Stoneyard masons carried out the stone repairs, while glazing repairs were undertaken by York Glaziers Trust.

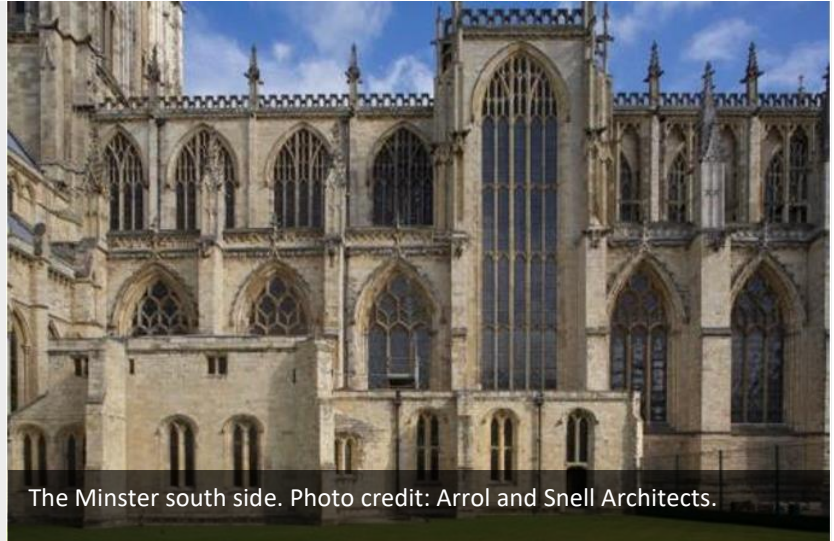
Serious stone decay and structural instability to the south side of the quire and Lady Chapel was the most urgent outstanding problem identified in recent Quinquennial Inspections. In 2014 a large fracture was recorded in the buttress of one area, which was deteriorating at an alarming rate, and there had been serious stone falls. Following completion of repairs to the east front, which commenced in 2006, this was the next major repair area to be tackled. The Minster needs to spend around £2.5 million a year on its rolling programme of repairs for the foreseeable future, as its magnesian limestone is prone to deterioration where exposed, and problems have been compounded by past repairs using stones of different geologies and the extensive use of wrought iron fixings which are now corroding, expanding and causing masonry to fail.

The Minster south side. Photo credit: Arrol and Snell Architects.
