Winchester Cathedral

Planning, commissioning and using conservation consultants when managing major projects

Presbytery conservation work

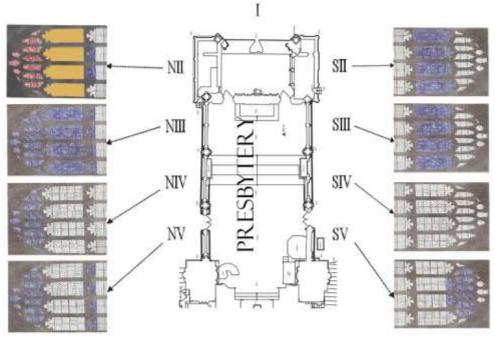
Winchester Cathedral, Presbytery Clerestory

Glass of different dates

Medieval glass circa 1440's

Medieval glass circa 1404-26

Early 16th century glass probably inserted by Bishop Fox

Distribution of surviving medieval and late medieval alass

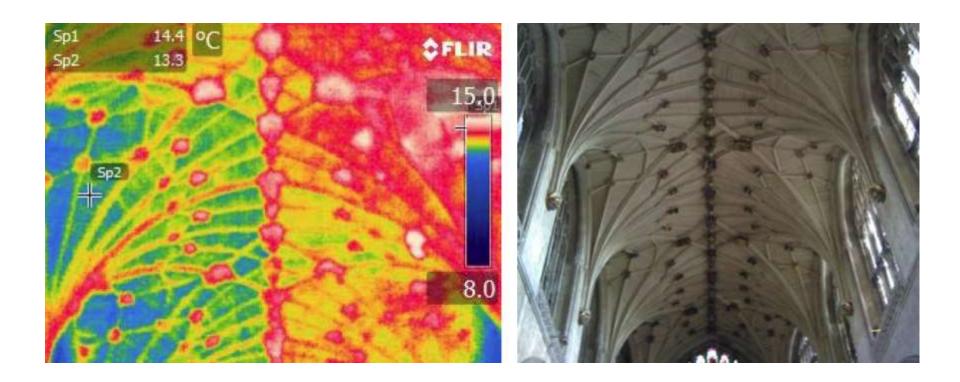
Establishing baseline data

Key findings from the environmental monitoring included:

Condensation occurring on the glass on all elevations throughout the year being most pronounced between September and March and worst on the north windows.

Whilst the north was wetter the **number** of wetting and drying cycles was higher on the south side

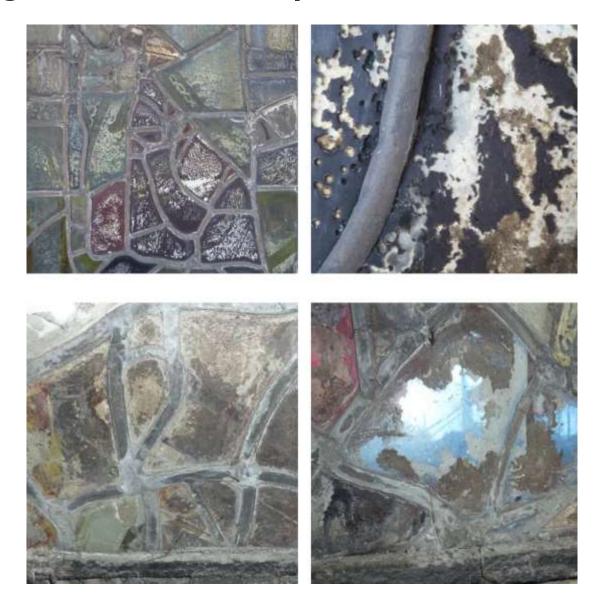
Assessing environmental impact

Image courtesy of Tobit Curteis Associates

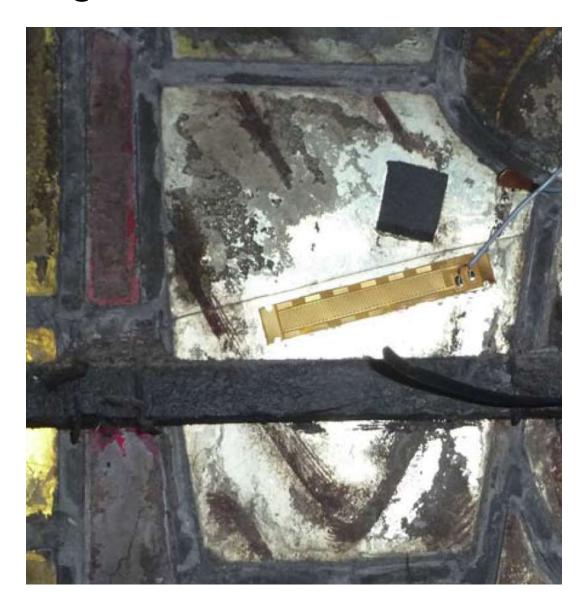
Understanding the micro-climate

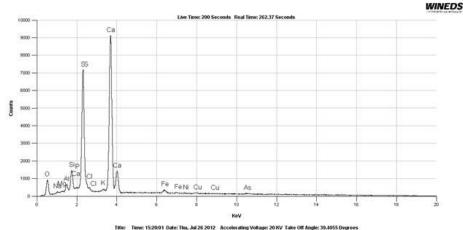
Window SII. Panel 5d internal face.

Sample 2 is same surface layer but with an internal crust on the surface of the applied layer.

- . Is the crusted surface on the internal face of the applied layer different to the base material?
- Is it possibly due to microbial growth?
- Is it likely that the link between any microbial growth and the applied surface layer is a factor in the loss of painted detail?
 - * The layer appears to be an organic pigment probably a thin wash of oil paint. There is evidence of microbial growth at the interface between the oil paint layer and the glass surface and on the inner surface of the oil paint layer.

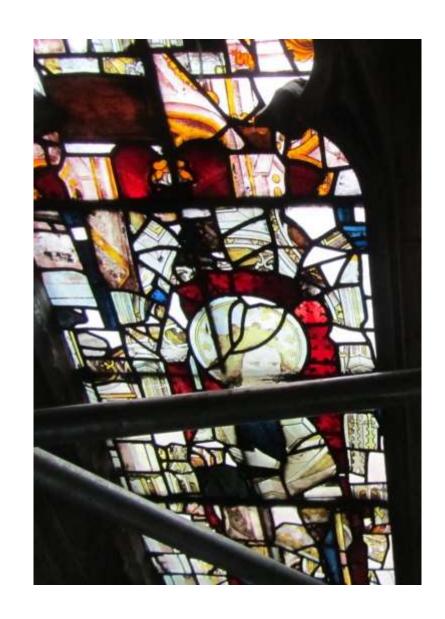
The **radiators in the feretory** were having little impact at high level

The pollutants on the widows interact with the condensation, in this case not only external deposits but also internal one from previous Gurney stove heating systems

The case for protective glazing was strong
