## Key Points

## Previous Flood Resilience Levels

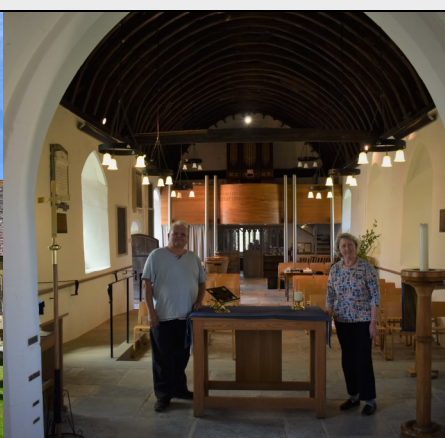
2 The new interior with movable furnishings and balcony

- pew seating was removed and replaced with stackable, easy-to-move seating
- a mezzanine balcony was installed, providing space for the storage of fabric items during flood events
- one way valves were installed in the graveyard wall
- electricity sockets were raised above 1 metre from the floor
- the damaged floor was replaced and a sump pump installed to drain standing water from the interior
- a flood response plan and associated equipment storage was created to allow a quick, coordinated response to future flood events

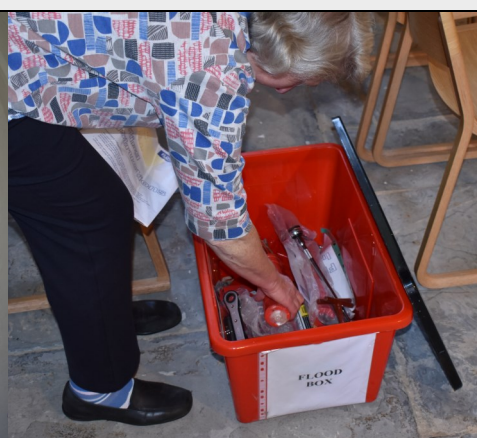
3 The flood box containing tools and plans to protect the church from floodwater
