CASE STUDY MANAGING GRASSLAND TO REDUCE THE RISK OF WILDFIRE

Key Points

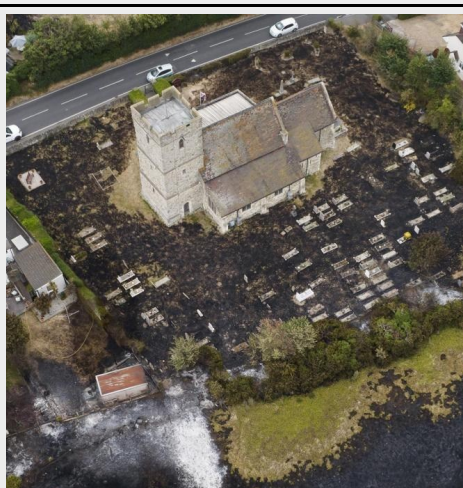
2 The aftermath of the fire surrounding the church.

During the course of the fire, the glebe land acted as a key area for the wider spread of the fire, connecting both halves of the village and giving the fire access to the churchyard. The churchyard was entirely burnt, but the shorter length of the grass limited the temperature and reach of the fire, saving the church building itself from the flames.

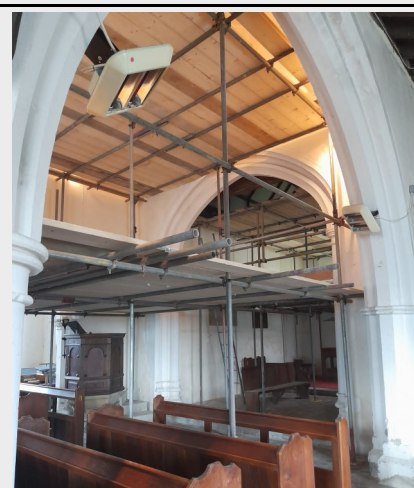
3 The cleaning process underway in the church interior.

- Extensive cleaning to remove traces and smell of smoke throughout the interior of the building and fabrics that were stored in the church at that time.
- Repairing damage to the inside and, following architect led pressure, the exterior of lead linings in the church's windows that are particularly vulnerable to the presence of smoke.
