CASE STUDY ADJUSTING A CHURCH BUILDING TO REGULAR FLOODS

N.B. This case study considers only one possible approach, which will not be suitable for every church. Always seek professional advice.

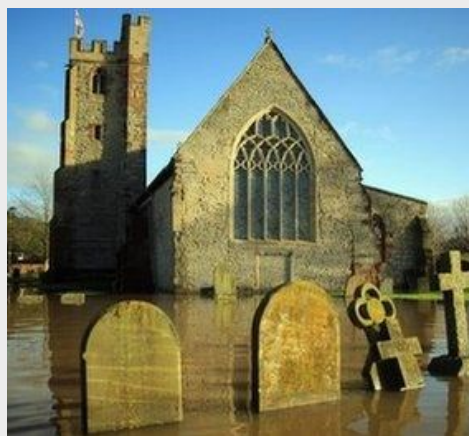
1 The 2013 flooding can be seen surrounding the church building here.

St Denys has been forced to adapt to an ongoing cycle of flooding, occurring roughly once every 3 or 4 years, flooding a total of 6 times since the millennium and twice since 2020. This pattern has come as the result of increased fluvial (river) flooding, due to rainfall falling in shorter, but more intense windows. It is likely to continue to get worse over the next 30 years unless preventative actions are taken. This has resulted in many changes to the church building, including:

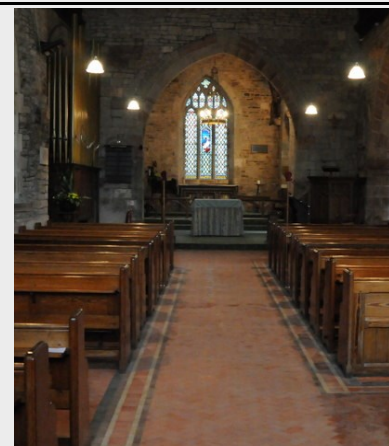
3 Carpets were removed from the interior to mitigate effects of the flood water.

- Transitioning away from having carpets covering the floors, after the previous one was lost in the 2007 flood.
- Replacing the suspended wooden vestry floor with a raised concrete floor.
- Replacing pews with seats.
- Using an electronic keyboard instead of the pipe organ.
