CASE STUDY PROTECTING A CHURCH FROM FUTURE SUBSIDENCE

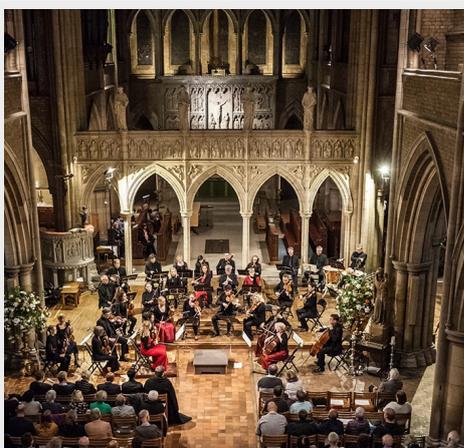
3 Cracking was visible throughout the building (Credit—James Balston)

Cracks at St Johns have been monitored closely from the turn of the millennium for signs of serious subsidence. For the last 15 years they have progressively worsened at least partially caused by mature trees which had self seeded in the previous century. Annually the south side of the building was rotating down and out, and would then retreating slightly in winter, but each year that it was happening, the movement continued to worsen. The QI report for the church identified it as a high priority concern, the architect predicting that there would be a significant structural failure in the next 24 months. This led the church to begin exploring options to secure the wall and ensure the structural integrity of the building.

The major two stages of the work that were crucial to securing the south side of the church were the underpinning of the south wall and removal of several trees that were exacerbating soil movement. Whilst this work was underway, the community was still able to use the building, and indeed the progress of the work became a central point of interest that drew in local residents to the church building, some for the first time.
