# Southwell Cathedral: South Quire Aisle Lead Roof (1 of 2 projects funded)

## Southwell Cathedral: North Side Roofs (2 of 2 projects funded)

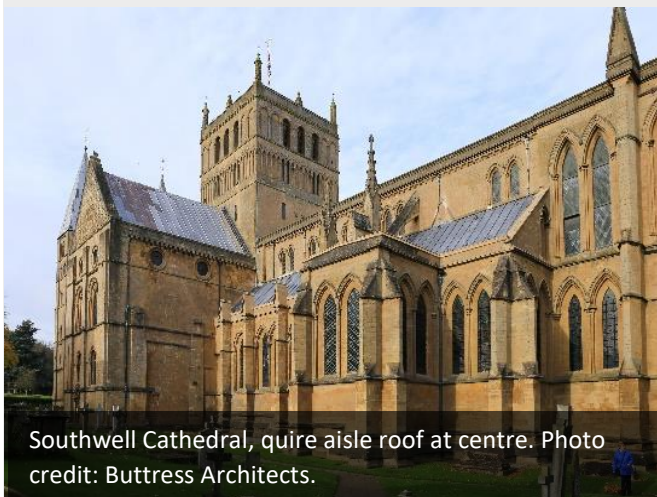
The quire aisle roofs were originally lead-covered but may have been tiled in slates, presumably as a cost-cutting measure, as early as the 18th century. The present slate covering dated from the 1880s and was worn out, with slipped and broken slates that were difficult to access. The most recent Quinquennial Inspection found that there had been a series of leaks over recent years. Water had been able to penetrate into the cathedral through the vaults and rot had occurred in places. If not addressed now, damage and costs would have escalated.

Southwell Cathedral, quire aisle roof at centre. Photo credit: Buttress Architects.

The works were all completed and included replacing the old roof, which was made entirely of slate, with a new lead roof, re-profiling of the parapet gutters and repairs to the roof timbers.
