Ely Cathedral: South Transept Repair (1 of 3 projects funded)

Ely Cathedral: Emergency Rewiring (2 of 3 projects funded)

Ely Cathedral: South Nave Aisle Roof & High-Level Repairs (3 of 3 projects funded)

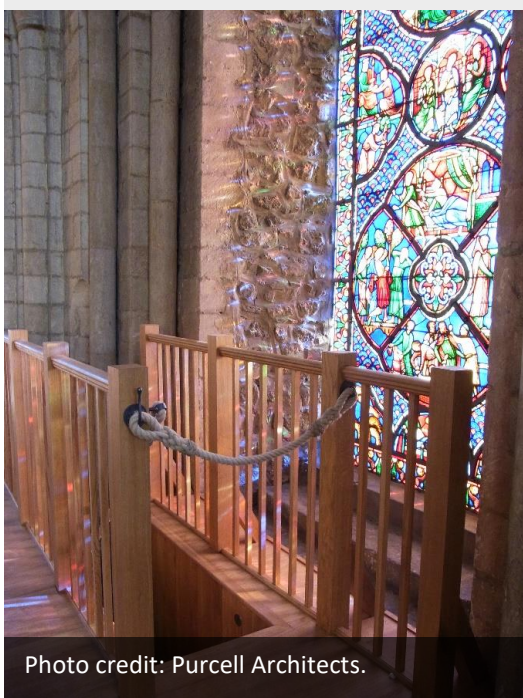
Photo credit: Purcell Architects.

Works were completed to timescales and involved the cleaning, repointing and repair of the external masonry to the lower sections of the transept south and east elevations and also the re-leading and repair of the windows to the transept east aisle and the remaining unrepaired windows to the transept south front.
