Hereford Cathedral: Sound System (1 of 3 projects funded)

Hereford Cathedral: Roof Repairs (2 of 3 projects funded)

Hereford Cathedral: North Aisle Roof Repairs (3 of 3 projects funded)

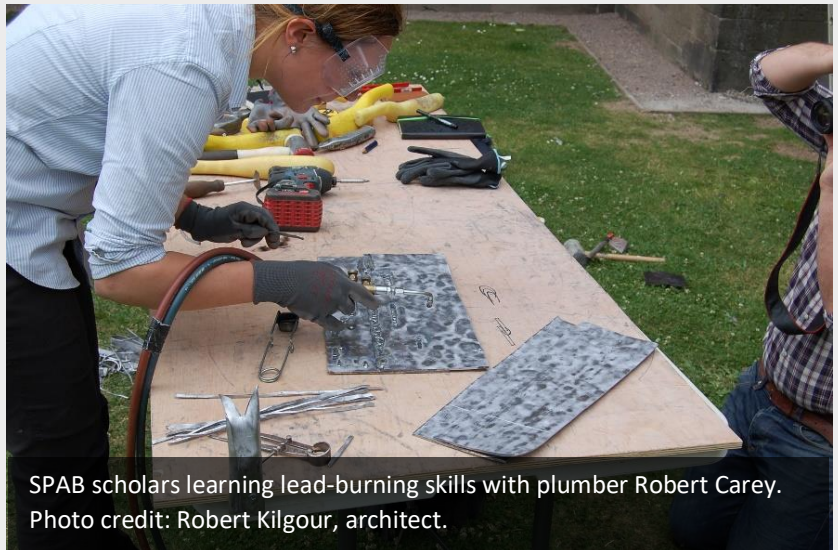
This project was to undertake work on the lead roofs and masonry of the Booth Porch and north quire aisle, and former choristers' vestry roof. Lead slippage and deterioration had occurred to the roofing, leading to water ingress, and excessive damp was also encouraging wood-boring beetle.

SPAB scholars learning lead-burning skills with plumber Robert Carey.
Photo credit: Robert Kilgour, architect.

The repair of the leadwork to the roof has made the building more secure and has prevented further damage. The cathedral is considered safer and better able to operate as a result.
