Manchester Cathedral: South Aisle and Chapel Roof Repairs (1 of 2 projects funded)

Manchester Cathedral: Emergency Tower Repairs (2 of 2 projects funded)

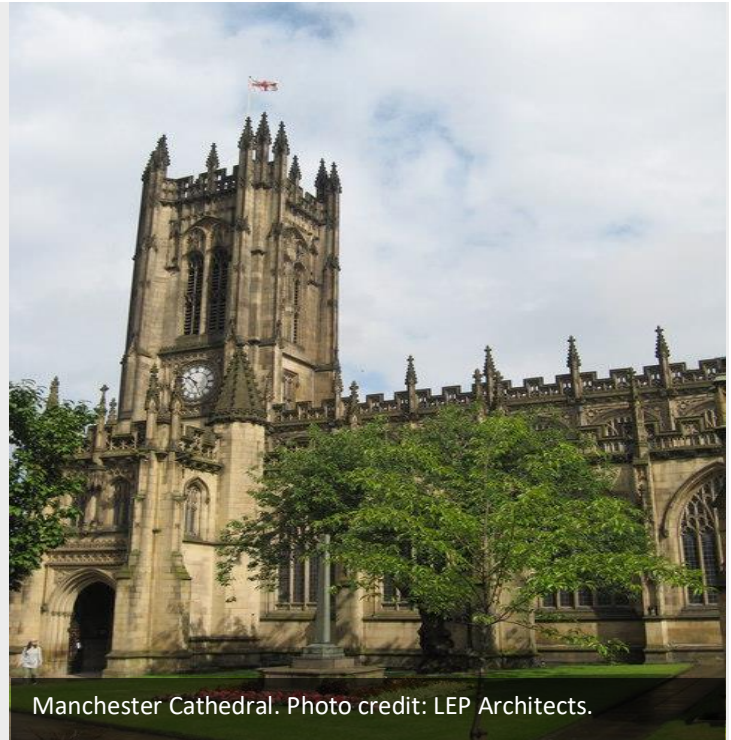
Replacement roofing was needed on the south-east area of the cathedral. Numerous cracks in the lead roof to part of the south quire aisle, Jesus Chapel and Fraser Chapel had been observed, and the flat asphalt roof of the Chapter House, which had replaced an octagonal pyramid roof damaged by bombing in 1940 leaked and required replacing before it failed completely. The cathedral had wanted to re-instate the original pyramidal roof to the Chapter House. In assessing the grant, Expert Panel members were supportive of this aim in general, but given the demands on the fund for fundamental and urgent repairs elsewhere, the reinstatement element was not deemed as high a priority and a partial grant was given for replacing the flat roof. The cathedral had been fundraising for several other projects including the organ and work to the interior, and commented that raising money for such 'invisible' roof repairs was particularly difficult.

Manchester Cathedral. Photo credit: LEP Architects.

The roofing works are complete, were on schedule and essential for the cathedral. They included carpentry, timber repairs, fast fixing, lead sheet covering and flashings, copper strips, sheet coverings and flashings repairs, and repair, renovating and conserving of masonry.
