## Wells Cathedral: North Nave Aisle Roof Repairs (1 of 3 projects funded)

## Wells Cathedral: North Quire Aisle Parapets Repairs (2 of 3 projects funded)

## Wells Cathedral: Nave Roof Repairs (3 of 3 projects funded)

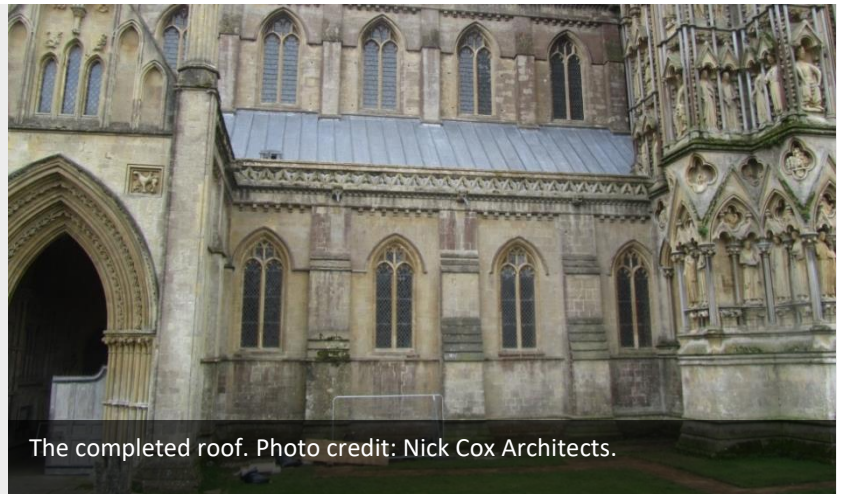
This project focuses on the repair of the western half of the north nave aisle roof, dealing with failure of the lead, which was allowing water ingress affecting the medieval timberwork.

Local Somerset company, Ellis & Co, renewed the lead at the west end of the north nave aisle roof between March and October 2015. The works included the erection of a scaffold and temporary roof to enable the works; stripping, recasting and relaying the lead roof area, including the formation of a new rainwater outlet; carpentry and structural repairs to timber substrate and roof structure, and the laying of new floor screed in the triforium below.
