Church Commissioners
Mission, Pastoral and Church Property Committee
Mission and Pastoral Measure 2011

The parish of Castleford: the churches of St Paul, Glasshoughton; All Saints, Hightown; St Michael and All Angels, Castleford

Note by Joanna Chandler-Clarke

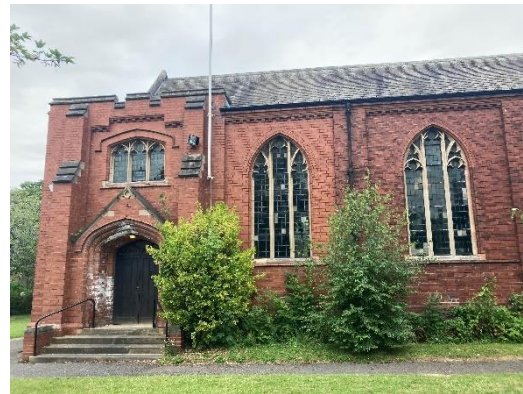
B Nave and Chancel, South Slope
Due to the design and surround context, it has been difficult to inspect the area of roof above the South Porch and where the Nave roof meets the South Aisle roof and it is advisable to get safe high level access arranged for a further inspection.

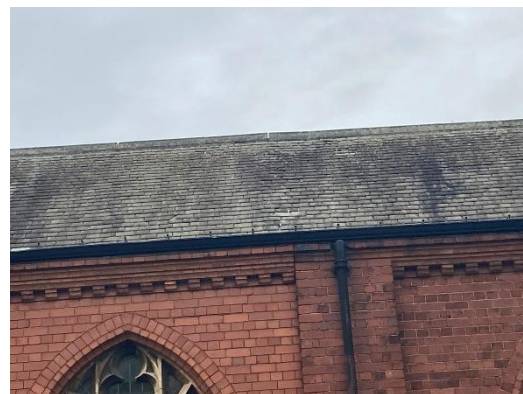
C There are open joints to the ridge, which should be repointed to prevent water ingress.

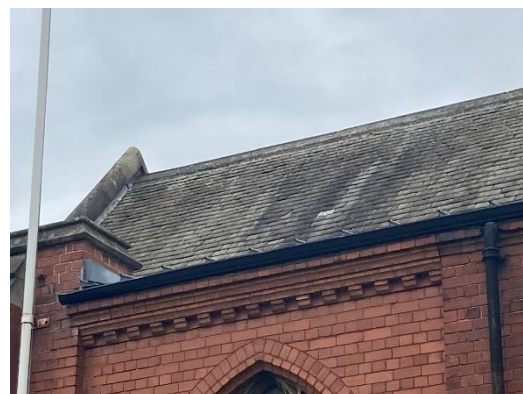
B There are some loose and displaced slates, particularly to the West end, which should be refixed in position. A number of slates have been replaced using Welsh slates and it would be preferable if these could be replaced using Westmorland slates when the roofer is on site.

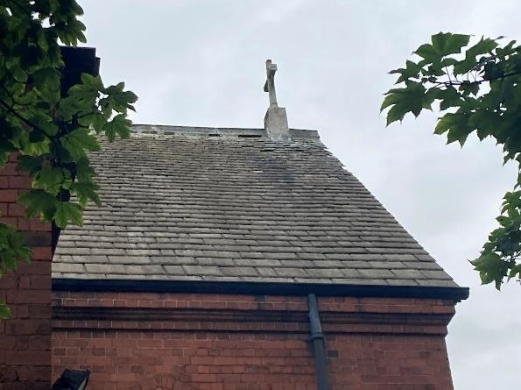
B	There is an area of displaced and missing slates around the ridge and verge to the East end, adjacent to the cross. These should be refixed and missing slates replaced.

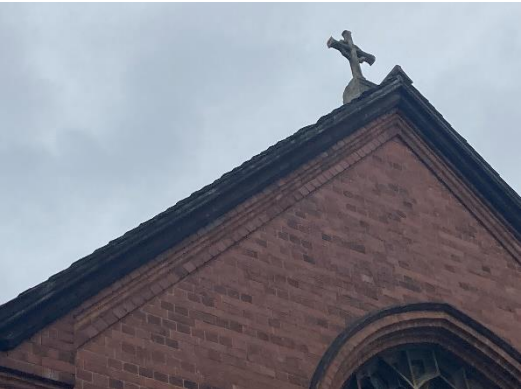
1
C	On the East gable, there is no edge detail or cover which could be a potential entry route for insect or bird nesting. When high level access is available it would be advisable to review this detail.

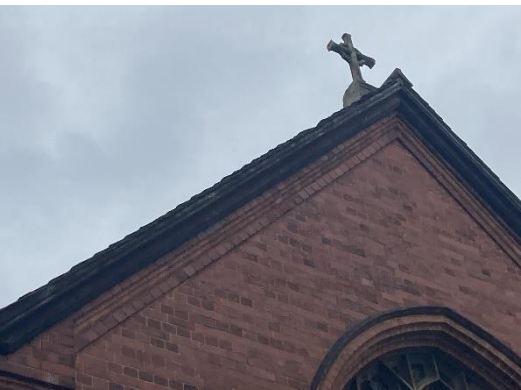
2
C	The fascias boards on the East gable of the Chancel require decoration.

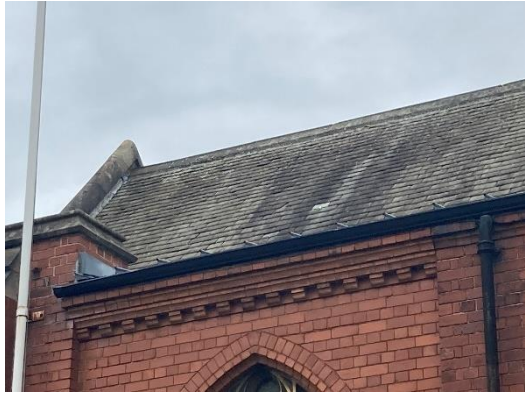
Priority	Description	Photograph	Costing Band
A	Gutters should be cleared seasonally as part of an ongoing maintenance strategy.

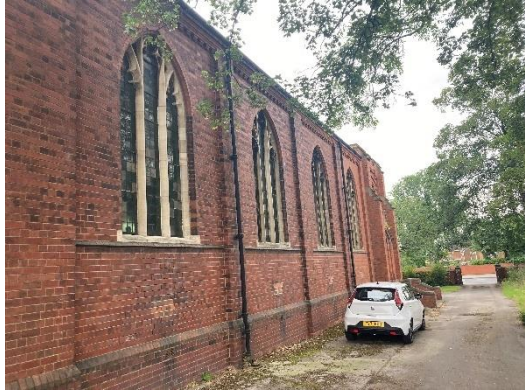
1
B	Nave and Chancel, North Slope Due to the design and surround context, it has been difficult to inspect large areas of the North facing roofs. It is advisable to get safe high level access arranged for a further inspection.

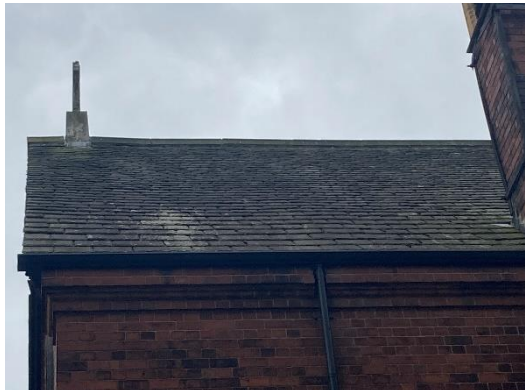
1
C	There is an area of displaced and missing slates around the ridge and verge to the East end, adjacent to the cross. These should be refixed and missing slates replaced.

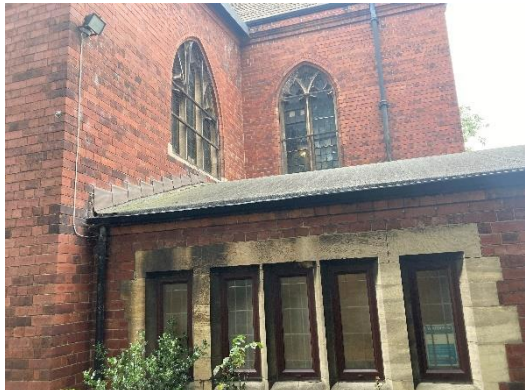
1
D	Vestry and Lady Chapel Roof The duo pitched roof has been covered in mineral felt due to previous lead theft. The current roof covering is in acceptable condition but consideration should be given towards replacing in a more appropriate material such as zinc or stainless steel.

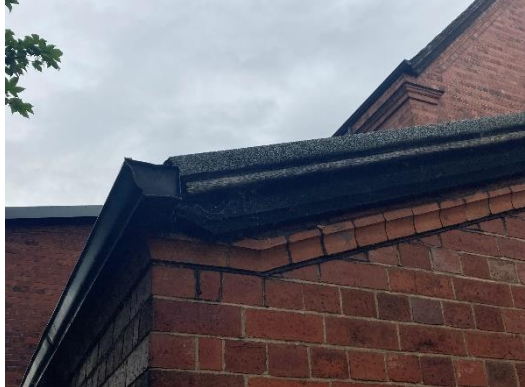
1
D	The fascia boards to the East gable require decorating.

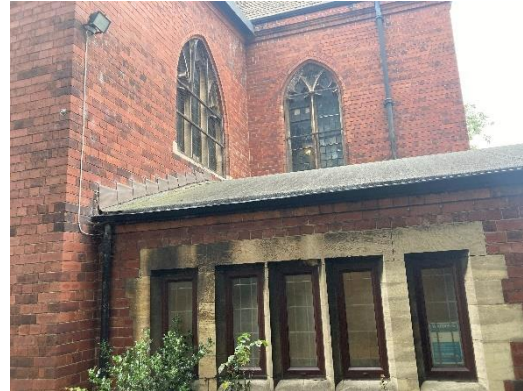
A Gutters should be cleared seasonally as part of an ongoing maintenance strategy.

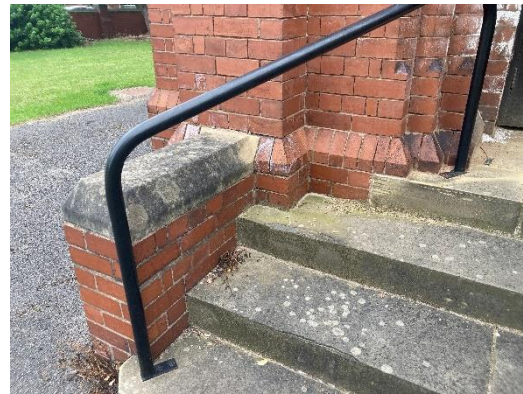
C South Elevation
There are some open joints to the buttress to the West of the South porch, which should be repointed.

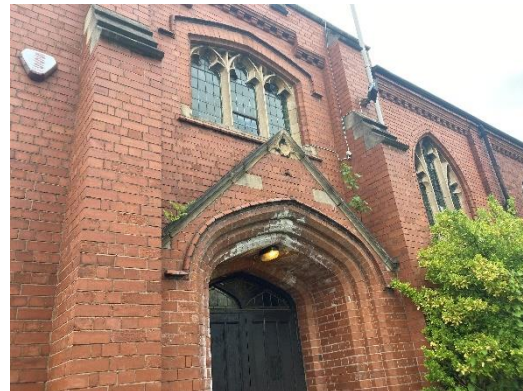
B There is vegetation growth to the coping stones of the South porch, which should be removed and open joints to the stones should be repointed in lime mortar.

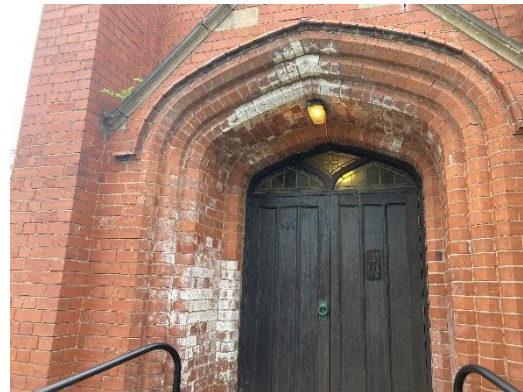
There is high levels of brick salting, particularly to the doorway arch of the South porch. This is caused by water ingress through the porous masonry of the South porch coping stones. The salts should be brushed off and consideration should be given to re-bedding the copings on a lead DPC.

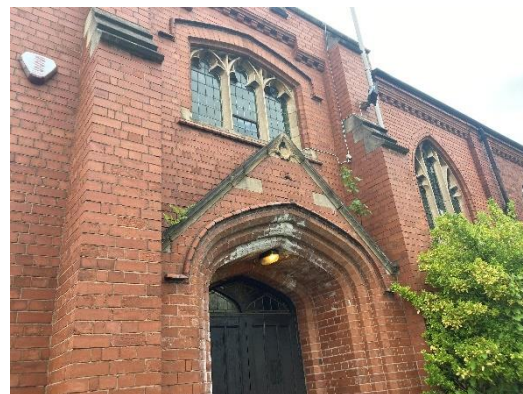
There are some recessed joints and broken brickwork where a light fitting was installed to the South Porch, with the broken bricks replaced and recessed joints pointed with lime mortar.

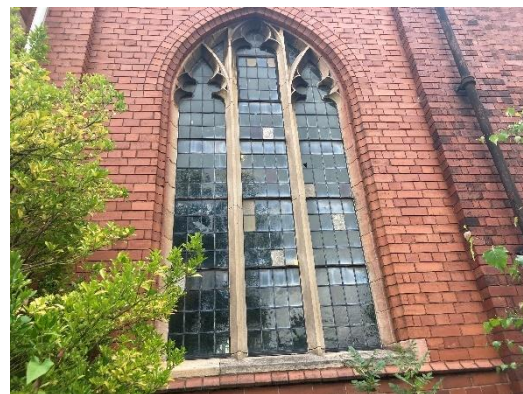
The condition of the windows on the South elevation generally is poor, with numerous glass quarries being replaced with fibreglass as they have been broken. The fibreglass replacements have not all been fixed and sealed into the windows and there is risk that water can penetrate into the building. There are also numerous cracked or broken glass quarries which should be replaced in matching glass to the original windows. The glazing bars are also in poor condition and require redecoration, along with the putty being in a poor state. It would be beneficial to undertake a full overhaul of all the windows on this elevation.

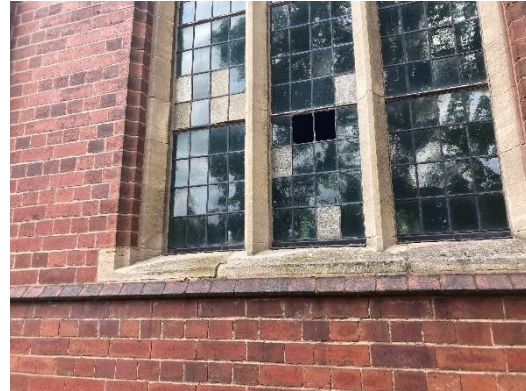
In particular, there are missing glass panes to the Eastern window on the South Aisle, which is a potential source of water ingress into the building, and these should be replaced but should be considered as part of a wider overhaul of the windows.

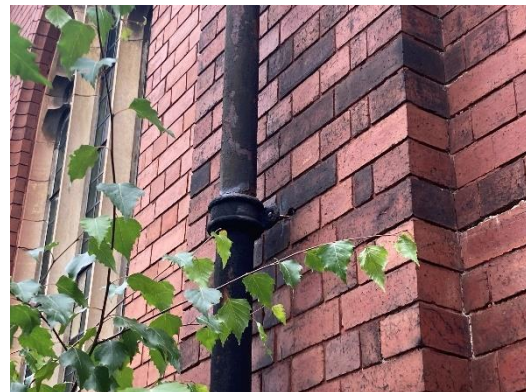
The cast iron downpipes require an overhaul, as they have started to rust. They should be fully redecorated with joints resealed and mounted on new bobbins with secure fixings.

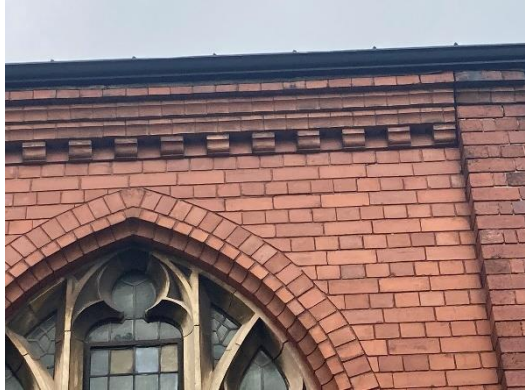
1
C	There is a step fracture running from the head of the Western most window through into the brick oversail. This corresponds to a crack internally. Allow for stitch repairing the crack and repointed in lime mortar, and the repair kept under observation for signs of further movement, subject to structural engineer's review.

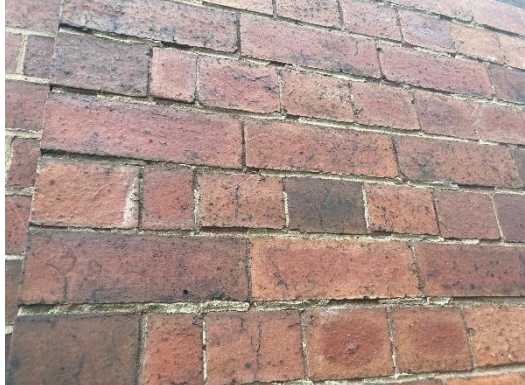
2
C	There is an area of failed pointing to the South Aisle where it meets the Lady Chapel, which should be raked out and repointed in lime mortar.

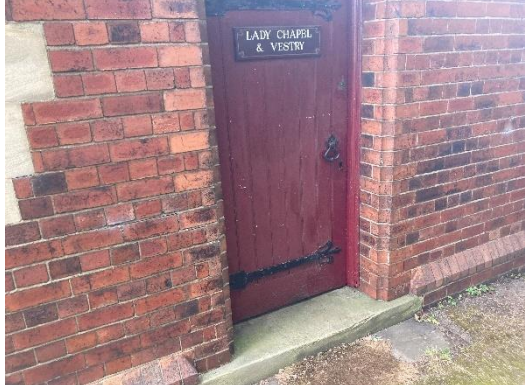
2
D	The door to the Vestry corridor is in acceptable condition but should be redecorated as part of a maintenance strategy.

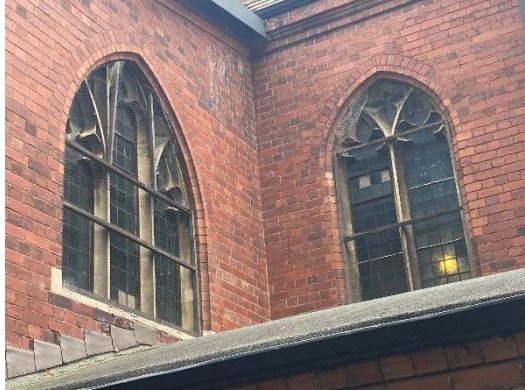
1
C	South Aisle, East Elevation As noted in the previous inspection, there is open jointing to the stone sill of the window should be repointed using lime mortar.

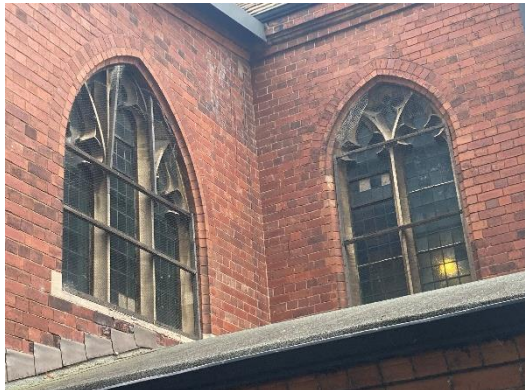
2
D	The timber and chicken wire guarding to the window is in poor condition and should be replaced, ideally with a powder coated stainless steel guarding inset into the windows would be preferable.

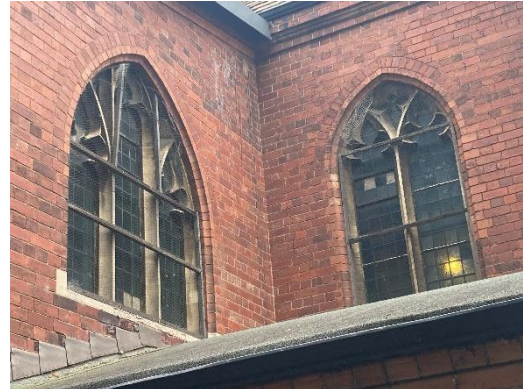
C There are some open joints to the brickwork above the mineral felt flashings, which should be repointed, or included as works to the Vestry/Lady Chapel roof.

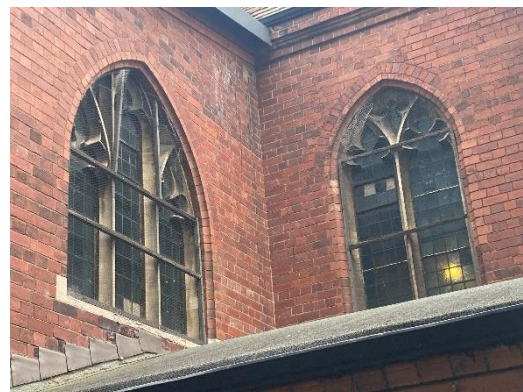
B Similarly to other elevations, The condition of the window is poor, with numerous glass quarries being replaced with fibreglass as they have been broken. The fibreglass replacements have not all been fixed and sealed into the windows and there is risk that water can penetrate into the building. There are also numerous cracked or broken glass quarries which should be replaced in matching glass to the original windows. The glazing bars are also in poor condition and require redecoration, along with the putty being in a poor state. It would be beneficial to undertake a full overhaul of the window.

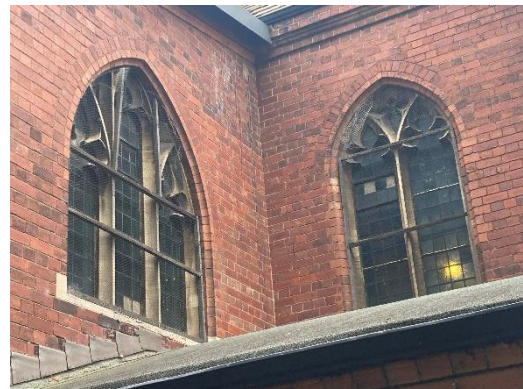
C Chancel, South Elevation Details match that of the other elevations with 2-light single window, some open jointing around the window to the brickwork which should be repointed in lime mortar.

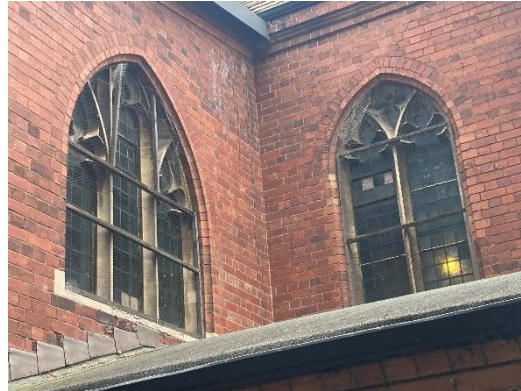
D The timber and chicken wire guarding to the window is in poor condition and should be replaced, ideally with a powder coated stainless steel inset into the windows would be preferable.

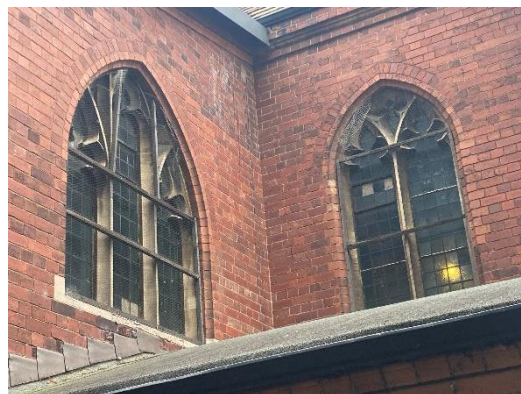
B Similarly to other elevations, The condition of the window is poor, with numerous glass quarries being replaced with fibreglass as they have been broken. The fibreglass replacements have not all been fixed and sealed into the windows and there is risk that water can penetrate into the building. There are also numerous cracked or broken glass quarries which should be replaced in matching glass to the original windows. The glazing bars are also in poor condition and require redecoration, along with the putty being in a poor state. It would be beneficial to undertake a full overhaul of the window.

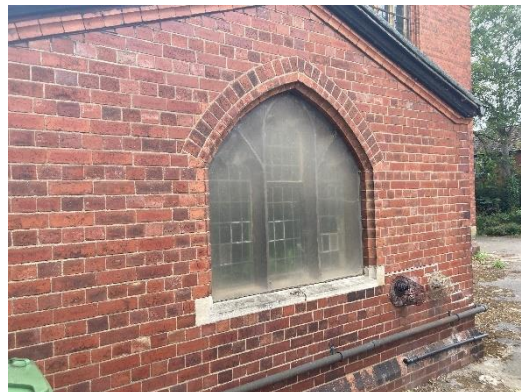
D Vestry, East Elevation
The window protection is loose and has been fixed using a combination of screws and silicon, the silicon has bled directly onto the mullions and tracery stonework. One of the fixings has split a mullion stone which should be repaired. The Perspex should be replaced with a stainless steel guarding as described elsewhere.

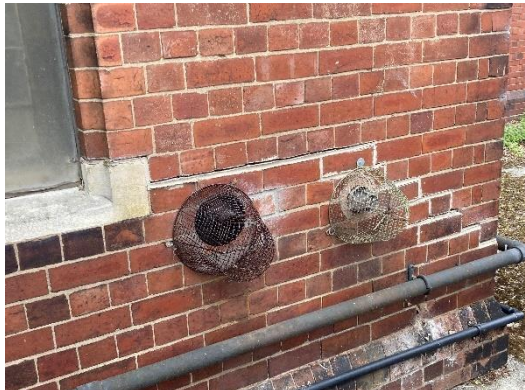
1
C	Vestry, North Elevation Previously mentioned fracture extends onto this elevation, see previous item.

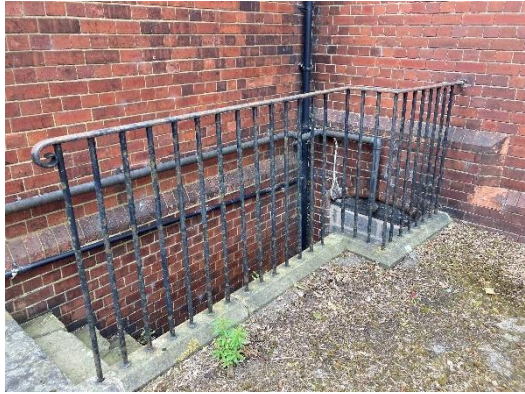
1
D	The railings to the boiler house steps require redecoration.

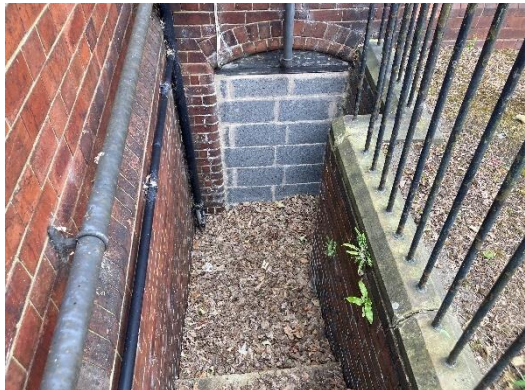
1
C	The boiler house steps have accumulated debris to the lower steps, which should be cleared.

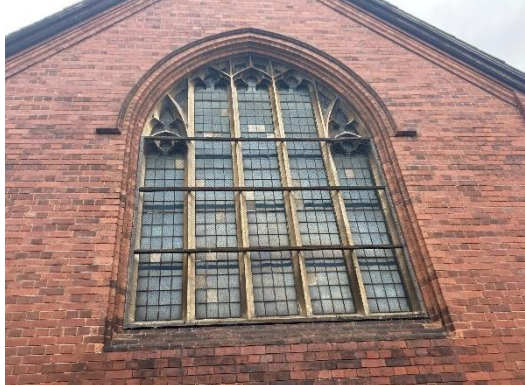
1
D	The timber and chicken wire guarding to the window is in poor condition and should be replaced, ideally with a stainless steel power coated inset into the windows would be preferable.

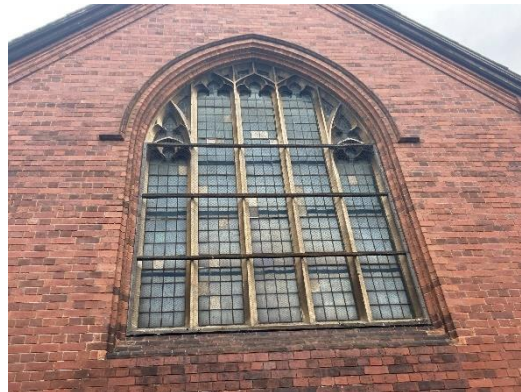
B Similarly to other elevations, The condition of the window is poor, with numerous glass quarries being replaced with fibreglass as they have been broken. The fibreglass replacements have not all been fixed and sealed into the windows and there is risk that water can penetrate into the building. There are also numerous cracked or broken glass quarries which should be replaced in matching glass to the original windows. The glazing bars are also in poor condition and require redecoration, along with the putty being in a poor state. It would be beneficial to undertake a full overhaul of the window.

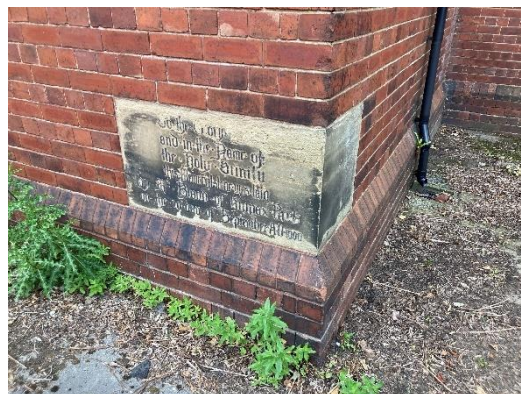
C The cornerstone of the building is starting to erode in areas, caused by surrounding masonry being pointed in a cementitious mortar. This should be removed and area repointed in lime mortar.

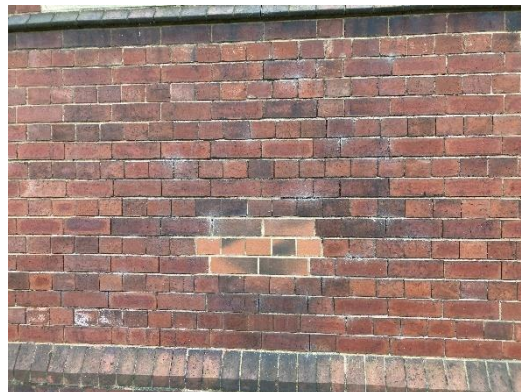
E North Elevation
Beneath each of the windows is an area of recessing pointing and brick infill (presumably to infill previous ventilation grilles). The later brick infill should be removed and replaced with matching brickwork to the church, along with the area of recessed joints being repointed in lime mortar.

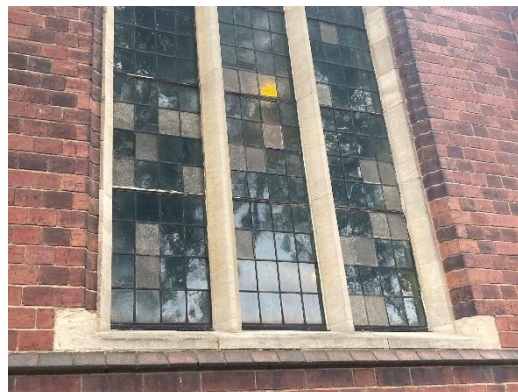
B The condition of the windows generally is poor, with numerous glass quarries being replaced with fibreglass as they have been broken. The fibreglass replacements have not all been fixed and sealed into the windows and there is risk that water can penetrate into the building. There are also numerous cracked or broken glass quarries which should be replaced in matching glass to the original windows. The glazing bars are also in poor condition and require redecoration, along with the putty being in a poor state. It would be beneficial to undertake a full overhaul of all the windows on this elevation.

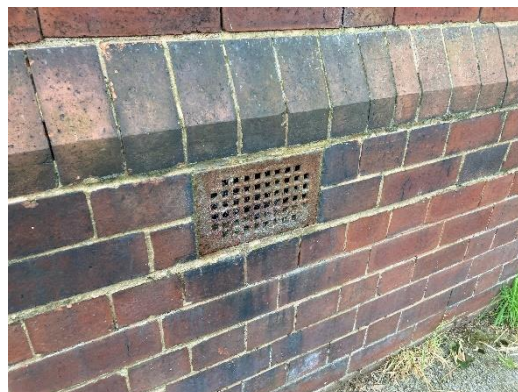
D The cast iron ventilation grilles to this elevation are rusting and require re-decoration

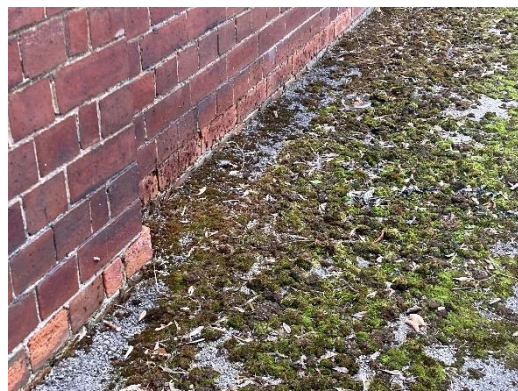
C There is brick decay and spalling to the low level brickwork, which is being exacerbated by the asphalt laid around the base of the building. A section of asphalt should be removed and a gravel margin installed, along with decayed brickwork replaced.

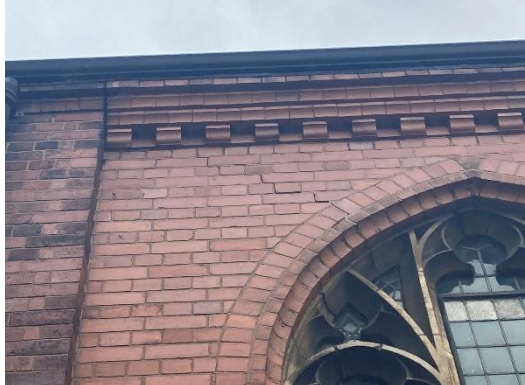
1
C	There is a step fracture running from the head of the Western most window through into the brick oversail. This corresponds to a crack internally. Allowance should be made for the crack to be stitch repaired and repointed in lime mortar, and the repair kept under observation for signs of further movement, subject to review and confirmation by structural engineer.

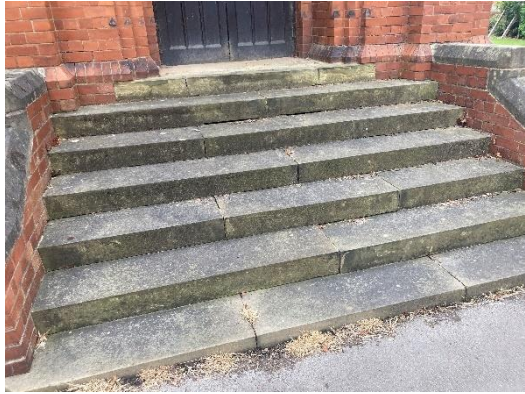
Priority	Description	Photograph	Costing Band
C	There are numerous open joints to the steps of the North porch which should be repointed.

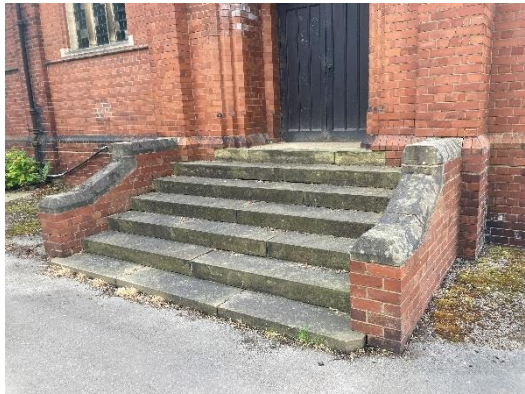
1
E	While the North porch is no longer in use for entry, consideration should be given to installing handrails to the steps in case of future use.

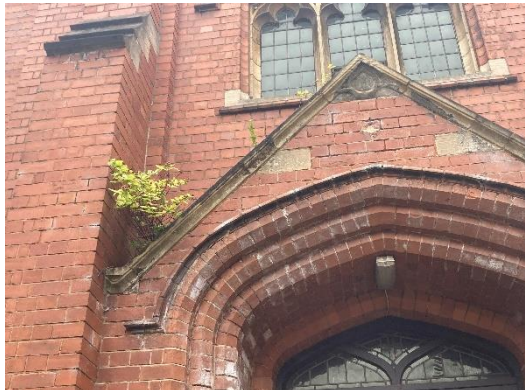
2
B	There is vegetation growth to the coping stones of the North porch, which should be removed and open joints to the stones should be repointed in lime mortar.

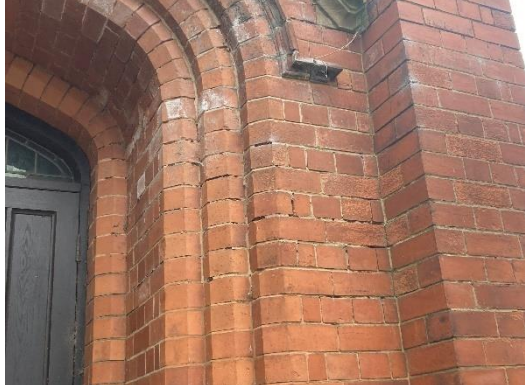
1
C	There is also some missing and fractured pointing to the right hand side of the North porch arch, which should be repointed.

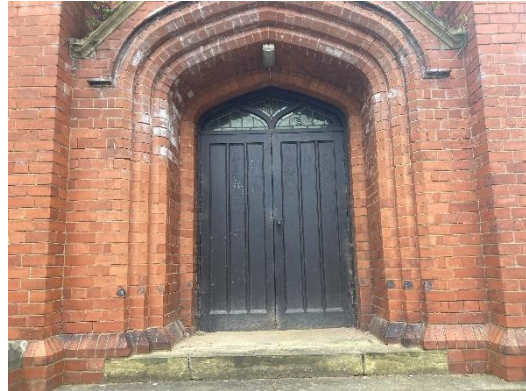
D The entrance doors to the North porch would benefit from being redecorated.

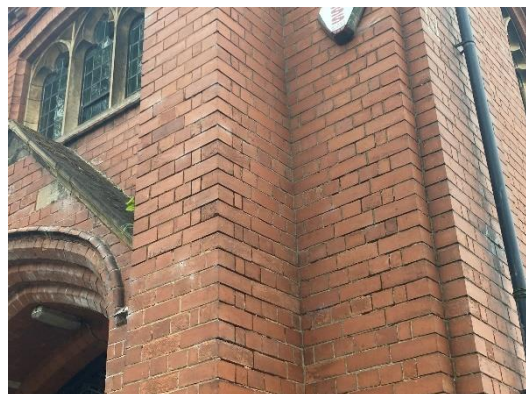
C There is some recessed joints to the pointing of the Western most buttress, which should be repointed.

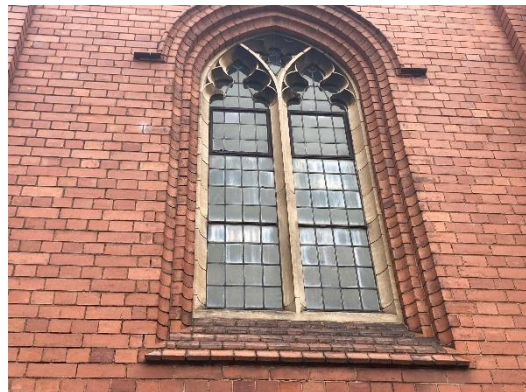
B West Elevation
To the Northern most window, the glazing bars and framing is in poor condition and should be overhauled, with the openers made functional to assist with natural ventilation within the building.

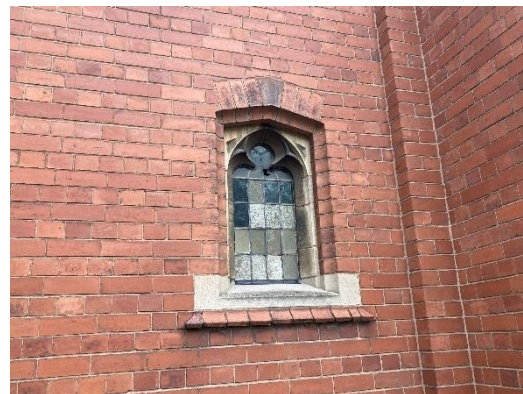
B The small trefoil window on the West gable of the North Aisle (to the Store internally), has numerous glass quarries being replaced with fibreglass as they have been broken. The fibreglass replacements have not all been fixed and sealed into the windows and there is risk that water can penetrate into the building. There are also numerous cracked or broken glass quarries which should be replaced in matching glass to the original windows. The glazing bars are also in poor condition and require redecoration, along with the putty being in a poor state. It would be beneficial to undertake a full overhaul of all the windows on this elevation.

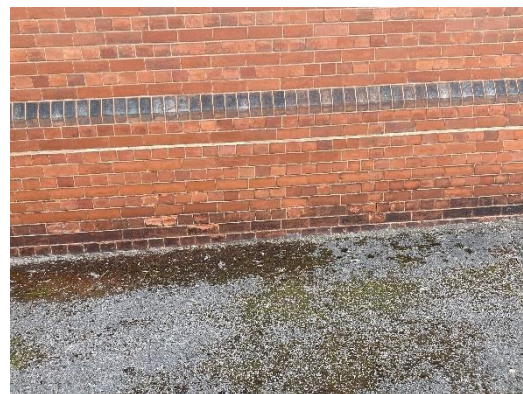
C There is brick decay and spalling to the low level brickwork, which is being exacerbated by the asphalt laid around the base of the building. A section of asphalt should be removed and a gravel margin installed, to assist with moisture management.

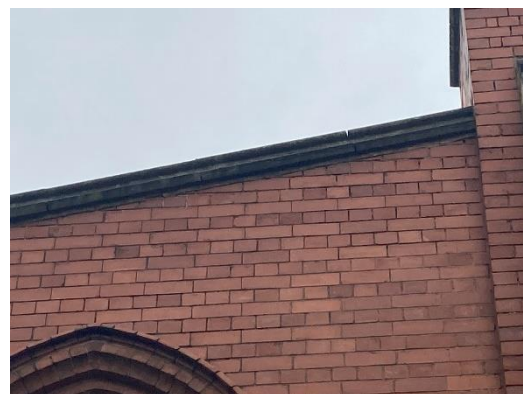
B There are open joints to the coping stones of the North Aisle coping stones, which should be repointed. There are numerous areas of water ingress at high level internally, and it would be beneficial to re-bed these coping stones on a lead DPC.

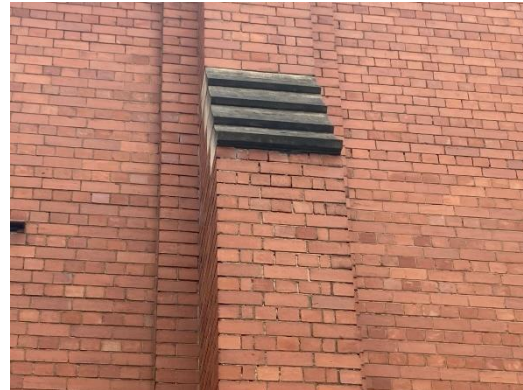
There is some recessed joints below the Northern buttress coping stones, which should be repointed.

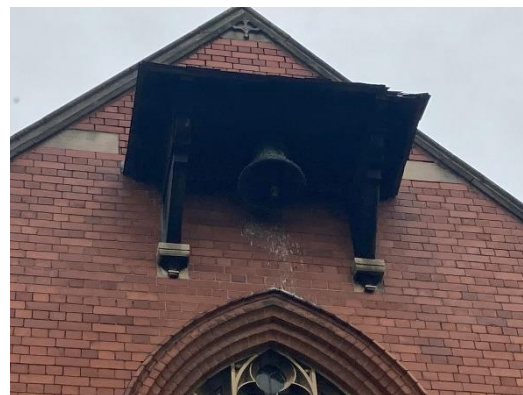
The bell although working, appears to be stuck at an angle. A bell specialist should be consulted for advice.

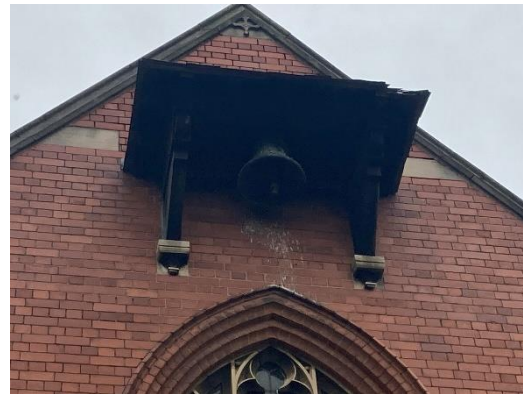
There appear to be a number of dislodged or missing slates at the eaves of the bell canopy.

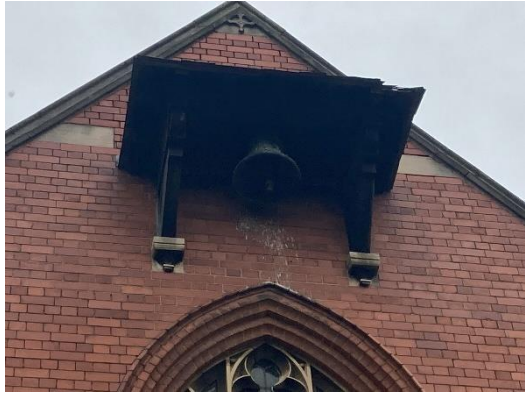
Priority	Description	Photograph	Costing Band
E	There also appears to be nesting birds near the bell and canopy, indicated by the guano on the wall and arch hood moulding. Consideration could be given to introducing bird deterrents if persistent problem.

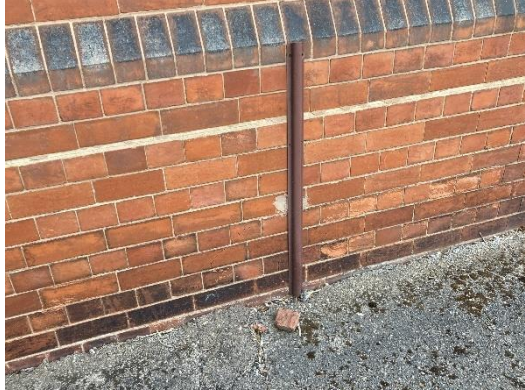
2
D	There is a redundant electrical conduit which should be removed.

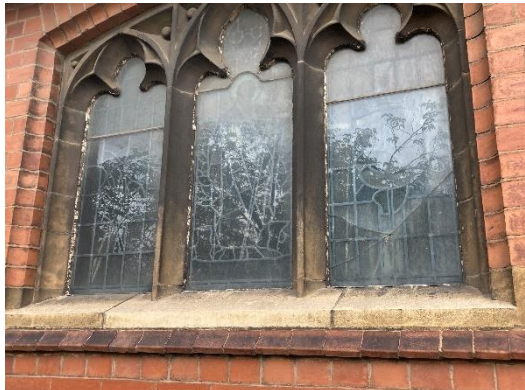
1
C	To the central window at low level, the security glazing is broken and should be replaced. As part of this the frames and glazing bars should be redecorated and re-puttied.

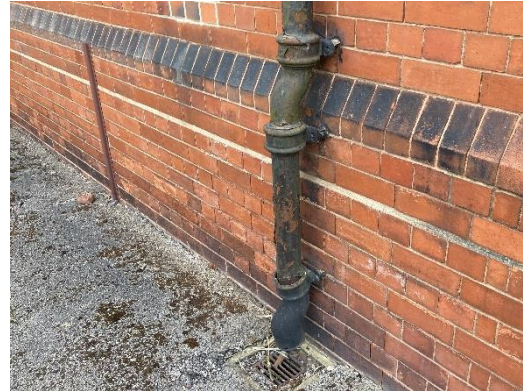
The shoe to the Southern downpipe is loose and angled towards the building, which should be refixed as soon as possible to prevent water ingress into the building.

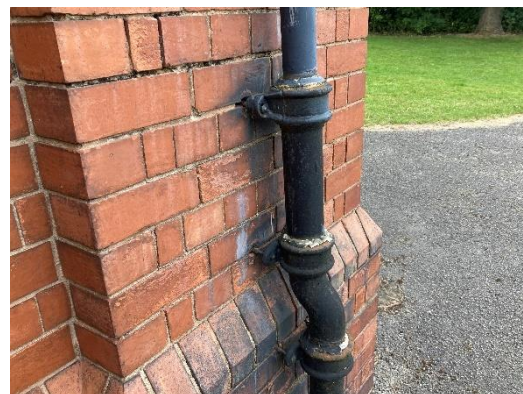
More generally, the cast iron downpipes require an overhaul, as they have started to rust. They should be fully redecorated with joints resealed and mounted on new bobbins with secure fixings.

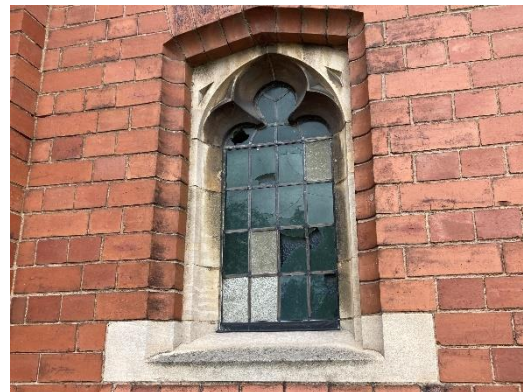
The small trefoil window on the West gable of the South Aisle (to the toilet internally), has numerous glass quarries being replaced with fibreglass as they have been broken. The fibreglass replacements have not all been fixed and sealed into the windows and there is risk that water can penetrate into the building. There are also numerous cracked or broken glass quarries which should be replaced in matching glass to the original windows. The glazing bars are also in poor condition and require redecoration, along with the putty being in a poor state. It would be beneficial to undertake a full overhaul of all the windows on this elevation.

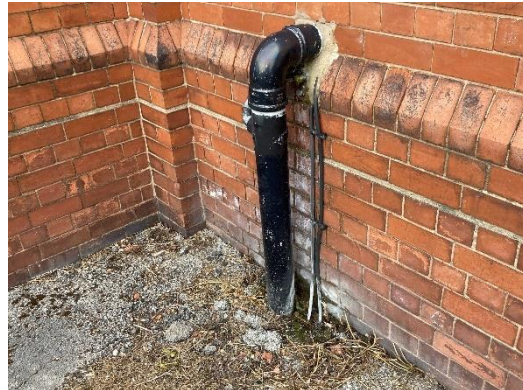
B There are leaks to the toilet SVP, which has caused algae growth and salting to the brickwork below. The leak should be fixed and the algae/salts be removed. The SVP should be redecorated as part of a wider maintenance strategy.

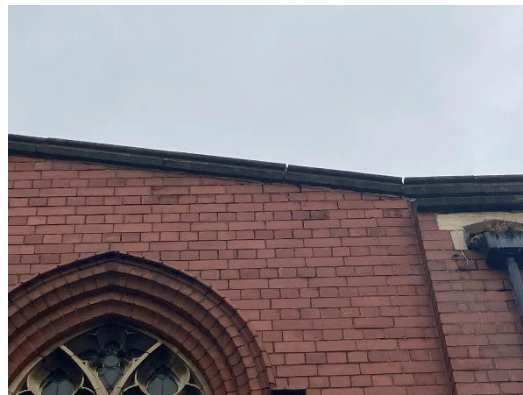
B There are open joints to the coping stones of the South Aisle coping stones, which should be repointed. There are numerous areas of water ingress at high level internally, and it would be beneficial to re-bed these coping stones on a lead DPC.

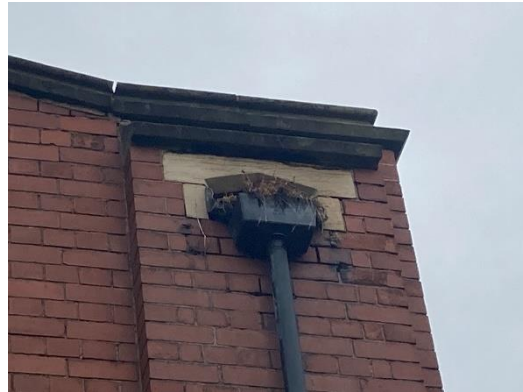
A The hopper to the South is full of bird nests and debris, which should be cleared.

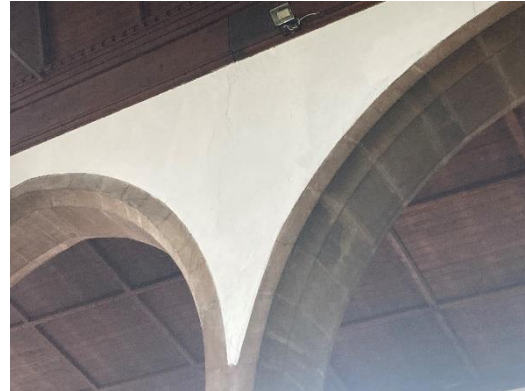
Obs The spandrel panels have been painted in a non-breathable paint. While not ideal in this location, the condition should be kept under observation for signs of flaking and decay.

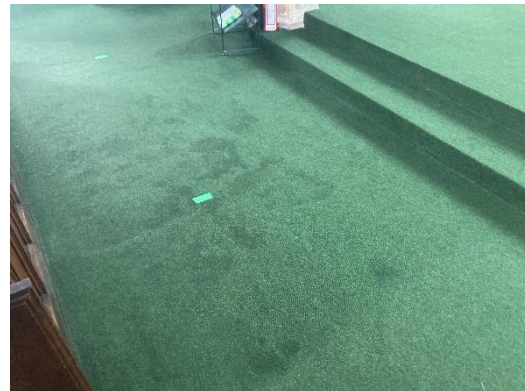
D The carpet has staining in areas, which should be either cleaned, removed or replaced.

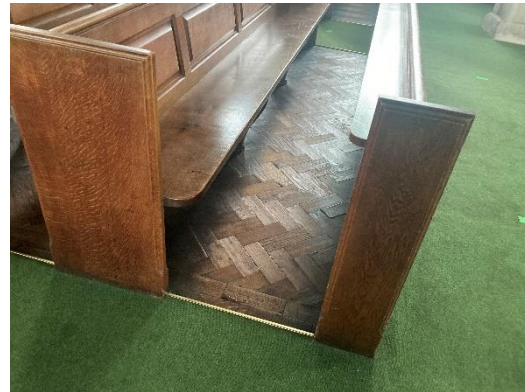
C There are some loose sections of parquet flooring which should be refixed to eliminate trip hazards.

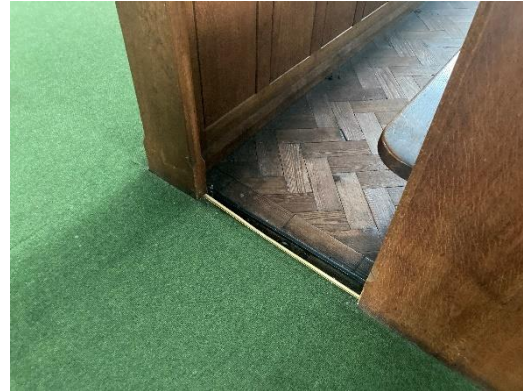
The front pew to the South is loose and causing the surround carpet, tie bar and parquet flooring to lift. The pew should be refixed with areas posing as trip hazards re-laid level and secured.

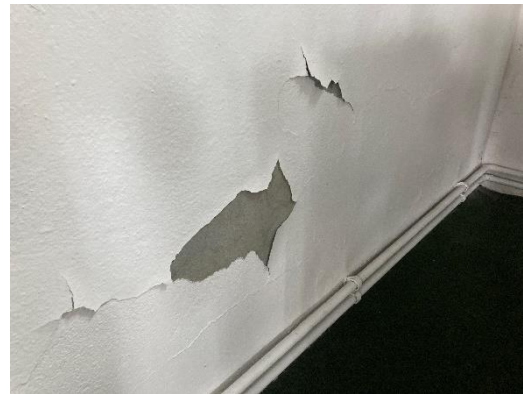
North Aisle and North East Chapel
There is some failing paintwork, particularly towards the East of the North wall and below the first window from the East. The walls have been rendered in a cementitious plaster, which has been decorated in a non-breathable material. This should all be removed and replastered in lime to prevent moisture from becoming trapped.

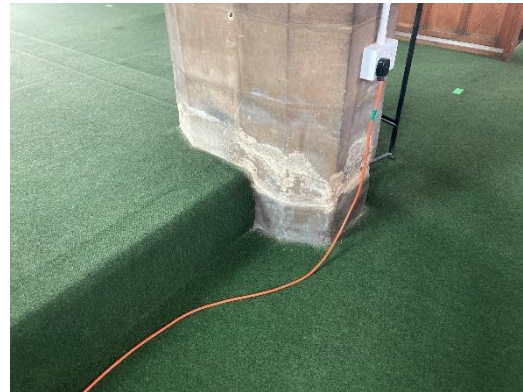
Slight decay to base of column, which should be kept under observation to determine rate of deterioration.

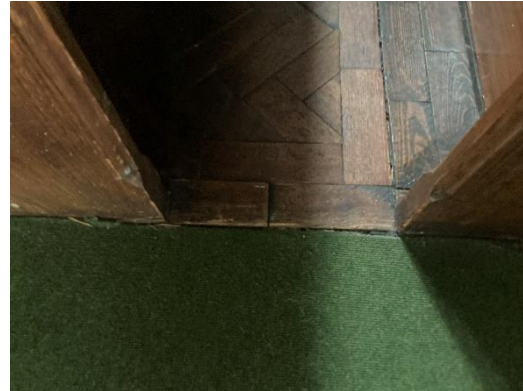
Loose carpet to pew entrances with missing transition strips causing a trip hazard.

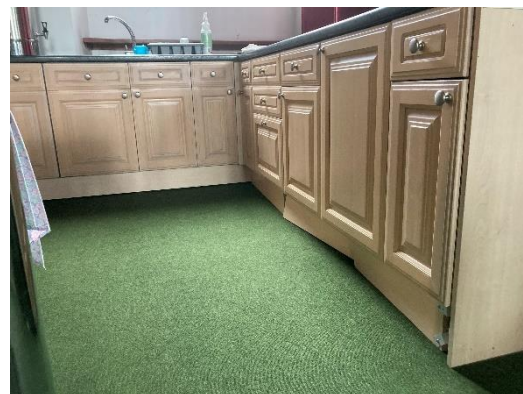
The kitchen to the rear of the North Aisle would benefit from a scheme of modernisation. The kickboards are loose and should be refixed.

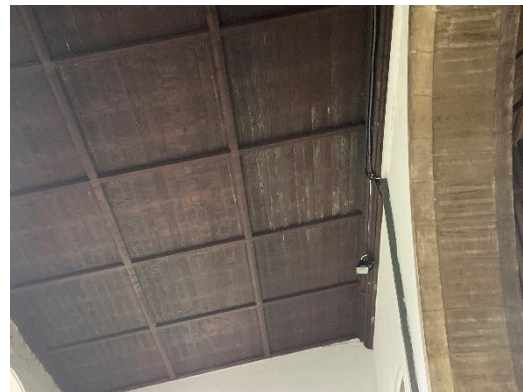
South Aisle and South East Chapel
As highlighted in the previous QI, there is some staining to the boarding as a result of the lead covering being stolen a number of years ago. This cannot be addressed without redecoration.

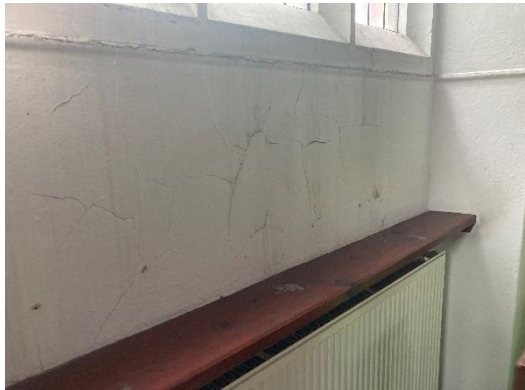
3
D	Further areas of failing paint finish, see above for remedial works.

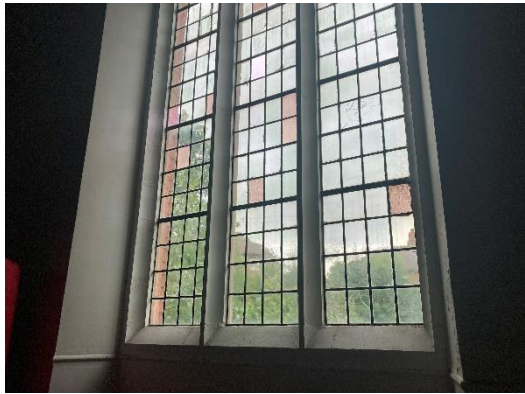
1
B	There has been a history of problems with vandals breaking the plain glass and numerous quarries have been replaced using an alternative material which, when new, will have been transparent but now has become opaque and striated. There are also many other broken glass quarries which should require replacement. It would make desirable when the broken quarries are replaced, that the glazier be asked to replace the old repairs in glass matching the original.

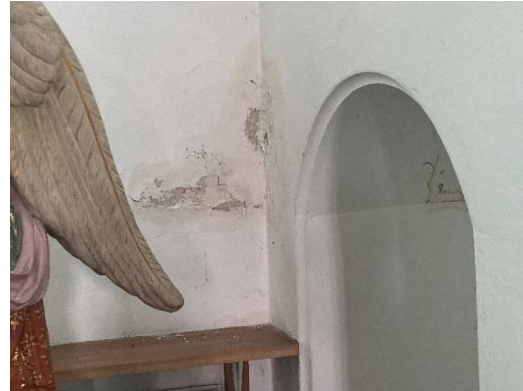
There is evidence of damp ingress to the recess and to the South East corner at 2m height likely due to water ingress from the valley gutter formed at the junction with this wall and the Vestry. Once the arrangement externally has been improved this should dry out and can be repainted with a breathable paint.

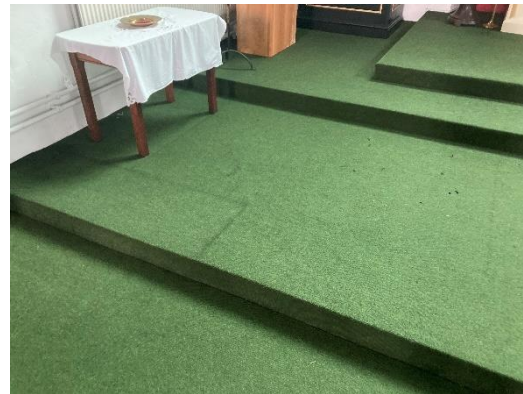
Loose chancel step stones should be re-bedded with marked carpet cleaned, replaced or removed.

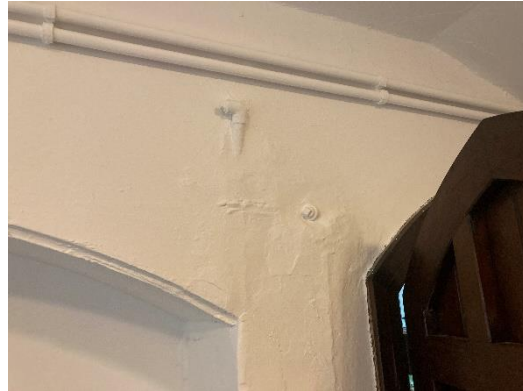
Obs Redundant gas pipes in West wall.

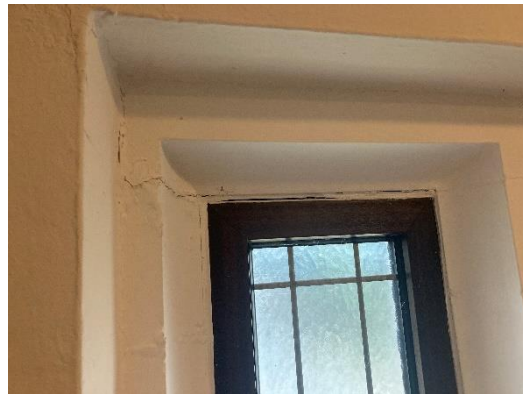
C The fractures mentioned externally at the window surround stones. External defects should be addressed before filling and redecorating internally. Repairs should be kept under observation for further signs of movement.

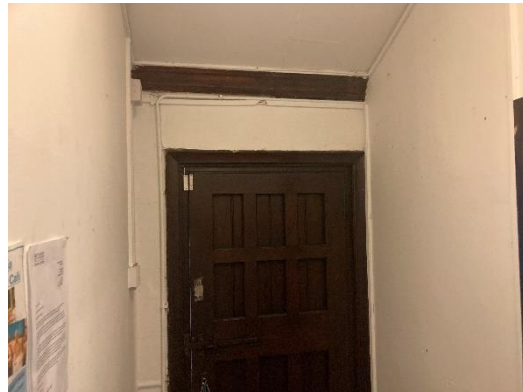
D Vestry Lobby
Keep plate is missing from the Vestry door; a new one should be fitted and the woodwork around re-stained.

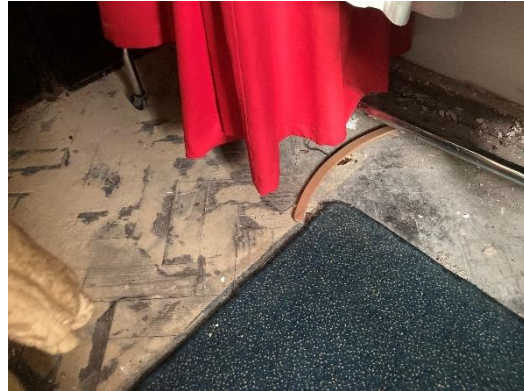
There is some concern with the amount of moisture getting in at the Vestry valley junction on the North wall that dry rot may break out within the block flooring. A swift rectification of the defect would help to stop this occurring.

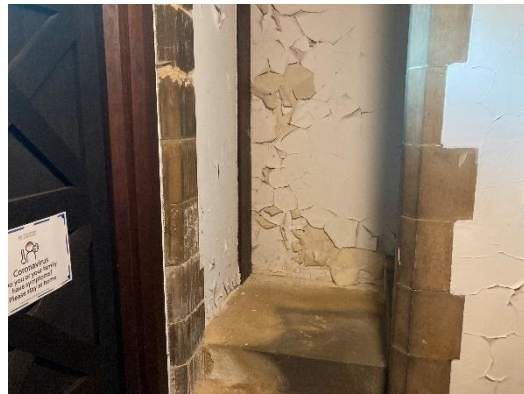
South Porch
There is some flaking to the paintwork to the West wall which would benefit from redecoration with a breathable paint.

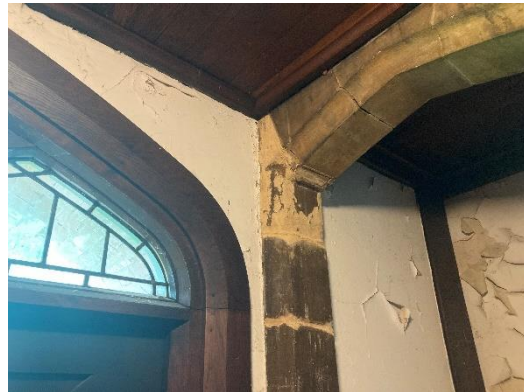
There is some deterioration to the quoin stonework to the opening to the stair, almost certainly due to water penetration as a result of debris collecting over the Porch. Rectify external defect and keep under observation.

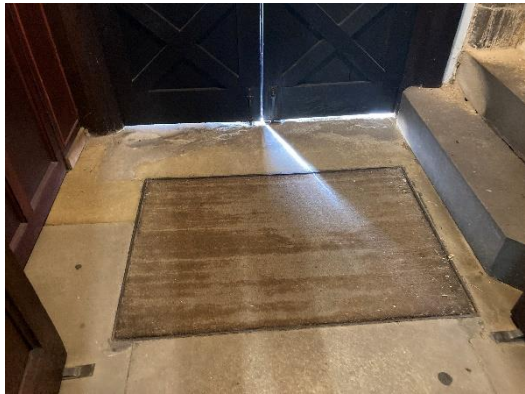
2
B	The doormat is worn within its surround, and the raised edges of the stones are causing a trip hazard. A new mat should be installed on a raised substrate to eliminate trip hazard.

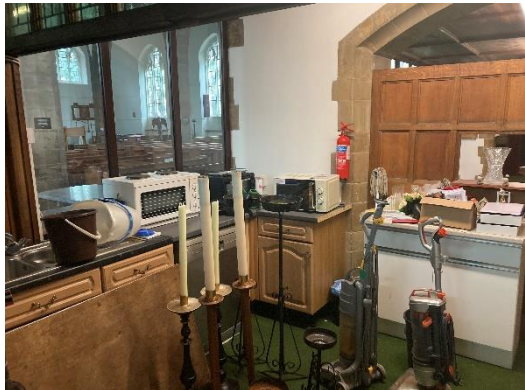
1
E	North Porch/Kitchen The kitchen would benefit from a scheme of modernisation.

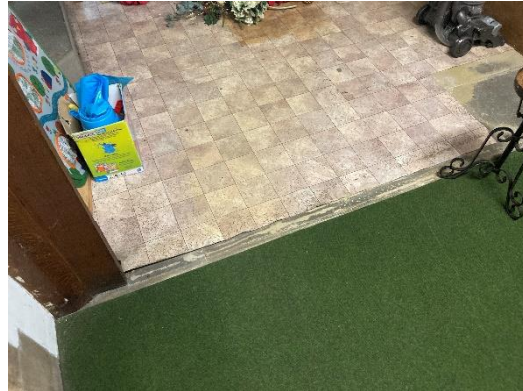
B

Loose transition strip between carpet and vinyl now acting as a trip hazard. This should be replaced.

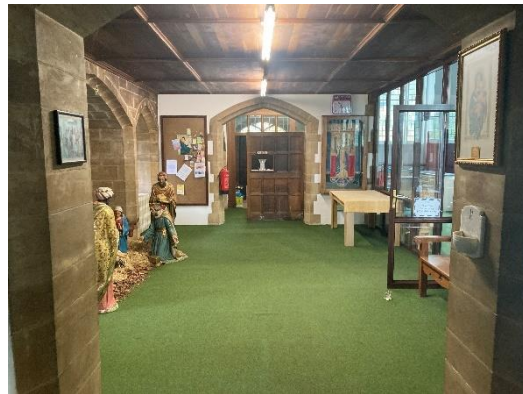
A Narthex has been created by dividing the central section from the Nave with a uPVC double glazed curtain wall with double doors centrally located. All in satisfactory condition.
