Church Commissioners
Mission, Pastoral and Church Property Committee
Mission and Pastoral Measure 2011

The parish of Castleford: the churches of St Paul, Glasshoughton; All Saints, Hightown; St Michael and All Angels, Castleford

Note by Joanna Chandler-Clarke

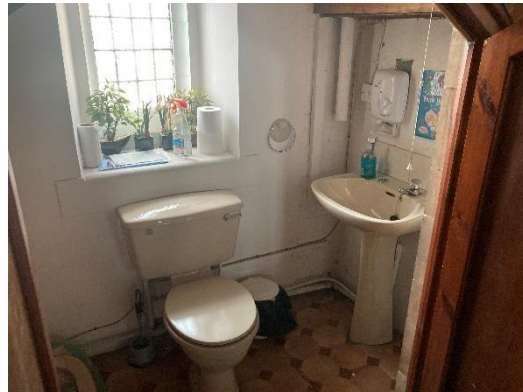
Toilet

The toilet and sink installation would benefit from a scheme of modernisation.

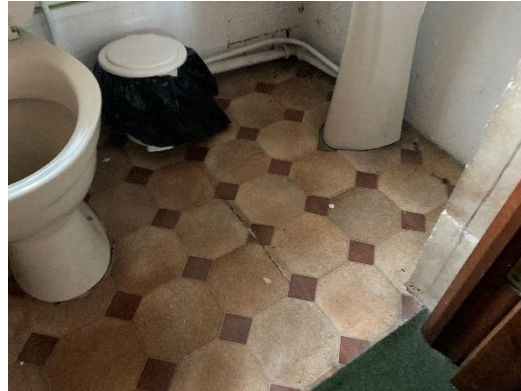
C There are tears and splits to the vinyl, which should be replaced.

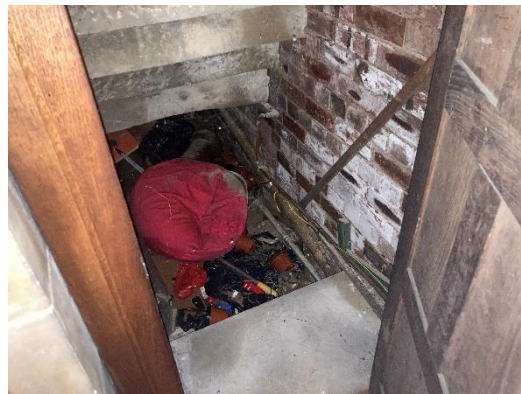
C Salting to the brickwork in the toilet cupboard. External defects in this area should be addressed (tarmac, open joints etc), and the salts brushed off. These works should be monitored for signs of further brick salts.

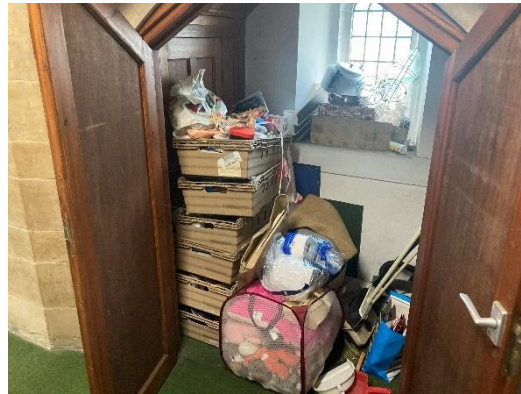
Obs Narthex Store
Close inspection was difficult due to objects being stored, but all appeared satisfactory.

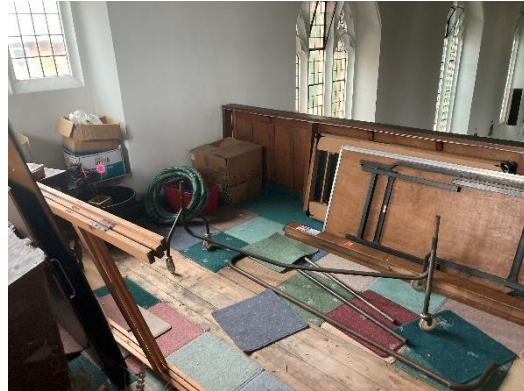
North Organ Loft
Floor is covered with carpet samples which are now becoming dislodged and are becoming a trip hazard. Replace with one piece of carpet or remove leaving bare boarding.

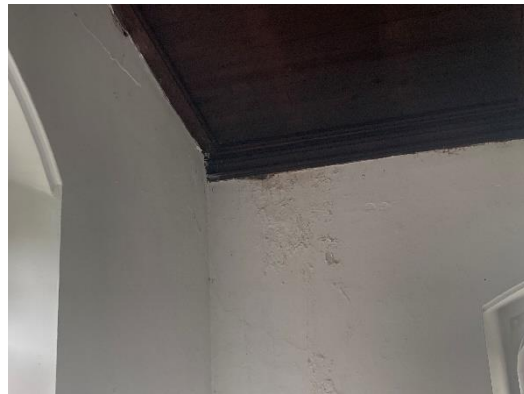
Evidence of water penetration at high level. The previous QI notes this may be due to a blocked sump or valley gutter. Further high level access is required for investigation.

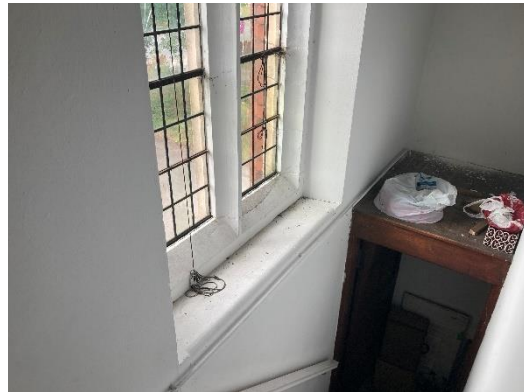
As noted elsewhere, the glazing bars are in poor condition and require refurbishment.

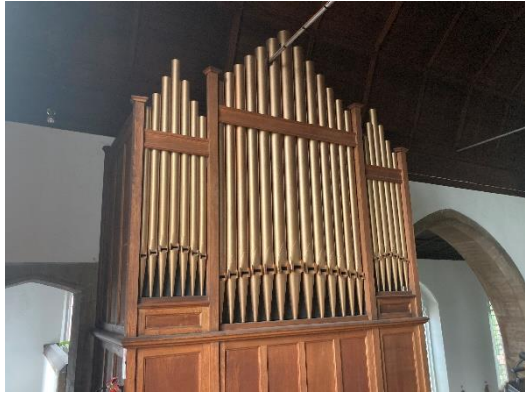
Priority	Description	Photograph	Costing Band
D	<p>Central Organ Loft Substantial pipe organ by Abbott and Smith of Leeds. The last inspection reports the organ is in working order, however it should be appraised by an Organ specialist.</p>

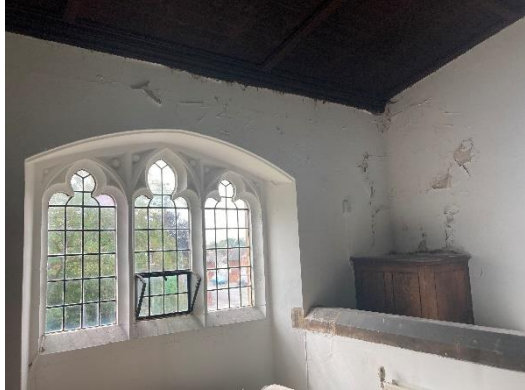
1
B	<p>South Organ Loft Evidence of water penetration at high level. The previous QI notes this may be due to a blocked sump or valley gutter. Further high level access is required for investigation.</p>

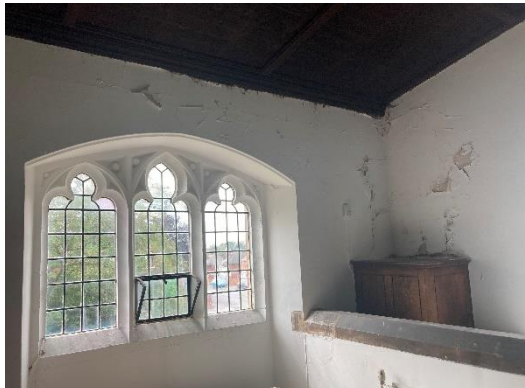
1
B	<p>None of the ventilators are working and it would be beneficial to the condition of the fabric if some of these ventilators could be brought back into working order; which could be done in conjunction with other glazing works.</p>

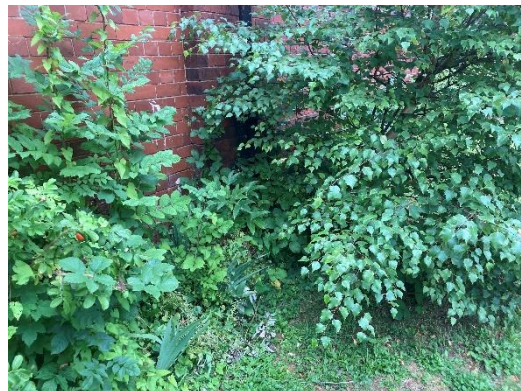
B A number of shrubs are growing against the South Aisle wall, whilst attractive, this can hold moisture in the soil against the building. There is no indication that this is causing any damage at the moment, so the situation can be monitored for the present.

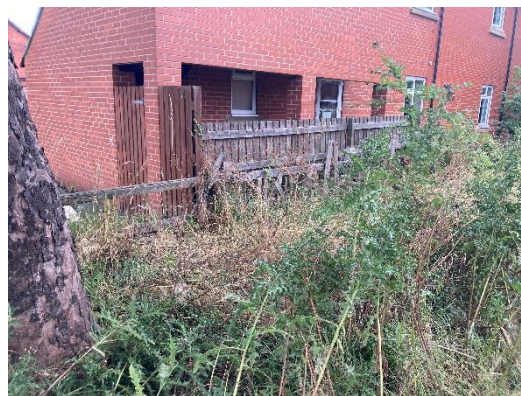
D The fence to the North boundary looks in poor condition and could be replaced. This area is also overgrown and vegetation should be cleared as part of any works. If the fence comes under the responsibility of the church then this could replaced.

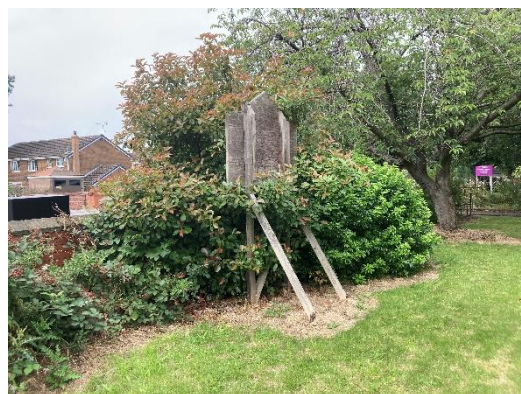
C The Church Noticeboard is in poor condition requiring some repair to the timbers and would benefit from repainting.

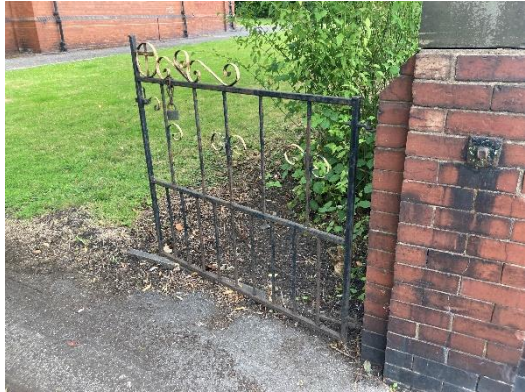
2
D	The vehicular gates to the North would benefit from the vegetation being removed and the gates repainted.

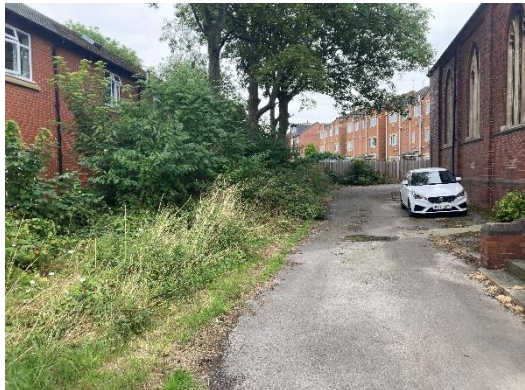
1
D	The tarmac to the North of the site is becoming pitted and requires patching. It would be beneficial to replace this hardstanding with a porous covering, or SUDS.

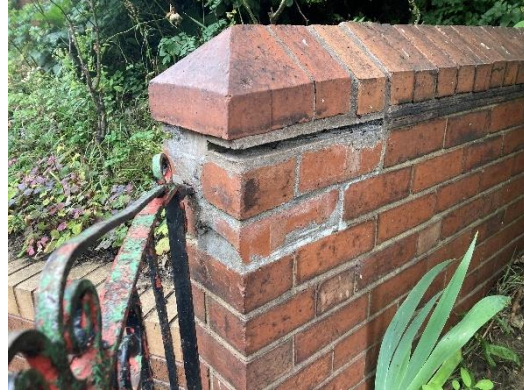
D Open joints and poor brick repointing to wall abutting the Vestry, which should be repointed in lime mortar.

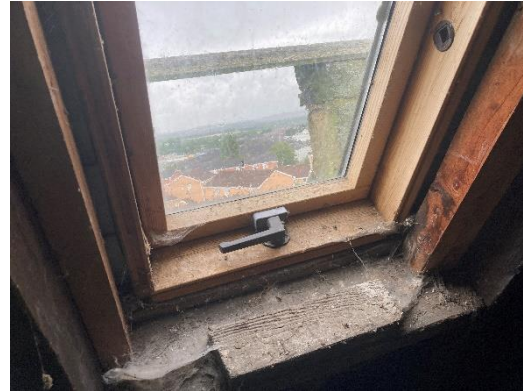
C Church, Tower Roof
 Inspection of the roof was made difficult by the rooflight which did not give sufficient access onto the roof itself. An openable roof light or roof hatch should be installed to enable future inspections and access for regular maintenance.

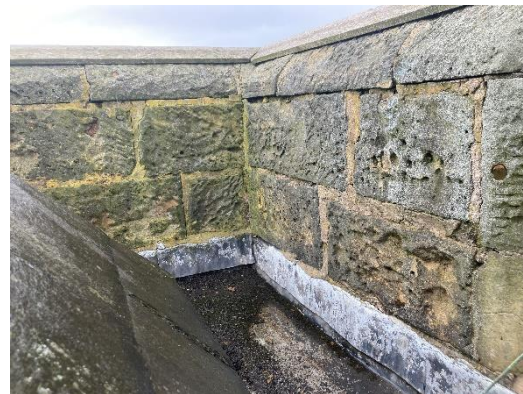
A There is debris and vegetation growth building up in the gutters which should be cleared seasonally as part of a maintenance programme.

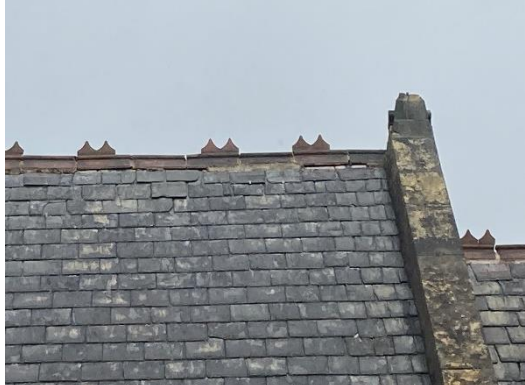
1
C	<p>There are some open joints and missing mortar to the ridge which should be fully repointed.</p>

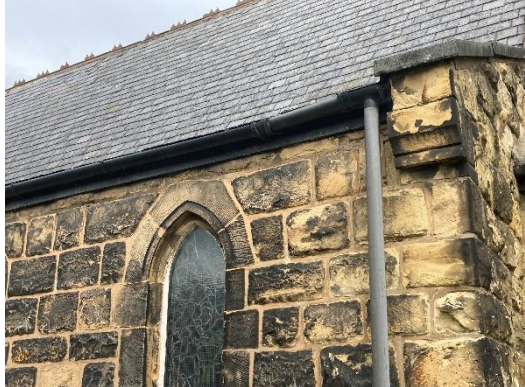
3
D	The rainwater goods are later UPVC replacement which has lost some of its original colouring should be replaced for an aesthetic improvement. All the gutters and downpipes are of an inadequate size for the size of the roofs and should be changed for larger format and preferably replaced in cast iron or aluminium.

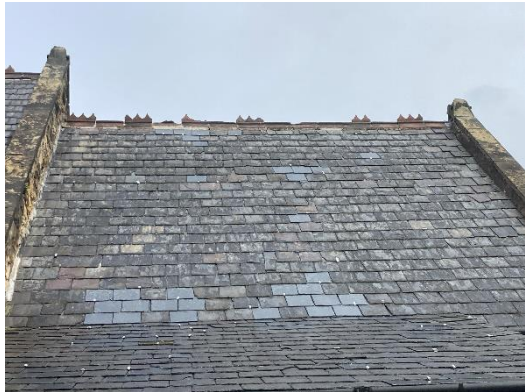
1
C	<p>There is some open joints and missing mortar to the Ridge which should be fully repointed.</p>

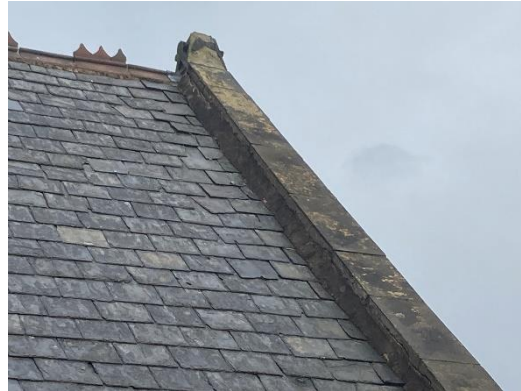
C There are some recessed and open joints to the coping stones on the East end of the Chancel. They should be repointed with consideration given to re-bedding on a lead DPC.

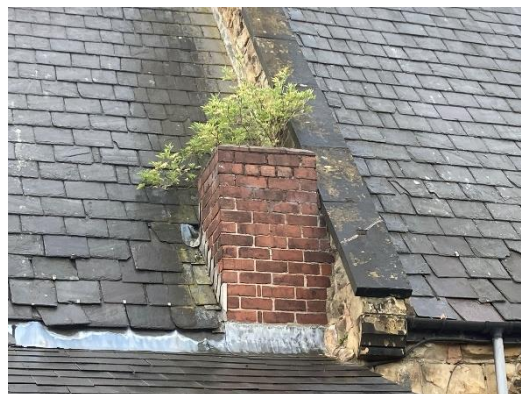
D Chancel North Slope
Vegetation growth to the chimney stack from the vestry which should be removed. It was not possible to determine the condition of the flaunching from a ground level inspection. However given the algae growth and vegetation to the chimney it is assumed that this is in poor condition.

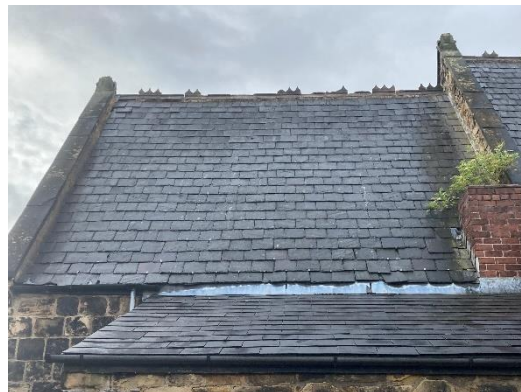
C There are frequent slipped and missing slates to the double pitched and cat-slide roof, which should be refixed or replaced.

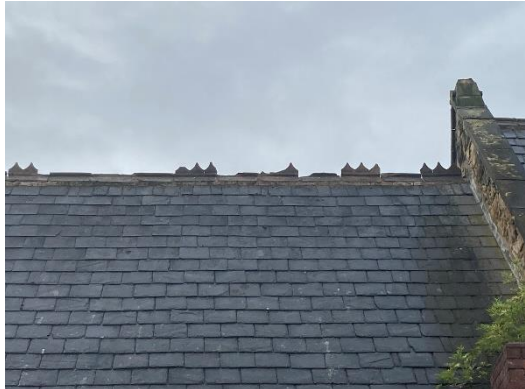
Priority	Description	Photograph	Costing Band
D	There is also been damage to the decorative ridge tiles and they should be replaced.

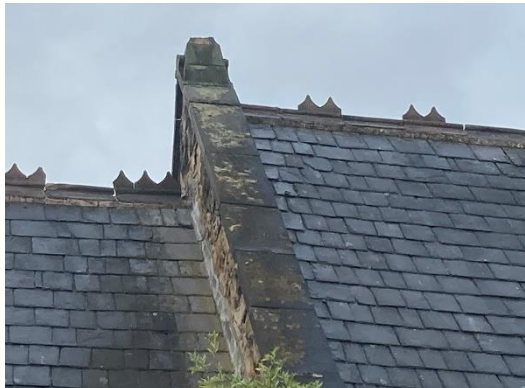
1
C	The coping stones to the east of the North Nave look in acceptable condition, although the mortar joints are recessed. They should also be fully re-bedded onto a lead DPC to assist with waterproofing the Nave.

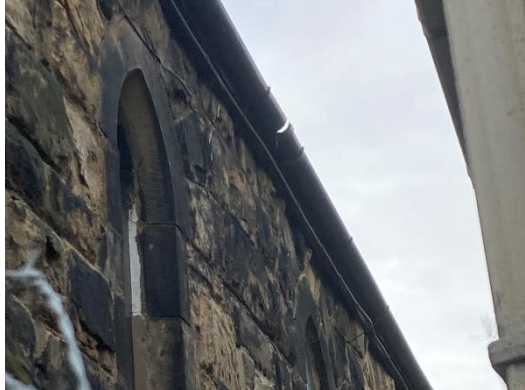
2
A	Nave North Slope There is a section of missing guttering to the north elevation, where water is discharging down the face of the building and onto the infill extension between the church and the whole. This should be replaced urgently.

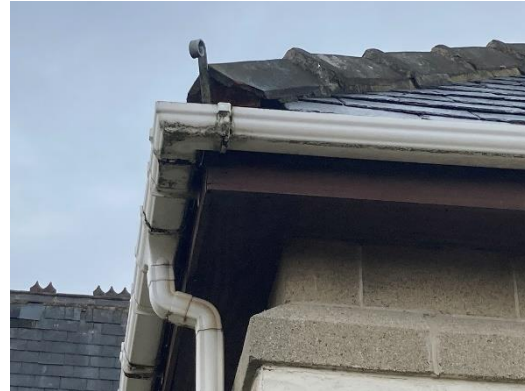
Obs There has been some later repairs to the hip tile pointing, as the original pointing has begun to crack and fail. The condition should be monitored further with a review to repointing.

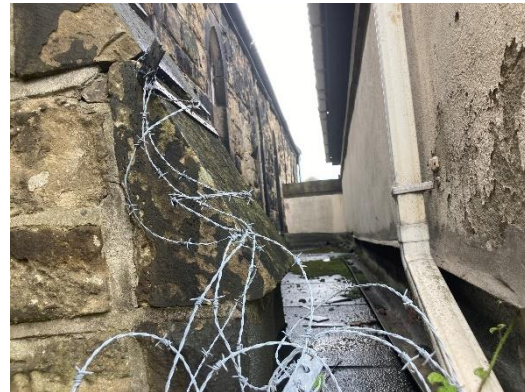
Obs Cupboard Storage Roof
There is a felted flat roof between the church and hall which was difficult to access during the inspection. There is a build up of Moss on the flat roof which should be cleared seasonally.

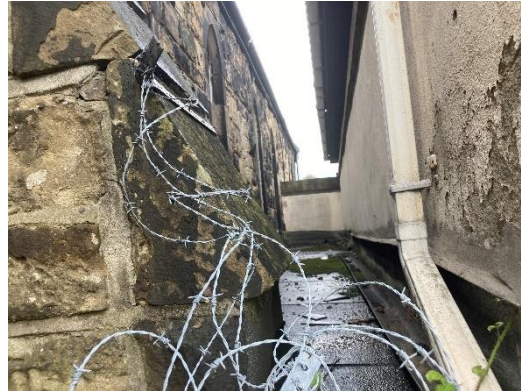
D The felt appears to be in poor condition, although there were no leaks to the storage cupboards immediately beneath. The condition should be monitored for signs of water ingress with consideration given to replacing the roof.

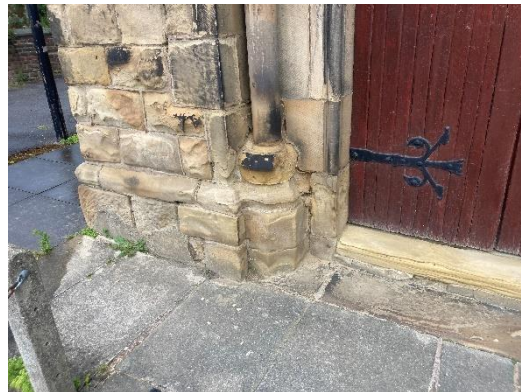
B South Aisle, South Elevation
There has been some decay to the decorative stonework around the South door which has been caused by cementitious mortar. The existing mortar should be removed and the elevation repointed with lime mortar. A programme of stonework repairs and replacements is also advised.

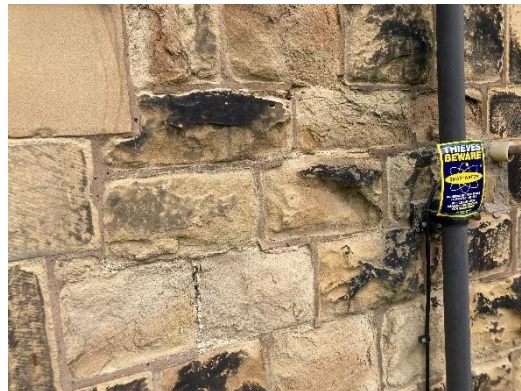
B A cementitious mortar has been used to repoint the elevation, which is causing accelerated decay of the stonework. It will be a large outlay but to arrest further stone decay it would be beneficial to remove the pointing and repoint in lime mortar.

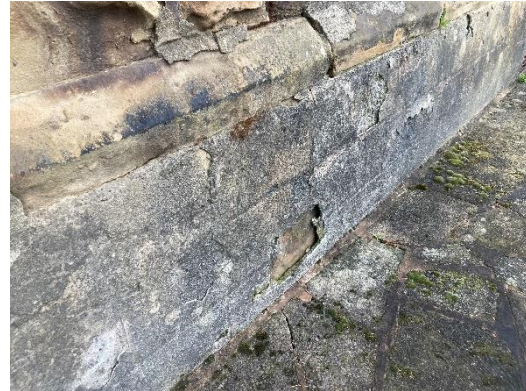
There is a cementitious render applied to the plinth the elevation which is causing further stone decay due to trapping moisture beneath. The render should be carefully removed and the plinth repointed in lime mortar. Allowance should be made for replacing some of the plinth stonework, although the extent is difficult to foresee.

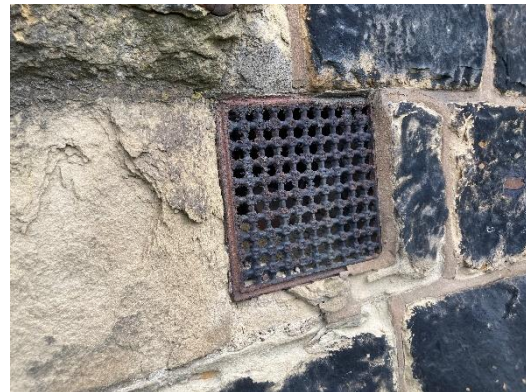
The cast iron ventilation grills within the wall have become rusty, they should be re-decorated.

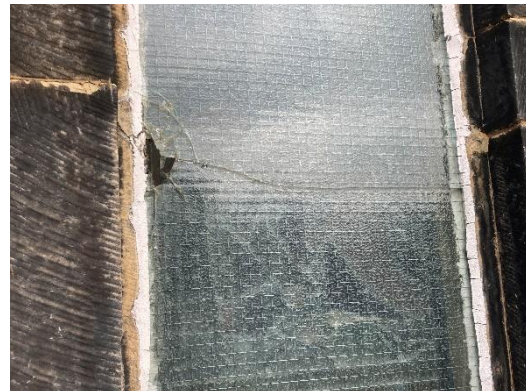
The windows have been all pointed with putty and cement mortar, both of which are failing and coming away allowing water to ingress into the building. The window should be repointed with burnt sand mastic.

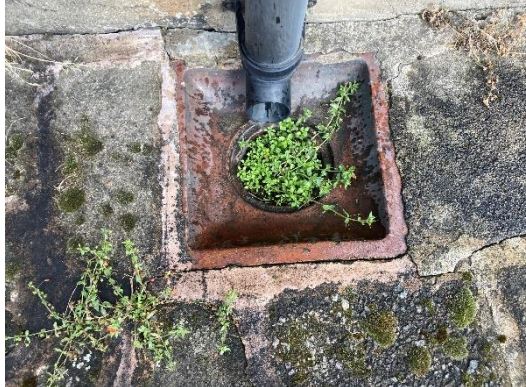
3
D	<p>The South door is generally in acceptable condition, with some minor areas of paint decay to the door and brackets. This should be decorated as part of a wider the maintenance strategy.</p>	 	1
A	<p>Gulleys are full of vegetation, which should be cleared as part of a wider maintenance plan. If problems persist, a below ground CCTV drainage survey should be commissioned to determine any non-visible defects which may be contributing to vegetation growth.</p>

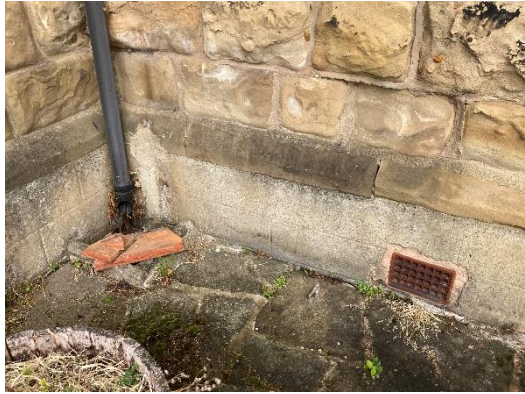
Priority	Description	Photograph	Costing Band
B	<p>South Aisle East Elevation and Nave East Gable</p> <p>The cementitious rendered plinth continues from the previous elevation. The render should be carefully removed and the plinth repointed in lime mortar. Allowance should be made for replacing some of the plinth stonework, although the extent is difficult to foresee.</p>

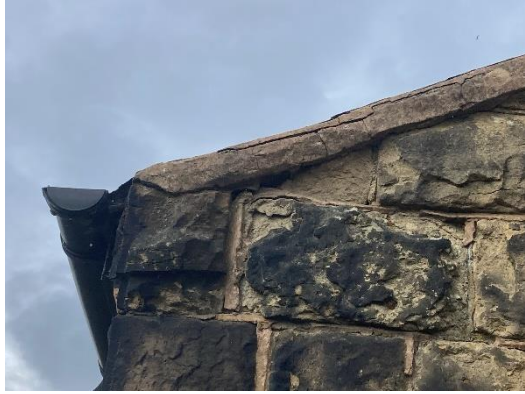
3
C	<p>There is some cracked verge pointing which should be replaced.</p>

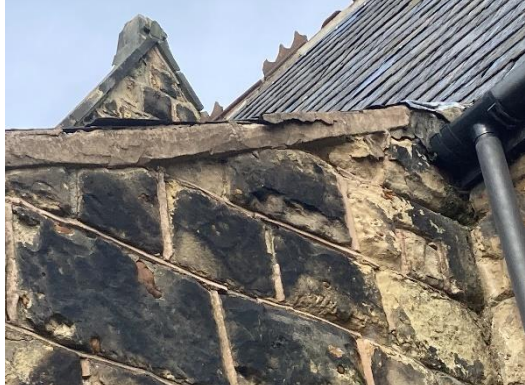
1
B	<p>Stonework decay, particularly at high level, caused by combination of cementitious mortar and water ingress. The existing mortar should be removed and elevation repointed with lime mortar.</p>

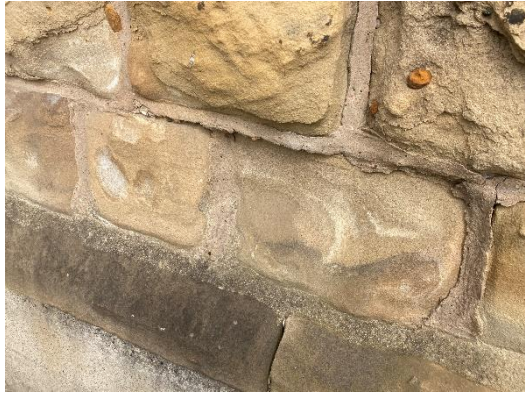
Priority	Description	Photograph	Costing Band
B	Cementitious mortar has been used on the elevation generally, as per other elevations, which should be removed to arrest accelerated decay of the stonework.

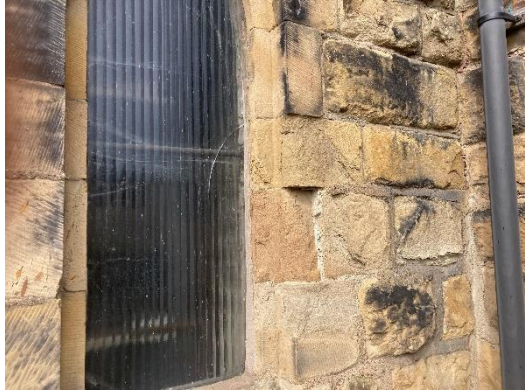
5
C	A particular area of decay is affecting stonework around the Organ window surround. The decayed stone should be removed and replaced with matching material.

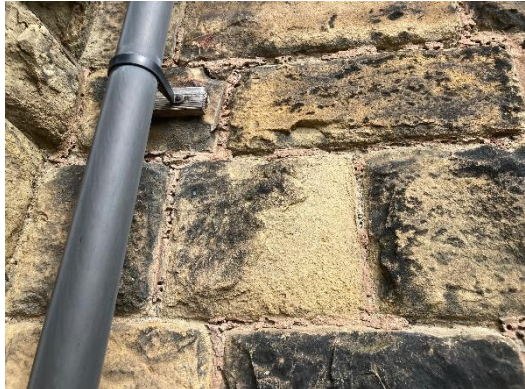
Priority	Description	Photograph	Costing Band
B	Evidence of masonry bee infestation to pointing, which appears to be a softer gypsum based pointing. Affected pointing should be removed, and area repointed in lime mortar, which could be undertaken with other pointing works.

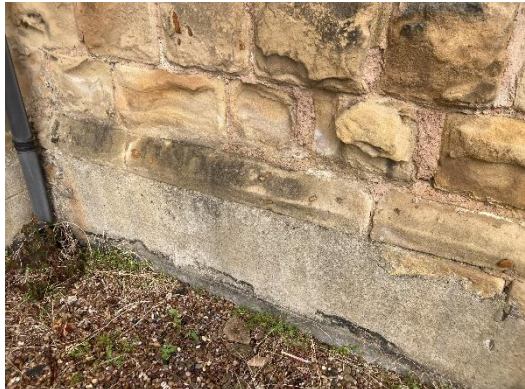
1
B	The cementitious rendered plinth continues from other elevations. The render should be carefully removed and the plinth repointed in lime mortar. Allowance should be made for replacing some of the plinth stonework, although the extent is difficult to foresee.

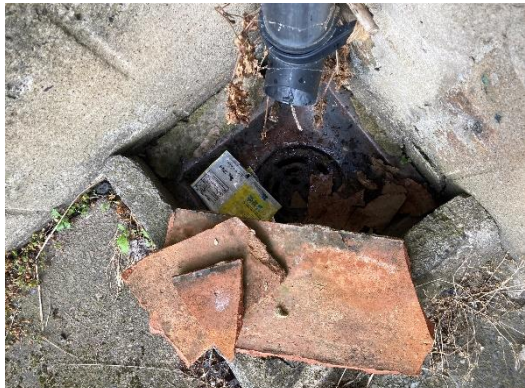
3
A	Gulleys are full of debris which should be cleared as part of a wider maintenance plan.

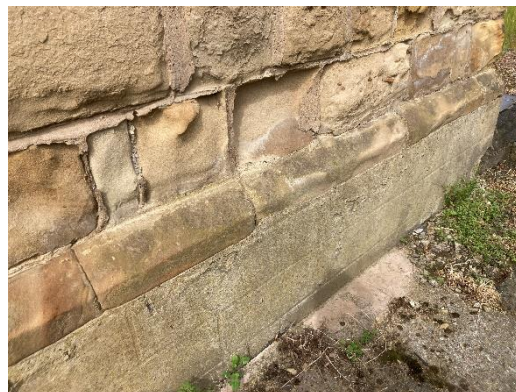
Chancel East Elevation

As highlighted on other elevations, a cementitious mortar has been used to repoint the elevation, which is causing accelerated decay of the stonework. To arrest further stone decay it would be beneficial to remove the pointing and repoint in lime mortar. Cement render below forcing water out through stone courses above.

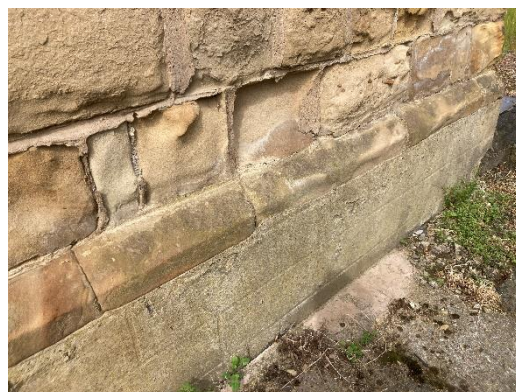
The cementitious rendered plinth continues from other elevations. The render should be carefully removed and the plinth repointed in lime mortar. Allowance should be made for replacing some of the plinth stonework, although the extent is difficult to foresee.

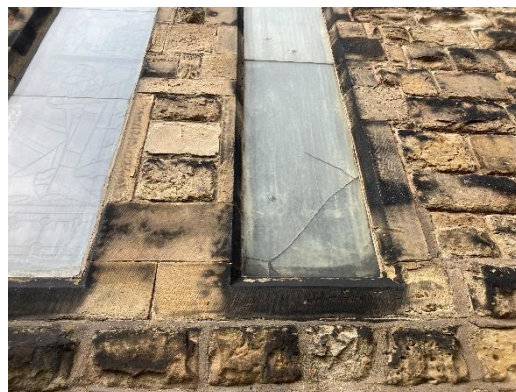
More widely, The security glazing to the windows is cracked or broken and would benefit from full replacement. As part of this replacement, the windows should be repointed with burnt sand mastic.

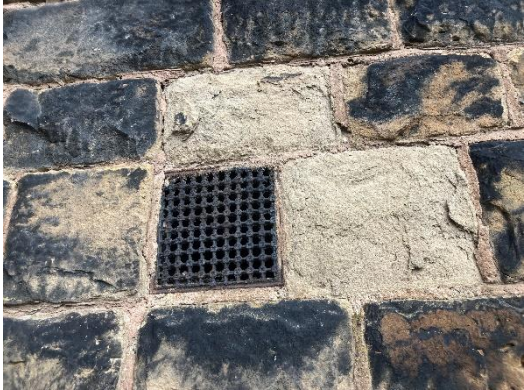
<p>C</p>	<p>The cast iron ventilation grills within the wall have become rusty, they should be re-decorated.</p>

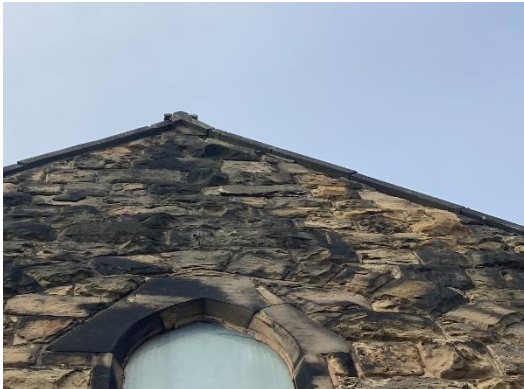
<p>1</p>
<p>C</p>	<p>Particular areas of stone decay to highlight are at high level beneath the coping stones. Re-bedding of the coping stones on a lead DPC would be advisable to arrest water ingress, alongside repointing the stonework in lime mortar.</p>

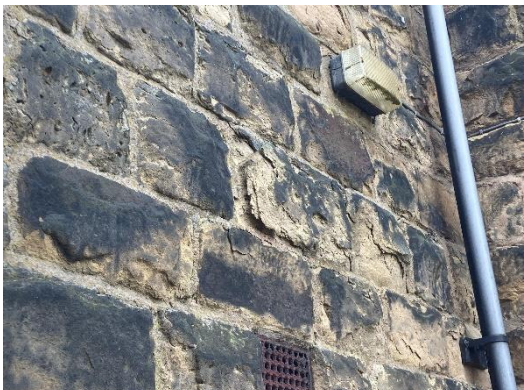
<p>3</p>
<p>C</p>	<p>Chancel North Elevation There is some particularly friable stonework on the north elevation of the Chancel. The loose material should be removed and remedied as part of a wider project of repointing and stonework replacement.</p>

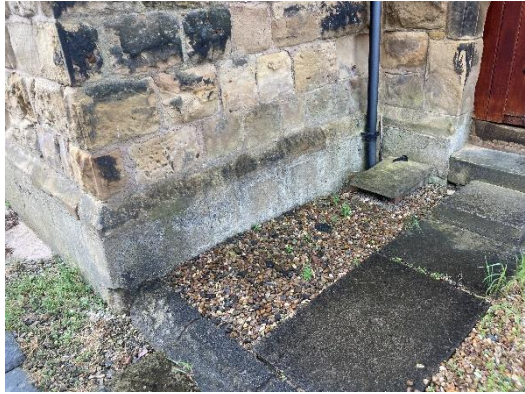
Priority	Description	Photograph	Costing Band
B	The cementitious rendered plinth continues from other elevations. The render should be carefully removed and the plinth repointed in lime mortar. Allowance should be made for replacing some of the plinth stonework, although the extent is difficult to foresee.

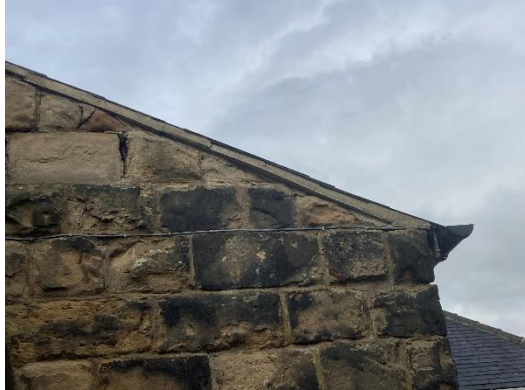
3
C	Vestry East Elevation There is some cracked verge pointing which requires repointing, with an area of decayed stonework at high level which should be replaced in matching stone.

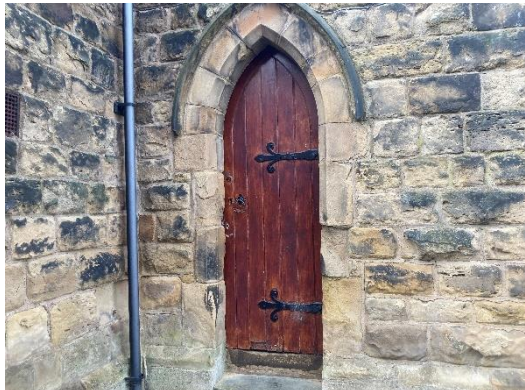
1
B	The elevation suffers with the same defects as the other elevations, such as the cementitious mortar and plinth, although the decay of the stonework is too a lesser extent than elsewhere in the building. A repointing in lime mortar with a programme of stonework repairs should be undertaken, as recommended for other elevations.

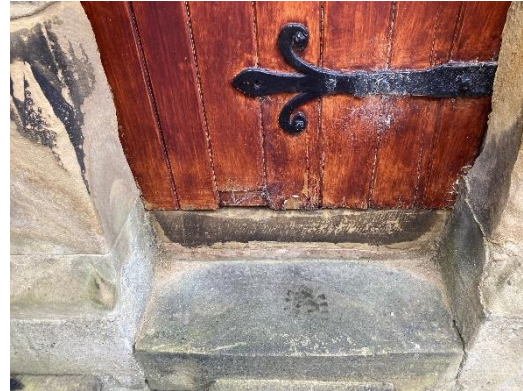
D There is a minor area of decayed timber to the bottom of the door with a new section of timber spliced in. The door and brackets would also benefit from decoration.

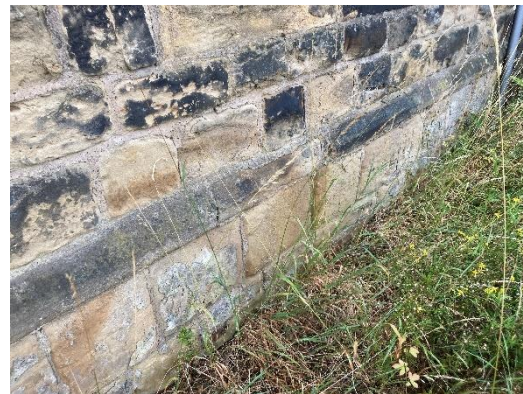
B Vestry North Elevation
Same as the previous section with stonework in slightly better condition, this could be down to better sheltering from the weather. The plinth has also not been rendered as highlighted elsewhere.

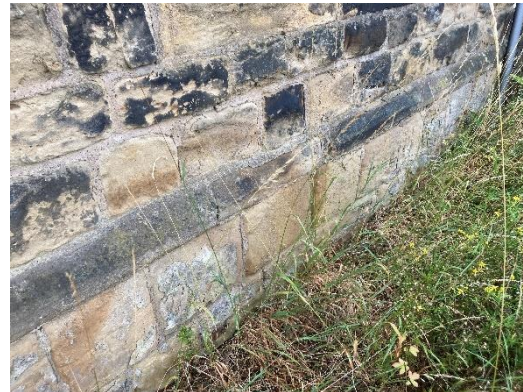
B A cementitious mortar has been used to repoint the elevation, as highlighted elsewhere.
While stone decay is slower on this elevation than elsewhere, it would be beneficial to remove the existing pointing and repoint in lime mortar.

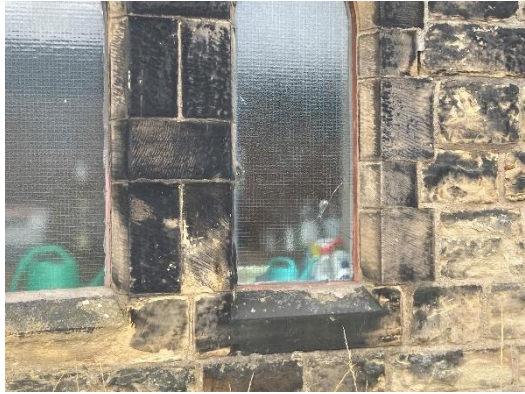
Priority	Description	Photograph	Costing Band
C	More widely, The security glazing to the windows is cracked or broken and would benefit from full replacement. As part of this replacement, the windows should be repointed with burnt sand mastic.

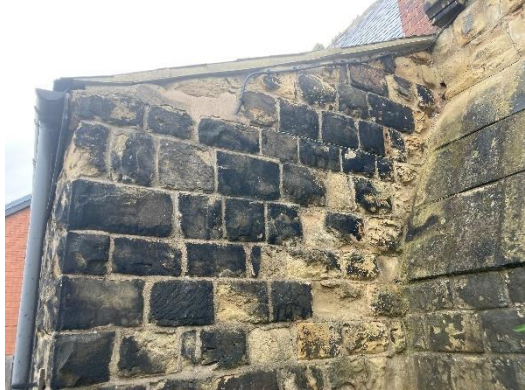
3
B	North East Vestry West Elevation As highlighted on other elevations, a cementitious mortar has been used to repoint the elevation, which is causing accelerated decay of the stonework. To arrest further stone decay it would be beneficial to remove the pointing and repoint in lime mortar.

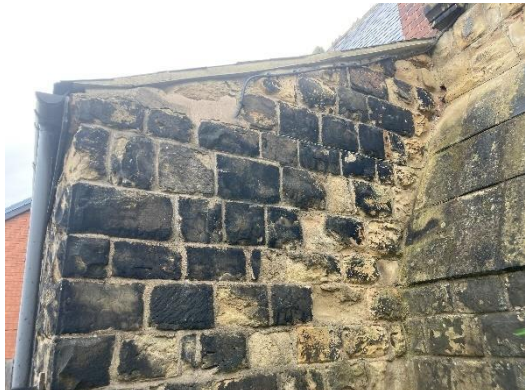
2
C	There is some cracked verge pointing which requires repointing, with an area of decayed stonework at high level which should be replaced in matching stone.

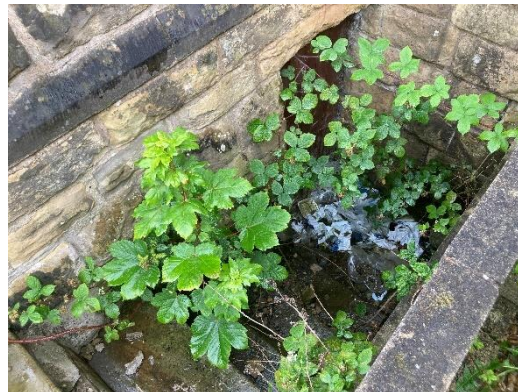
Boiler Access Steps

There was generally a large amount of vegetation, debris and general litter in this area which made inspection difficult. This should all be cleared and maintained annually.

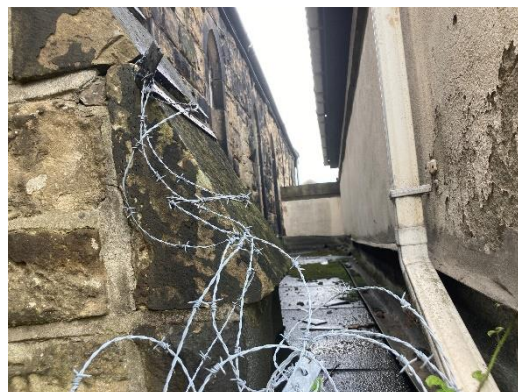
The north elevation is largely obscured from view by the close proximity of the church hall, which made inspection difficult.

It is assumed same defects as other elevations, although possibly in better condition due to the protection given by the Church Hall.

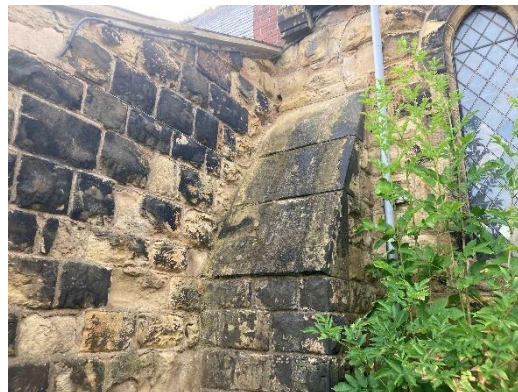
There are some recessed joints to the visible buttress abutting the Vestry. These should be repointed in conjunction with other pointing works.

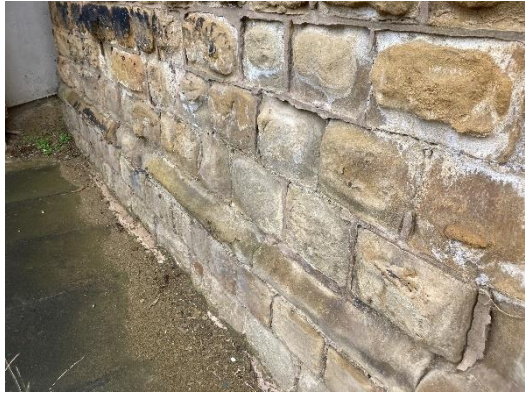
Priority	Description	Photograph	Costing Band
B	<p>West Nave Elevation</p> <p>A cementitious mortar has been used to repoint the elevation, which is causing accelerated decay of the stonework. It will be a large outlay but to arrest further stone decay it would be beneficial to remove the pointing and repoint in lime mortar. The trapped moisture within the wall is also causing salting which should be brushed off.</p>

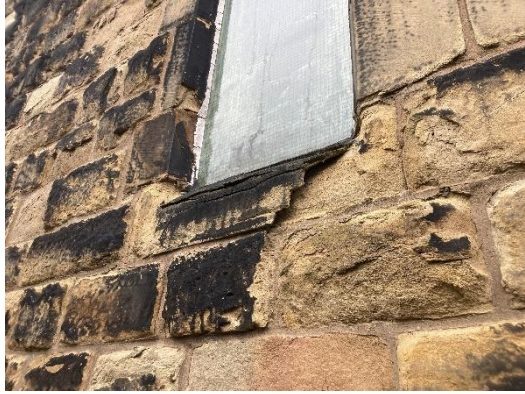
3
A	<p>There are particular areas of very friable stonework to the window sill which poses a health and safety risk. The loose material should be removed as a priority.</p>

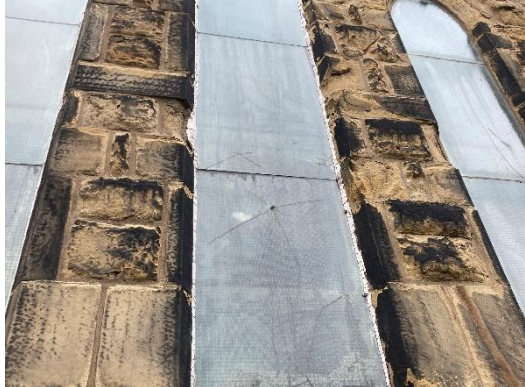
1
C	<p>More widely, The security glazing to the windows is cracked or broken and would benefit from full replacement. As part of this replacement, the windows should be repointed with burnt sand mastic.</p>

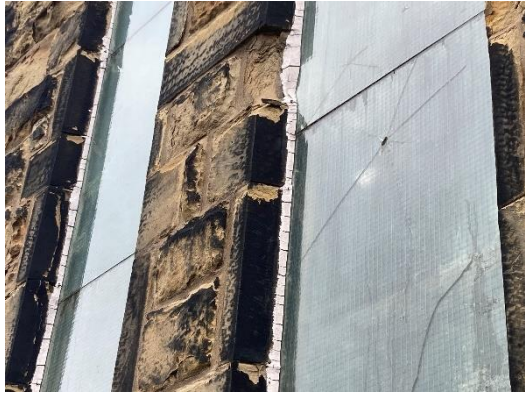
Priority	Description	Photograph	Costing Band
B	There are further areas of friable stonework to the window surround stones. It would be beneficial for the whole of this elevation to undergo a programme of stonework repairs, replacements and pointing.

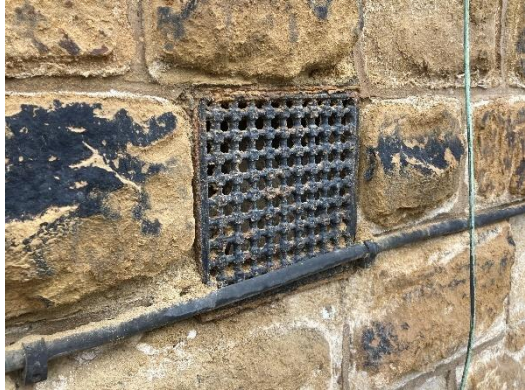
3
C	The cast iron ventilation grills within the wall have become rusty, they should be re-decorated.

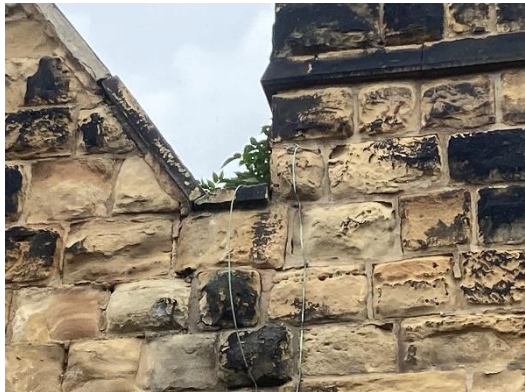
1
A	Vegetation growth to the coping stone and valley between the South Nave slope and the north elevation of the tower, which should be removed. Inspection of this valley was not possible due to lack of access to the tower roof. However it is assumed that this is in poor condition given the ventilation growth and the corresponding water ingress to the nave internally.

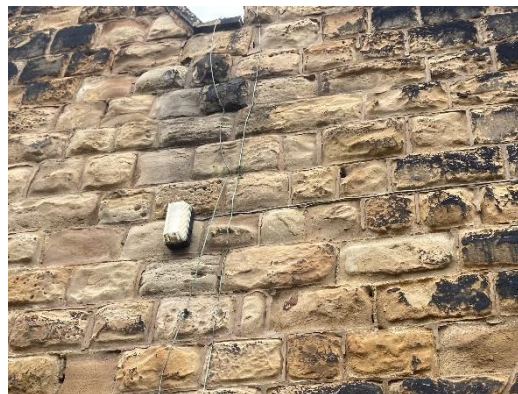
B There is a further area of stone decay to note, beneath the South Nave/Tower valley. As previously recommended, a programme of stonework repairs, replacements and pointing is recommended.

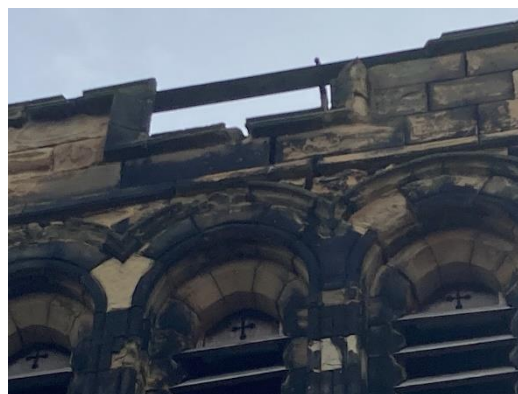
B Tower West Elevation
As noted in the previous QI, the parapet stonework should be rebuilt. There are some large cracks to the stonework above the tower windows which should be addressed as a priority. A structural report and further investigation is recommended to determine the cause.

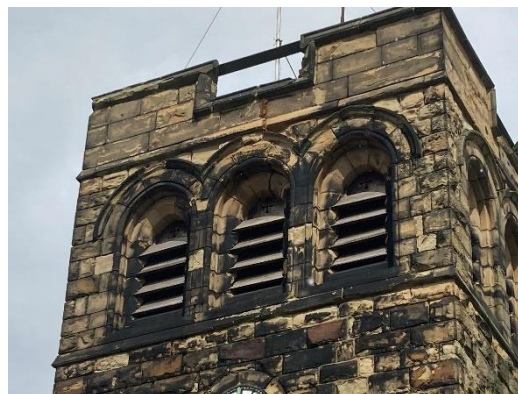
B Tower South Elevation
Similar comments apply to the parapet stonework on the South elevation, although it appears that the large cracks on the South elevation had been filled poorly with a cementitious or gypsum based mortar. A structural report and further investigation is recommended to determine the cause of movement.

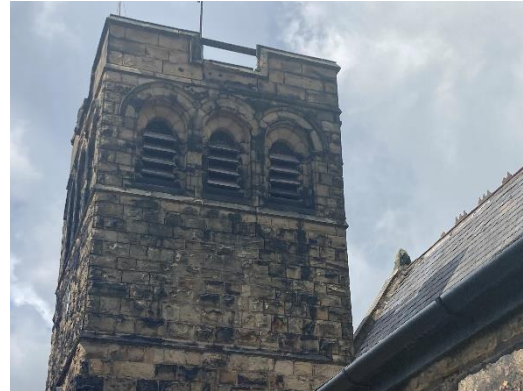
Tower East Elevation
Matches those of the other elevations and similar comments apply with regard to rebuilding the parapet stonework to address movement. Structural investigation is advised.

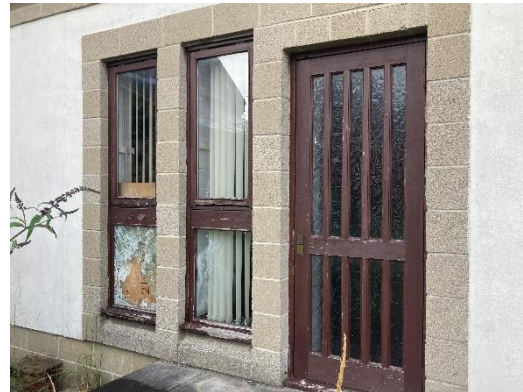
Hall East Elevation
The lower pane of one of the windows has been smashed and currently boarded up, with the broken glass replaced.

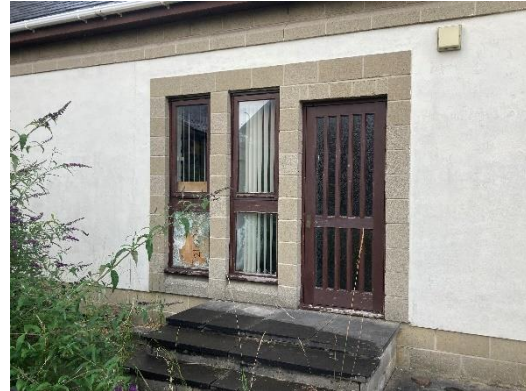
The paintwork to the door has started to fail and peel, particularly on the low level weather bar. The door set and corresponding glazing should be redecorated.

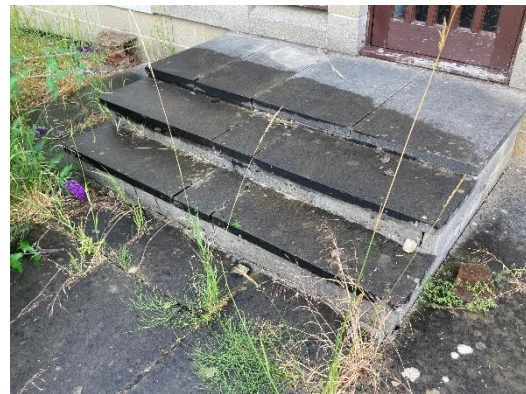
For the steps in their current configuration hand rails should be installed to both sides and the stair steps are unequal in height which causes a trip hazard. It would be beneficial to have these steps rebuilt.

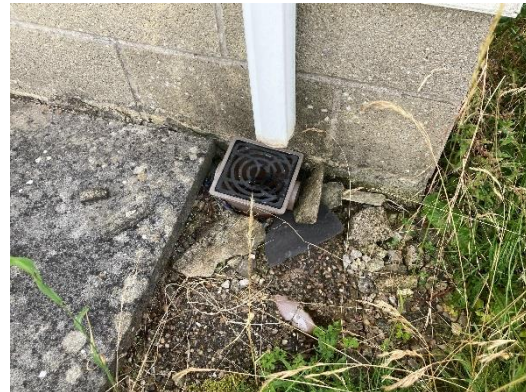
The downpipe does not extend into the gully beneath and rainwater is allowed to discharge against the block wall which is causing some minor algae growth. A shoe should be installed to extend the downpipe into the gully, with plinth blockwork cleaned.

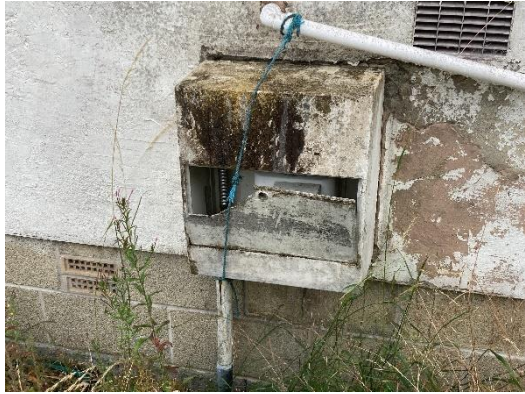
Priority	Description	Photograph	Costing Band
D	The gas meter box is in poor condition and should be replaced.

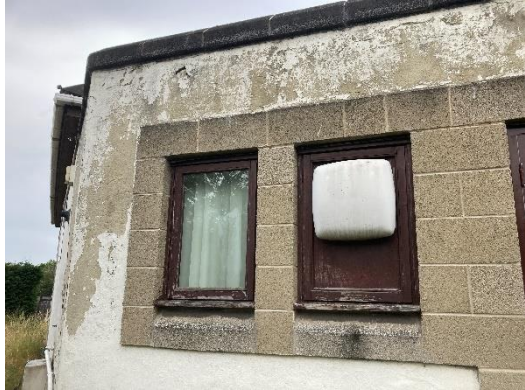
1
D	North West Elevation The paintwork to the render has failed, and the whole elevation should be redecorated.

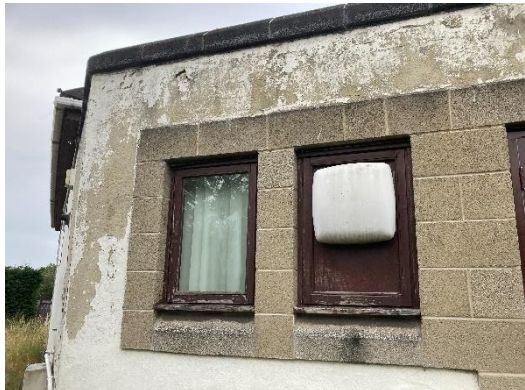
1
C	The paintwork to the windows has started to fail and peel, particularly on the sills; these should be redecorated.

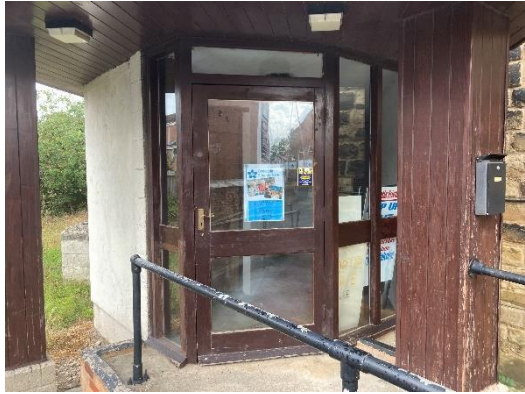
Priority	Description	Photograph	Costing Band
D	The paintwork generally to the door set, glazing and timber clad columns has started to fail and peel; which should be redecorated.

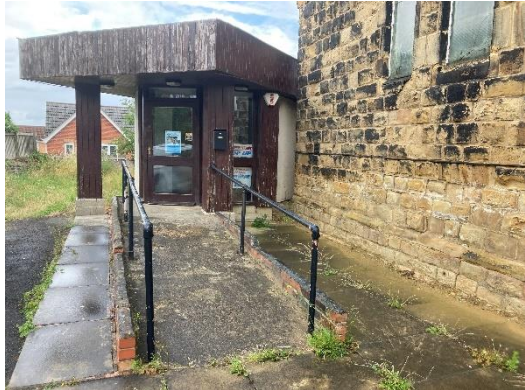
2
D	The paintwork generally to the ramp handrails has started to fail and peel; which should be redecorated.

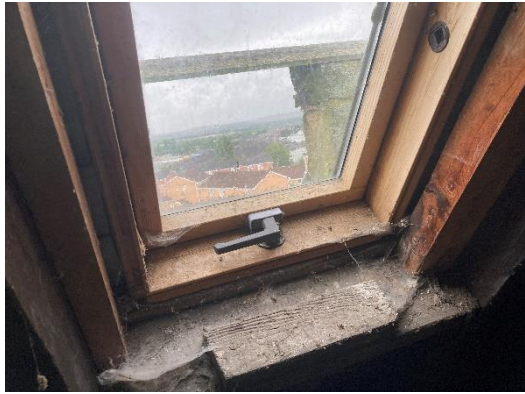
1
3.2	<i>Interior</i>		
B	Tower Access Floor Inspection of the roof was made difficult by the rooflight which did not give sufficient access onto the roof itself. An openable roof light or roof hatch should be installed to enable future inspections and access for regular maintenance.

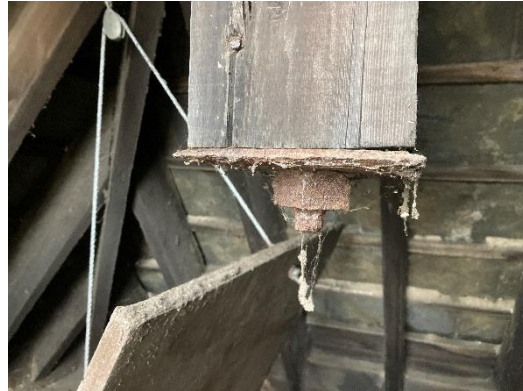
D Rusting to the cross anchor point and plate, which should be redecorated.

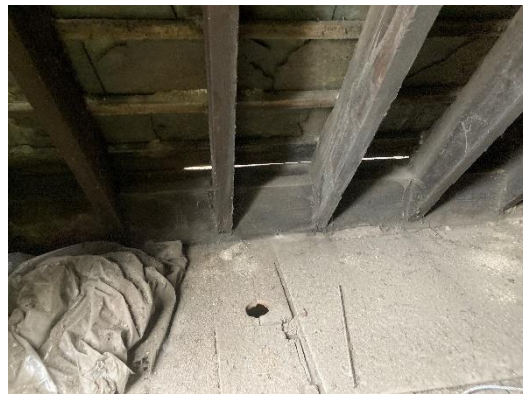
D The space is generally dirty, and would benefit from cleaning to promote regular access and maintenance to the space and roof.

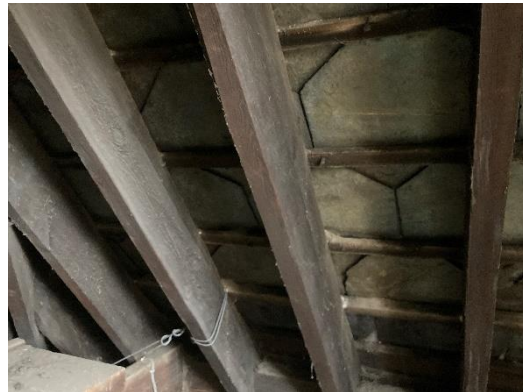
Obs The roof is not membraned and there are areas of daylight visible through the slating, although there does not appear to be any water ingress. This should be kept under observation.

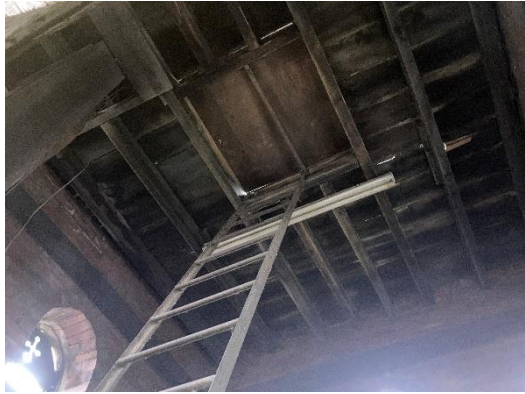
Priority	Description	Photograph	Costing Band
B	Belfry Room The ladder up to the tower roof is loose and requires re fixing.

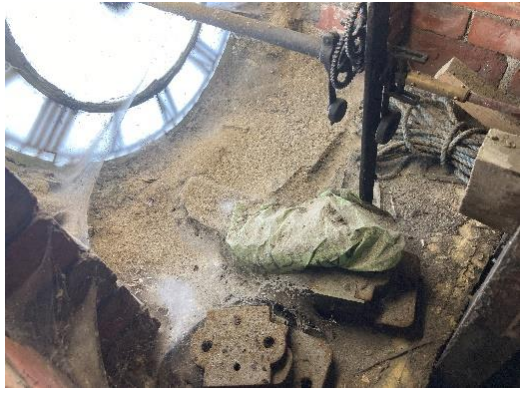
1
C	There is particular stone erosion and open joints around the clock light which should be cleared of any debris and openings consolidated with lime mortar
