Church Commissioners
Mission, Pastoral and Church Property Committee
Mission and Pastoral Measure 2011

The parish of Castleford: the churches of St Paul, Glasshoughton; All Saints, Hightown; St Michael and All Angels, Castleford

Note by Joanna Chandler-Clarke

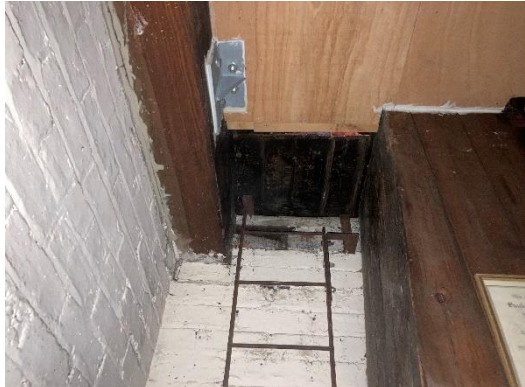
1
C	Access into the belfry through the floor hatch is tight and difficult. Consideration could be given to improving access through a wider opening and more handrails.

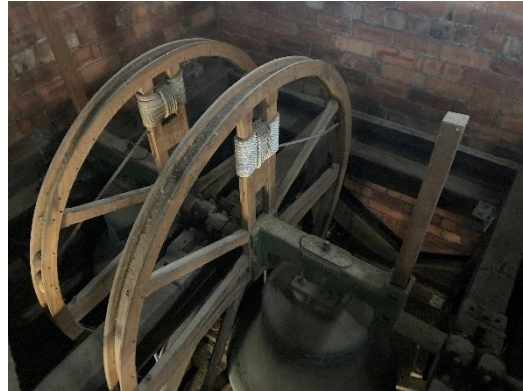
Obs Timber solid bell frame supporting 3 bells rung in good order with no sign of beetle attack. Bells made by Hayward Mills of Nottingham and recently overhauled prior to the last QI, reported to have come from All Saints Parish Church.

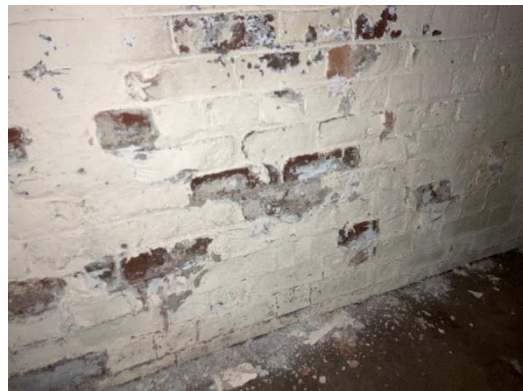
B Ringing Room and Clock Room
There is failed paintwork and brick efflorescence to a section on the north wall. This corresponds approximately to where the valley is, and addressing the issues with this valley should be the priority. The salting should be brushed off the wall and area kept under observation

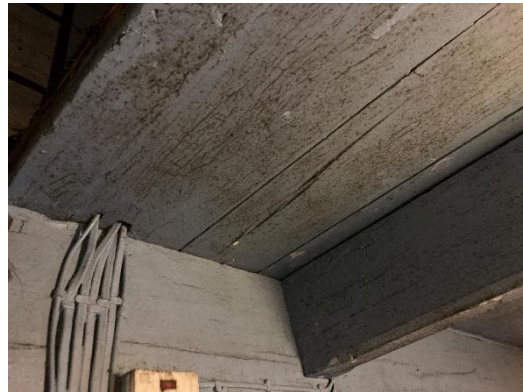
C Entrance Porch
Mould forming on painted boarded ceiling which should be cleaned off an area kept under observation.

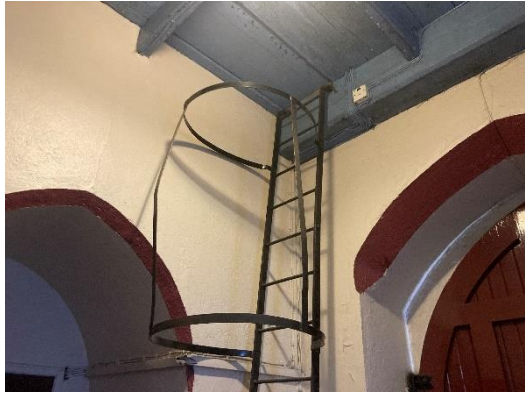
Priority	Description	Photograph	Costing Band
B	Metal access ladder to ringing room is loose and requires refixing and strengthening.

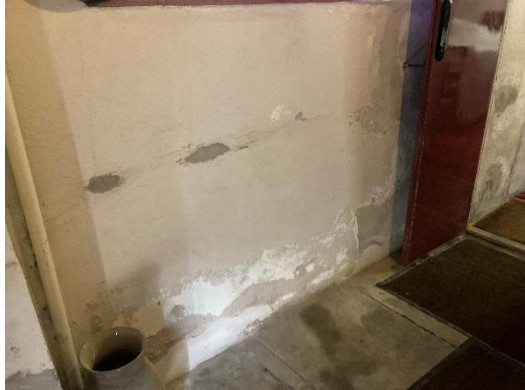
1
C	The walls to the entrance porch have all been rendered in a cementitious render painted with a non-breathable finish. This is exacerbating damp issues which are now widespread within the space. The render should be fully removed back to sound masonry and the area fully replastered in lime.

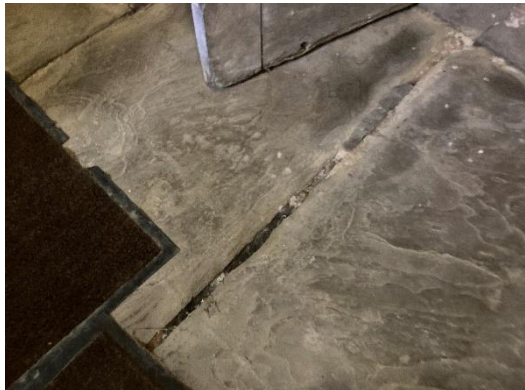
2
C	There are a number of open joints to the stone flagged floor which should be repointed in lime mortar.

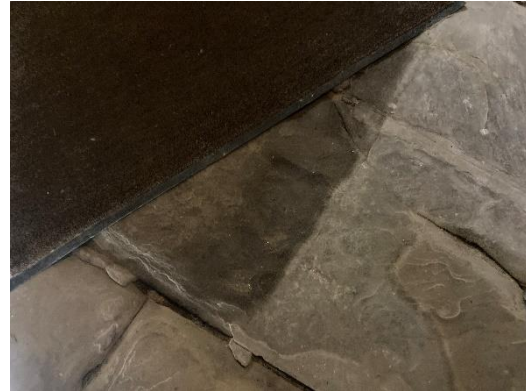
The current plastic backed entrance mats within the space are allowing damp to form beneath them. They should be removed and/or replaced with a breathable carpet.

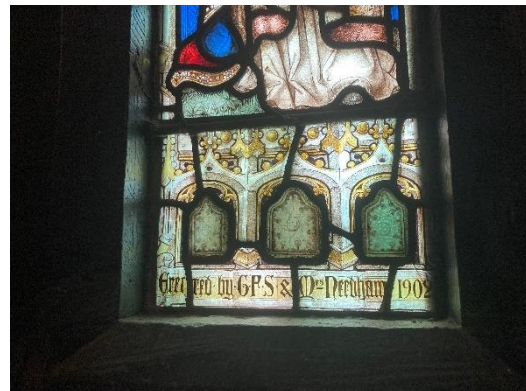
The saddle bars to the stained glass windows are rusting and should be re-decorated. The copper ties to the glass are intact and in acceptable condition.

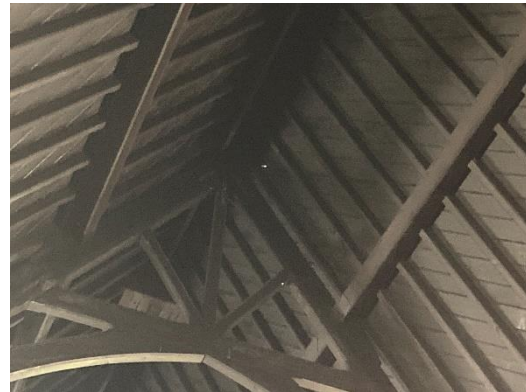
Nave
There is a small gap between the sarking boards and daylight is visible. This should be rectified by addressing the roofing defects described earlier.

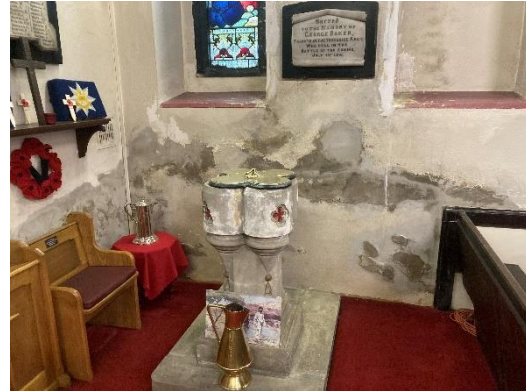
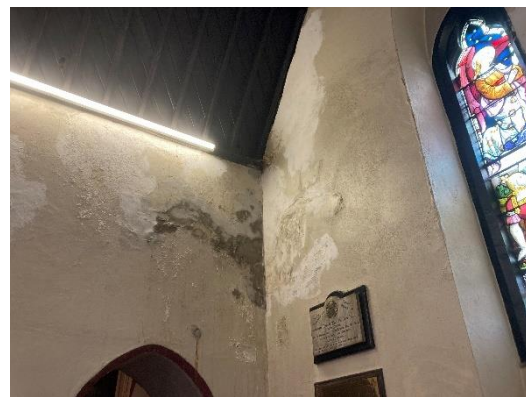
There are widespread areas of damp and patched plaster repairs, some of which correspond with external defects. The use of cementitious rendering and plasters internally is widespread exacerbating damp issues. While a large capital outlay, it is advised that all internal plaster to the Nave is removed and replastered in lime.

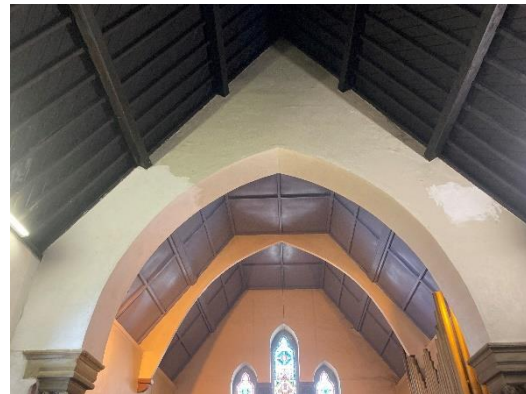
There are areas of recently plastering to the Chancel arch which correspond with areas of high level water ingress through the coping stones and East Nave gable. These areas should be kept under observation for signs of future water ingress.

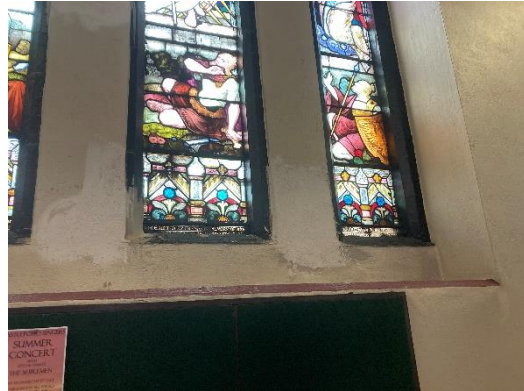
The saddle bars to the stained glass windows are rusting and should be re-decorated. The copper ties to the glass are intact and in acceptable condition.

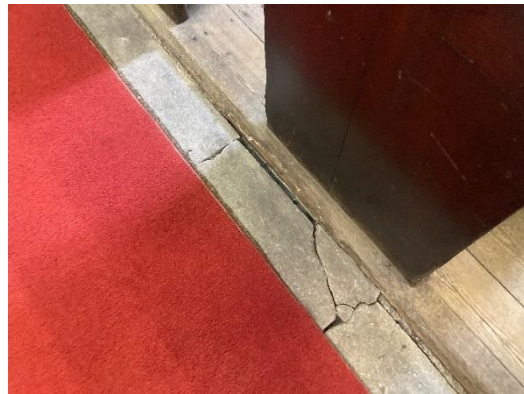
To the suspended flags down the aisle, there is two that are broken and rocking in position which could be reset with broken flags replaced.

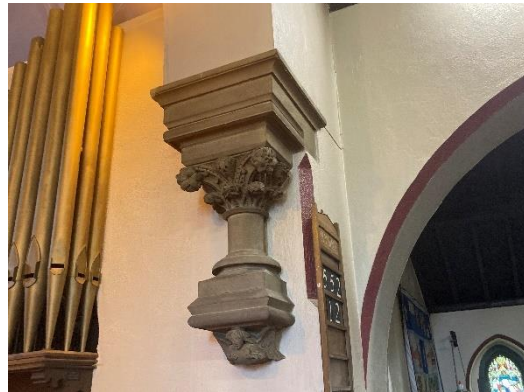
Despite the widespread damp at low and high levels, the decorative stonework to the columns and corbels are in very good, crisp condition.

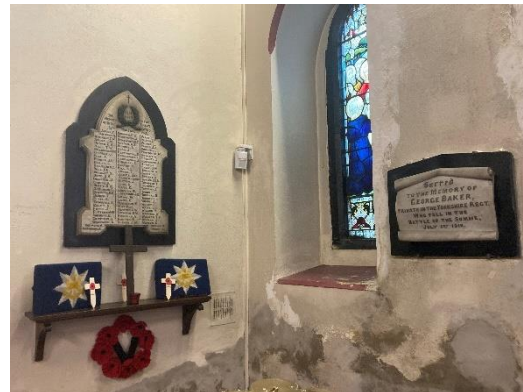
Obs Monuments (Nave)
The stone Thomas William Ball memorial to the West Wall is in good condition.
The Walter Hepworth, brass on wood, monument is also in good condition.
Plaque to the Great War in good order.
The memorials to George Bakr and Captain Wormald are also in good condition.

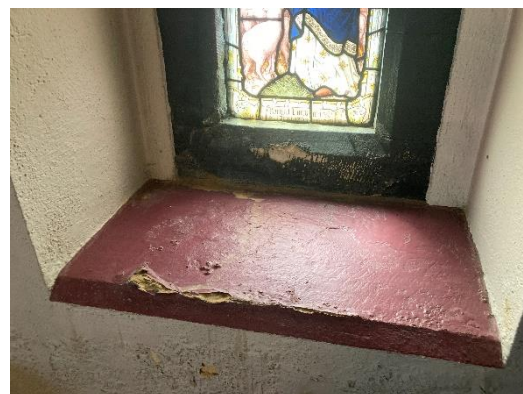
B South Aisle
There is stone decay to the window surround stones and the stones sill of these South aisle window. This issue has been exacerbated by cementitious render and non-breathable decorative finishes. The render and paint finish should be fully removed an area inspected for further decay.

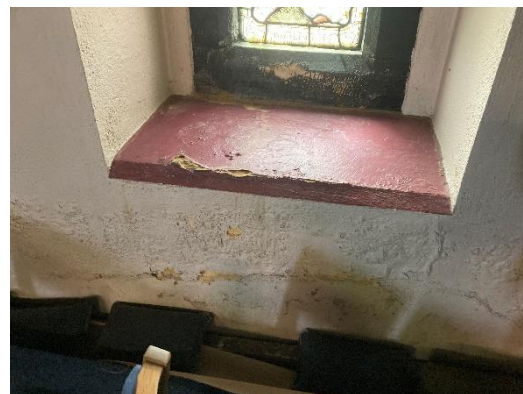
C Use of cementitious rendering and plasters internally continues and is exacerbating damp issues. While a large capital outlay, it is advised that all internal plaster to the South Aisle is removed and replastered in lime.

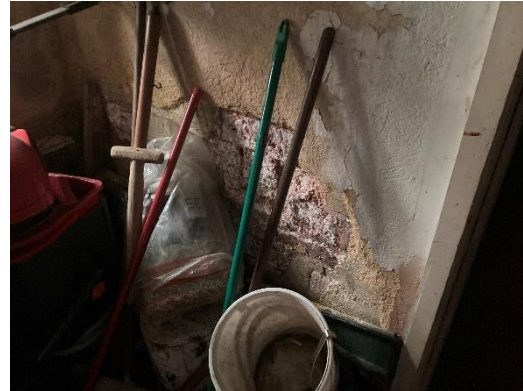
Boiler/Heating Room
Area of plasterwork decay to the wall of abutting the tower with brick salt starting to come through. The plaster work on the remaining walls is in a poor condition and the room should be stripped back to sound masonry and re plastered in lime.

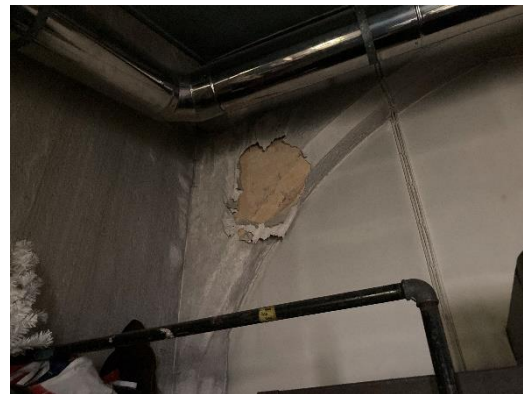
There is some peeling and failure of the paint finishes to the blind arcade and there is some decay of stonework beneath. All paint finish should be removed and lime wash applied, with allowance for further lime plastering.

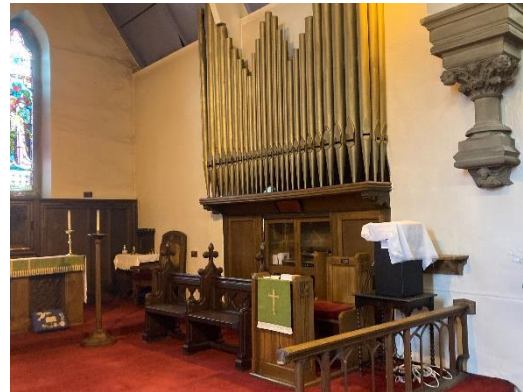
Chancel
Walls generally in better condition than the Nave and entrance porch although they have still been rendered in a cementitious material and covered with a non breathable finish.

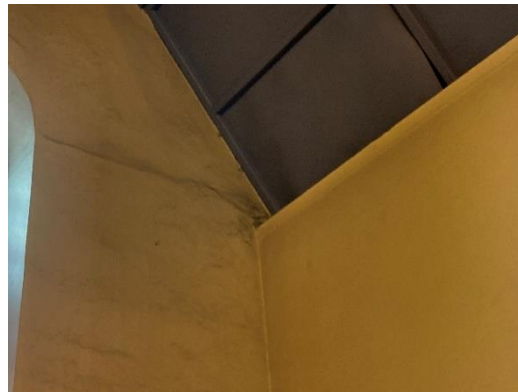
There are some small areas of damp and mould growth which corresponds with highlighted externally particularly to the southeast gable. Addressing the external defects in this area would start to mitigate issues although it would be beneficial to remove the existing plaster and replaster in lime with a breathable decorative finish.

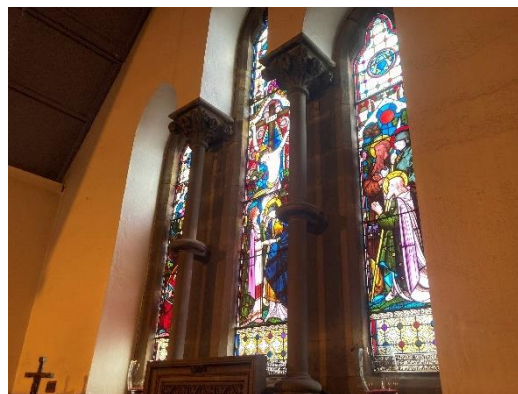
Some of the panels to the stained glass are deforming slightly and 1 of the panels to the central window has become detached from its ties. This should be re-fixed by a specialist glazier.

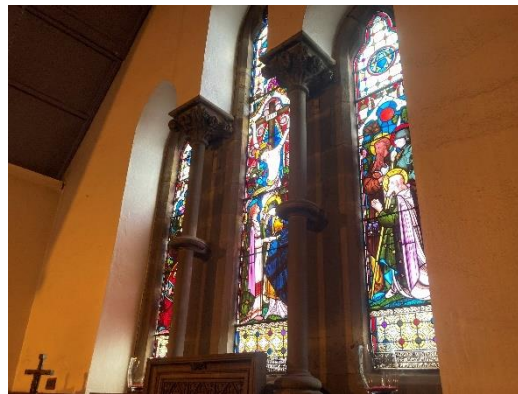
The decorative stonework to the windows are in very good, crisp condition.

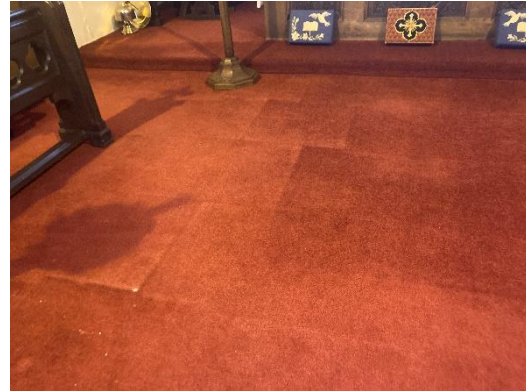
C There are some loose flagstones to the chancel floor and sanctuary step and they should be re-bedded.

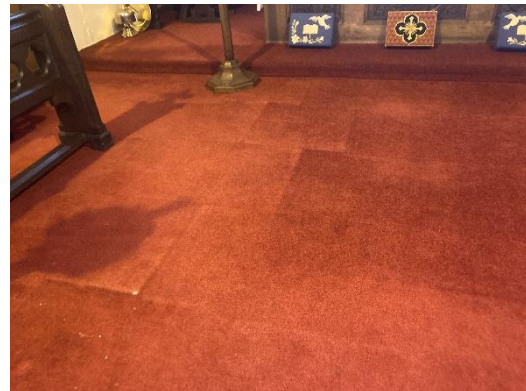
C The carpet, while in good condition, should be removed to help manage damp issue and aid moisture control within the building.

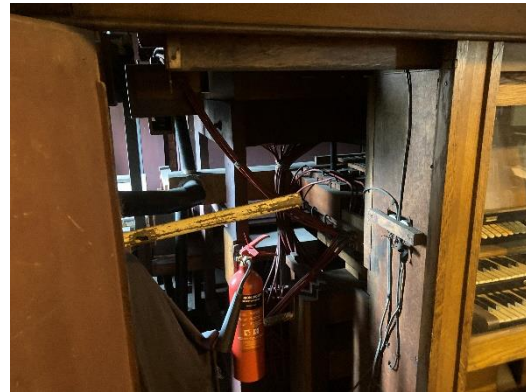
Obs Organ Chamber
The organ itself occupies much of the space and access and detailed inspection difficult.

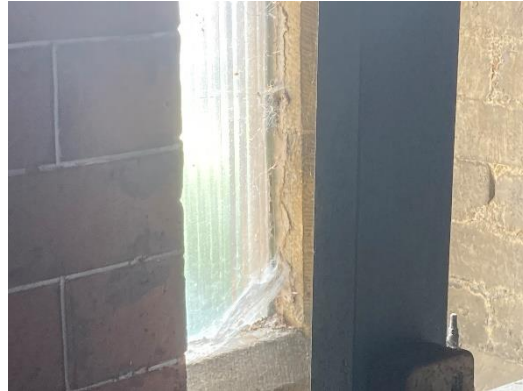
C There is some stone erosion to the interior of the windows on the east elevation, with loose material brushed off for more detailed inspection of the stonework condition.

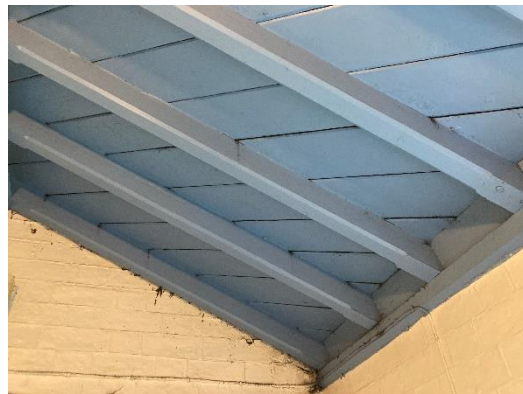
Obs Vestry
There are some isolated areas of water drips which should be kept under observation,

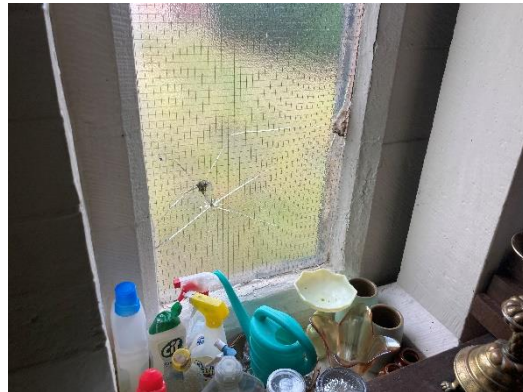
C There is some cracking to the wired glazing and the glazed unit should be replaced, in conjunction with other windows repair items.

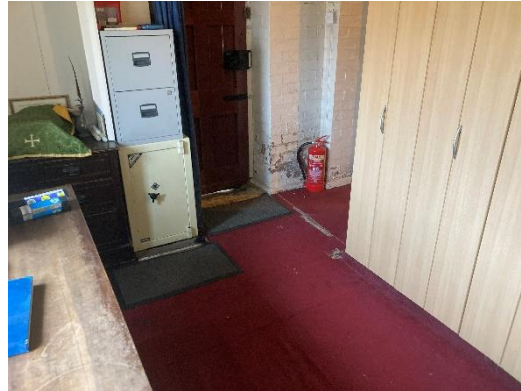
The painted brickwork walls have been covered in a non breathable material ,and there are some areas of failing paint and damp penetrating through particularly at low level. It would be recommended to strip all of the walls of their finish and allow for sufficient drying time before decorating in lime wash.

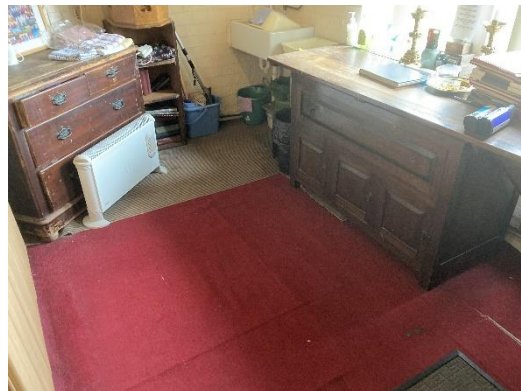
The carpet is in a worn condition and should be replaced for a cosmetic improvement. It was not possible to inspect the condition of the substrate beneath.

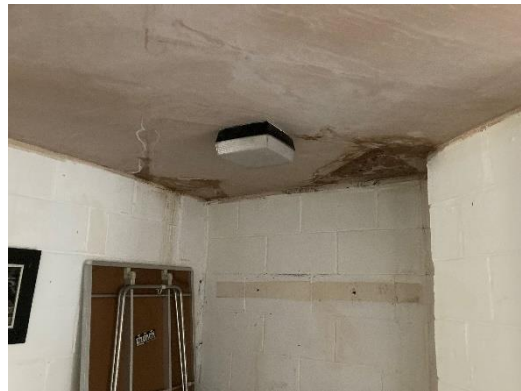
Hall - Entrance Lobby
Generally, in fair condition for type and age of construction. There are water stained areas of the plaster and new areas of ceiling patched in. It would be recommended to address roofing defects before replastering this space.

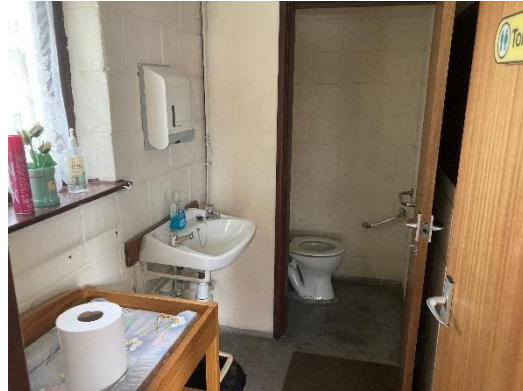
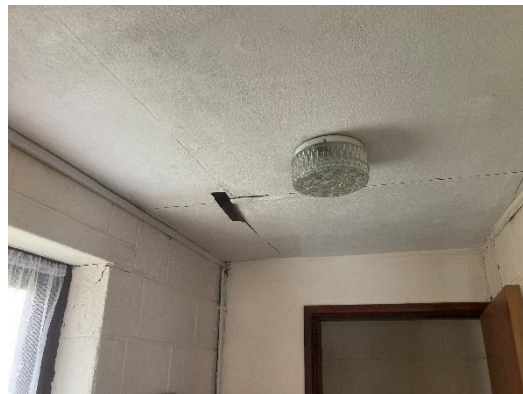
Female Toilet

The ceiling is in poor condition and patched with tape. While the toilets are functioning, it would be beneficial to overhaul them for a cosmetic improvement.

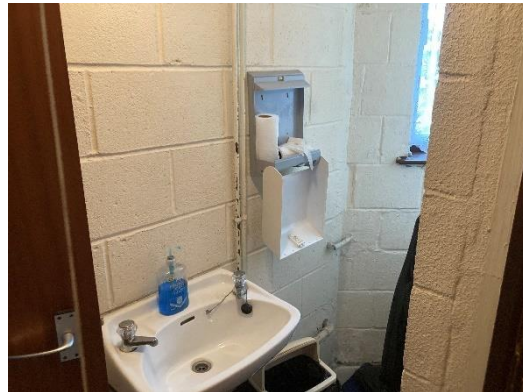
Male Toilet

The toilet and facilities are functioning but would generally benefit from an overhaul to improve their appearance.

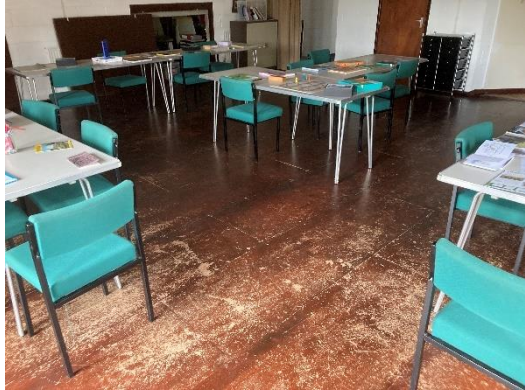
Priority	Description	Photograph	Costing Band
D	<p>Main Hall</p> <p>The main hall is in satisfactory condition generally for the type and age of construction, although it would benefit from a general overhaul and decoration.</p>	 	2
D	<p>The floor to the main hall is worn and consideration is to be given towards replacing for a cosmetic improvement.</p>

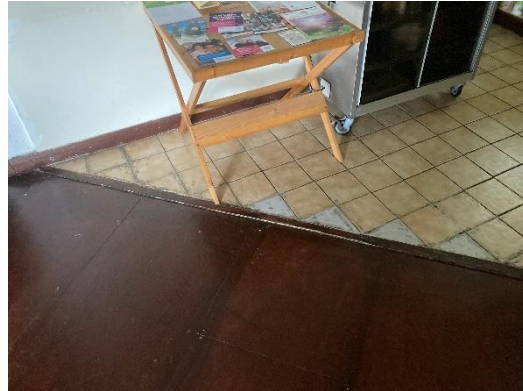
There is a loose transition strip between the Main Hall and Kitchen, which should as a minimum be fixed in location to avoid a trip hazard.

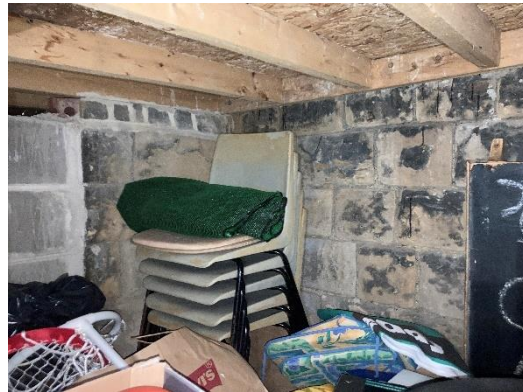
Storage off Main Hall
The storage extension which abuts the Nave of the church is satisfactory, and dry despite the condition of the roof above. This area should be kept under observation.

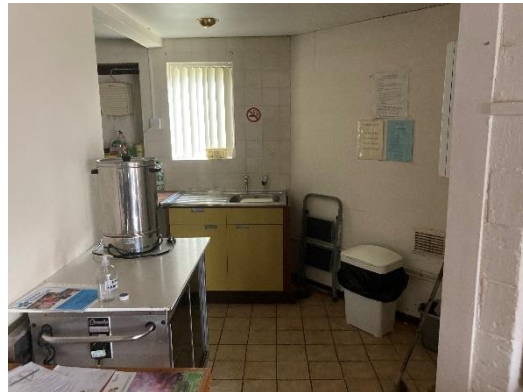
Kitchen
The kitchen functions and is operational although, like other areas of the Hall, is tired and would benefit from overhaul, modernisation and improvement.

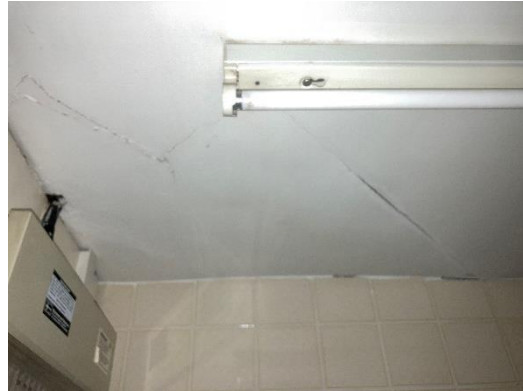
D Towards the rear of the kitchen is a series of cracks to the ceiling, which should be filled and redecorated, or replastered as part of a wider programme of modernisation.

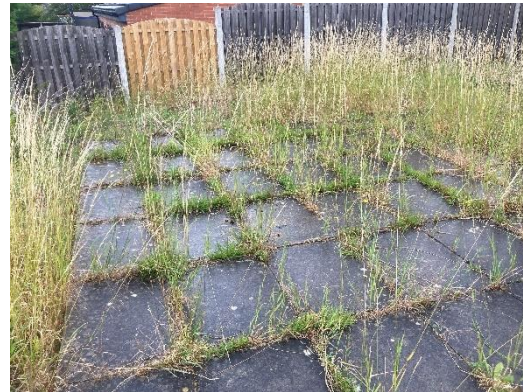
D Paths
A paved area to the rear of the hall is overgrown and requires vegetation clearance before cleaning of the slabs, and joints pointed.

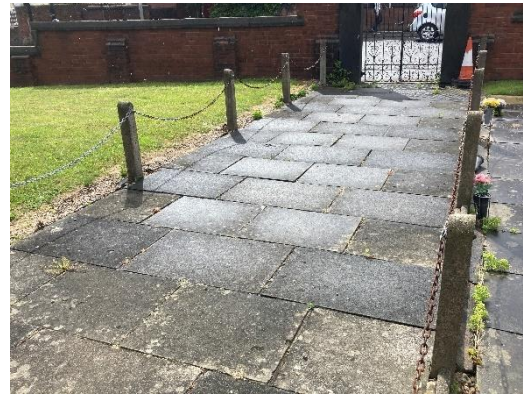
B There are a number of raised and displaced paving slabs on the entrance path. These should be re-bedded and joints pointed to eliminate trip hazards.

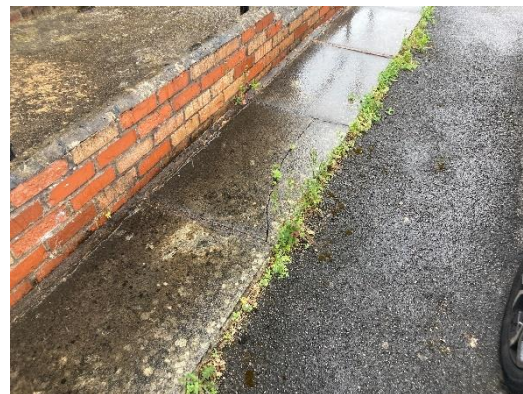
D There is a cracked paving slab and vegetation growth joints generally to the paving adjoining the Hall ramp. The joints should be raked out and cracked paving slab replaced.

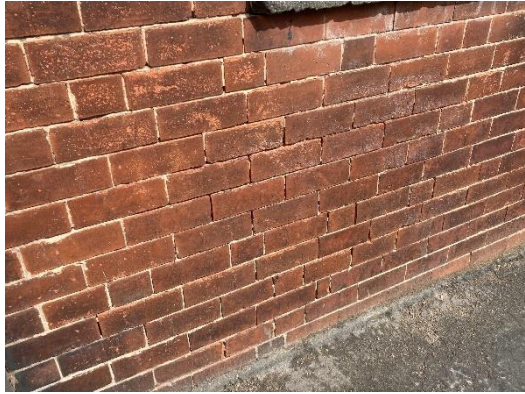
Priority	Description	Photograph	Costing Band
C	<p>Boundaries</p> <p>The boundary wall to the South of the Church has recessed joints which should be repointed in lime mortar. Some of the joints to the coping stones are also recessed and these should be repointed at the same time.</p>

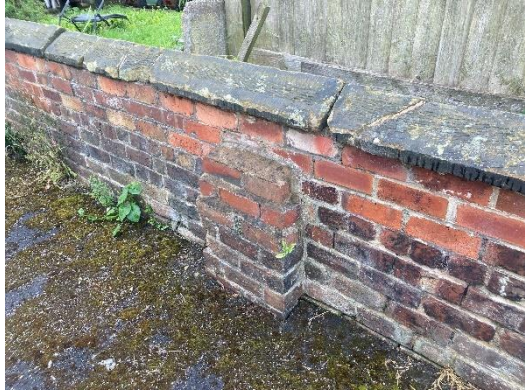
1
C	<p>The boundary wall to the East is in poor condition, having been repointed with cement mortar and having open joints to the coping stones. This wall should be fully repointed in lime mortar, along with the coping stones.</p>

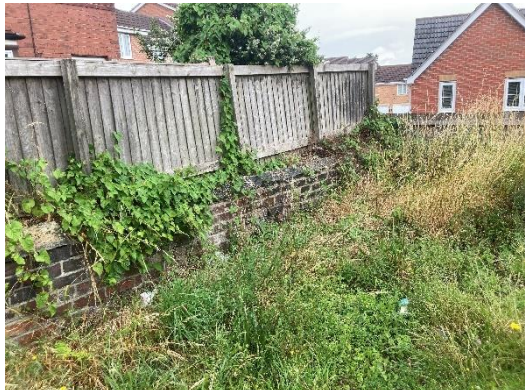
2
D	<p>There is vegetation growth to the North West corner of the site which prevents a clear inspection of the wall. This should be cleared with wall repointed as the above recommendation.</p>

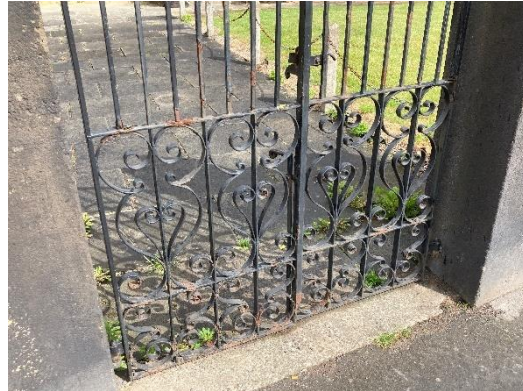
D Gates
Pedestrian gates would benefit from re-painting within 12 months.

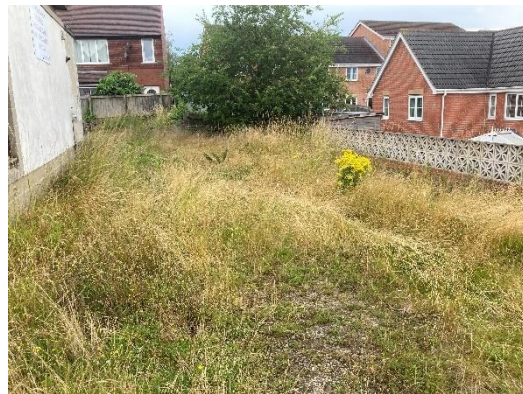
D Generally
The land to the rear of the hall is generally overgrown and would benefit from clearance.

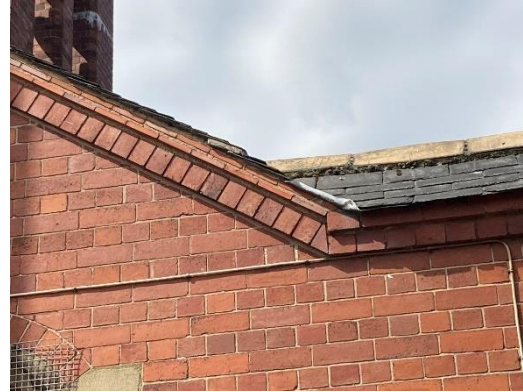
D *North Slope – Nave, Aisle and Chancel*
 The verges have been pointed in cementitious mortar which is cracking in places, particularly at the eaves and gutters. This should be repointed in lime mortar.

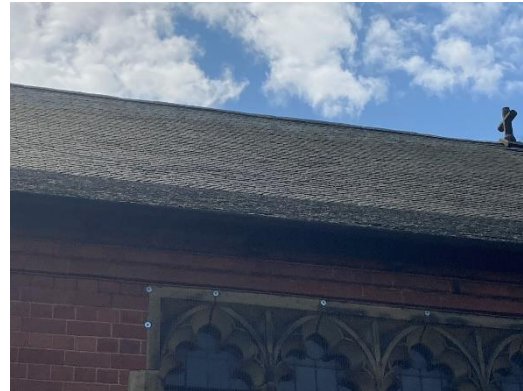
Obs The ridge appears to be in satisfactory condition from ground level inspection.

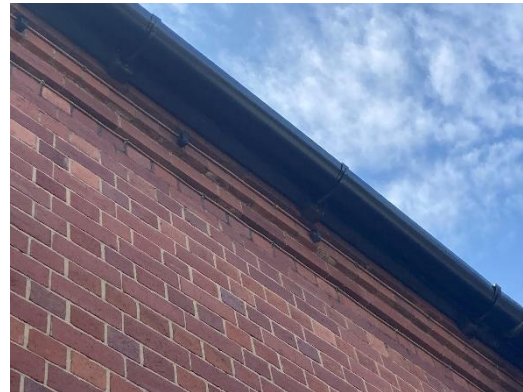
B It was not possible to inspect the gutters during the inspection due to their location, but they should be cleared out seasonally as part of a maintenance strategy.

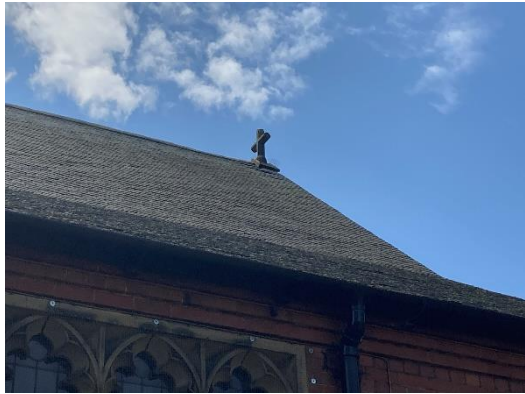
Priority	Description	Photograph	Costing Band
B	There are some disturbed slates adjacent to the cross which should be re-fixed back into position and two missing slates centrally which should be replaced.

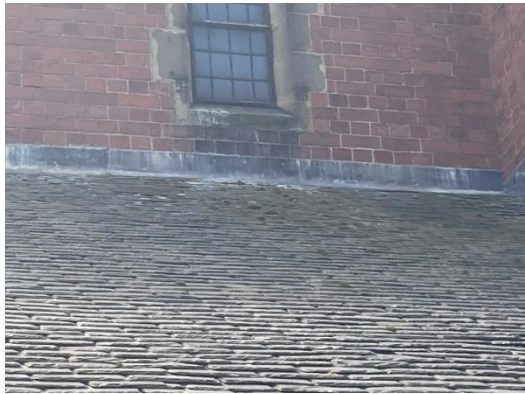
1
B	<i>Lady Chapel</i> There are a number of missing slates adjacent to the clerestory and a slipped slate adjacent to the Nave gable which should be replaced. There are also a number of slates with corners missing.

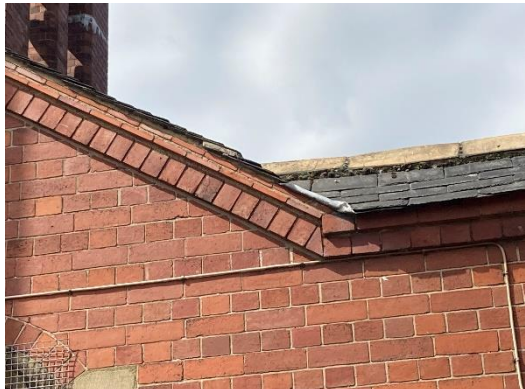
1
D	Cementitious verge pointing has been used which is cracked and should be replaced.

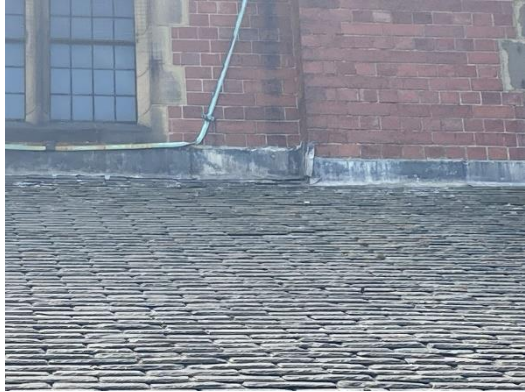
Priority	Description	Photograph	Costing Band
C	There is a small build-up of moss to the brick below the bellcote window which should be removed.

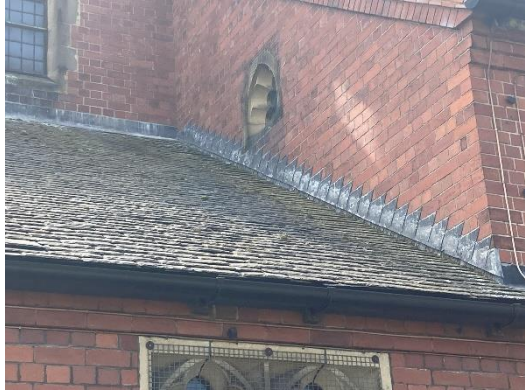
1
C	The lead flashing is in poor condition with an area of dislodged flashing to the corner of the bellcote. Consideration should be given to renewing with a suitable material.

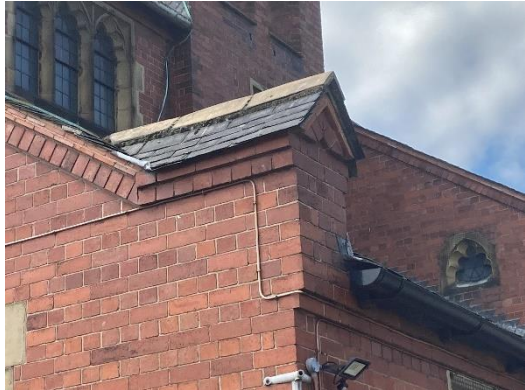
1
C	There is moss to the ridge pointing of the gablet which should be removed.

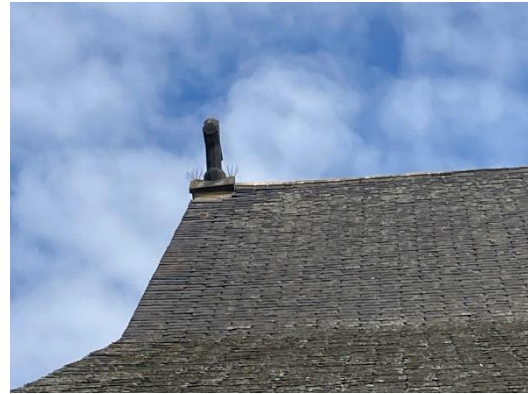
There is one missing slate to the Aisle to the west near the eaves which should be replaced.

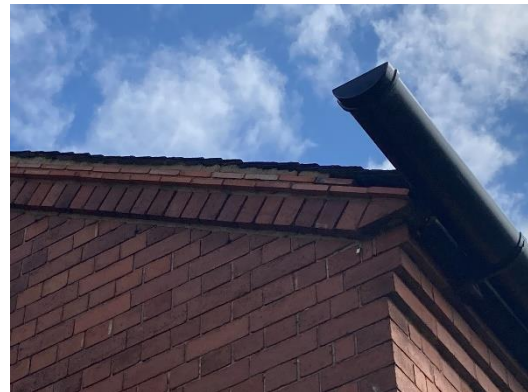
There is missing creasing pointing to the West Gable end, close to the eaves which should be repointed.

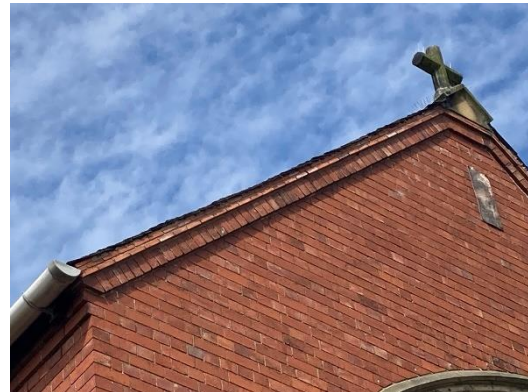
There appear to be some open joints near the cross on the Eastern Gable which should be repointed.

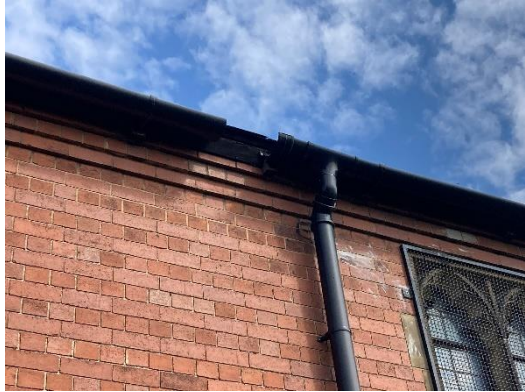
Priority	Description	Photograph	Costing Band
A	There is a missing section of gutter to the South Aisle which should be reinstated.

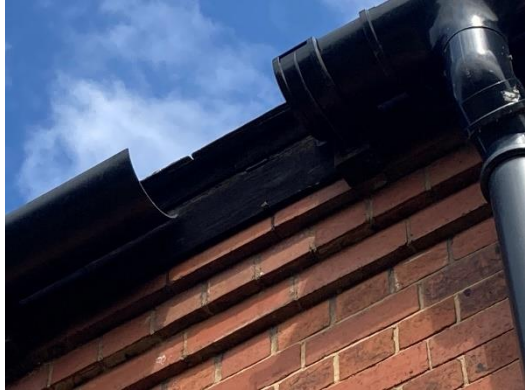
1
D	The fascia board to the South Aisle appears to be undecorated and should be redecorated.

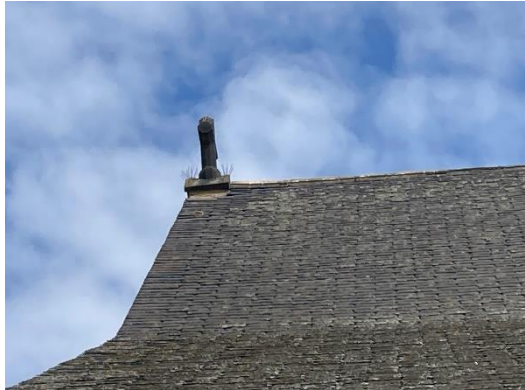
1
B	There are dislodged tiles to the cross on the west gable which should be reset in place.

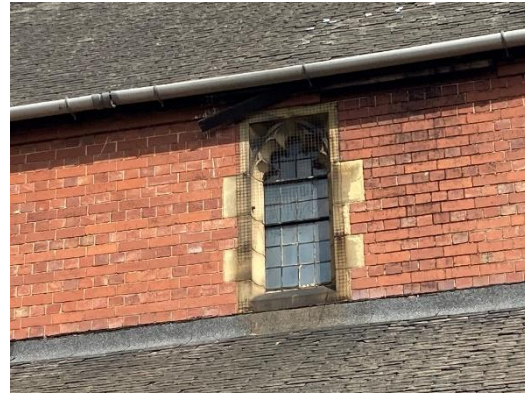
B There is a missing section of fascia board to the clerestory above the vestry. There is also a missing section of gutter adjacent to the missing area of fascia board.

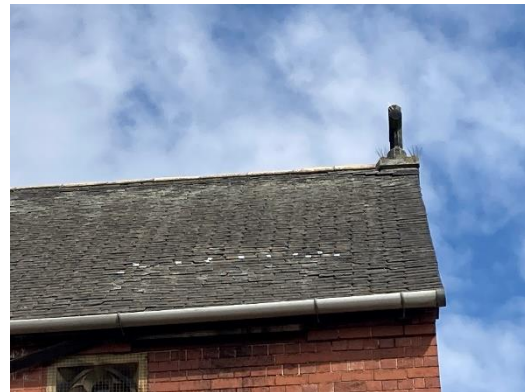
Obs An area of slates to the East Gable have been repaired with tingle strips.

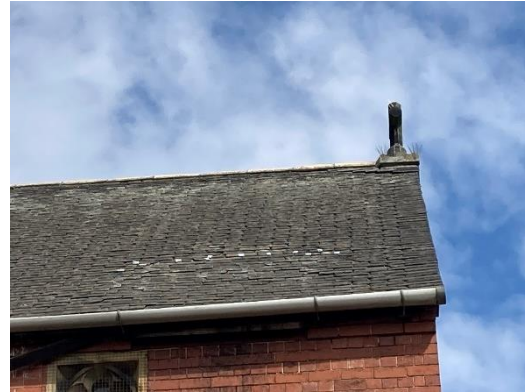
Obs The ridge appears to be in satisfactory condition from ground level inspection.

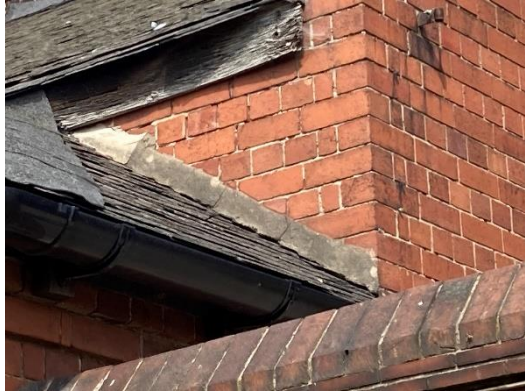
1
D	<i>Vestry</i> The fascia boarding at the southeast corner is completely rotten and should be replaced in new.

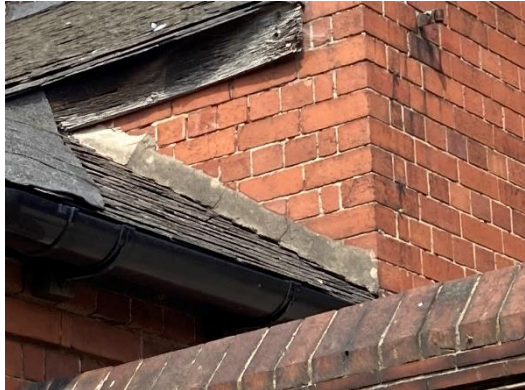
1
B	Replace failed mortar fillet with lead flashing.

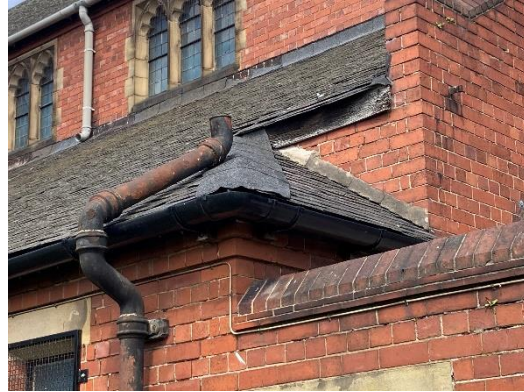
D There are sections of felt flashing that have slipped onto the roof and they should be re-fixed or replaced with a sympathetic material.

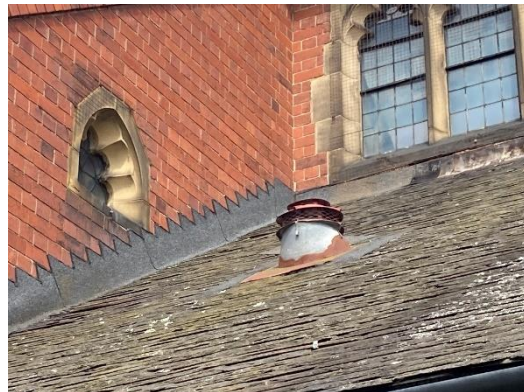
D There is significant rusting to the base of the flue, and this should be replaced.

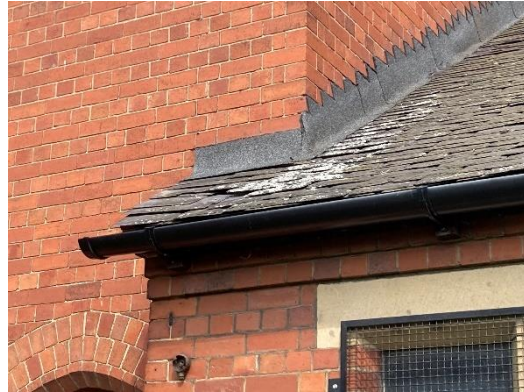
B There is a missing slate to the west of the vestry roof, which should be replaced.

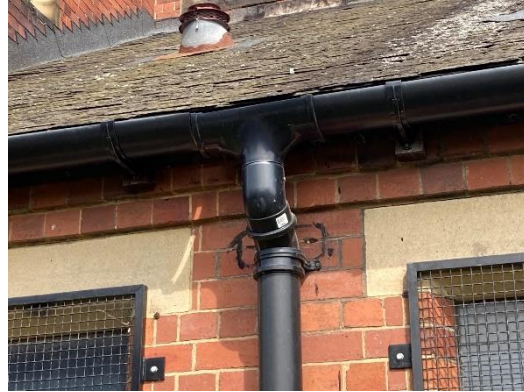
There is an open joint to the guttering which should be re fixed.

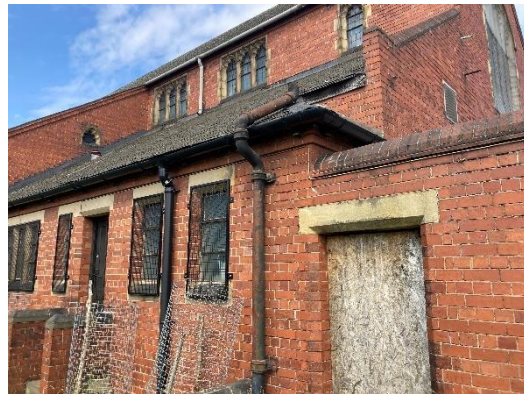
There is some decayed timber to the east end of the Vestry roof at eaves level which could be indicative of further timber decay, this should be investigated further.

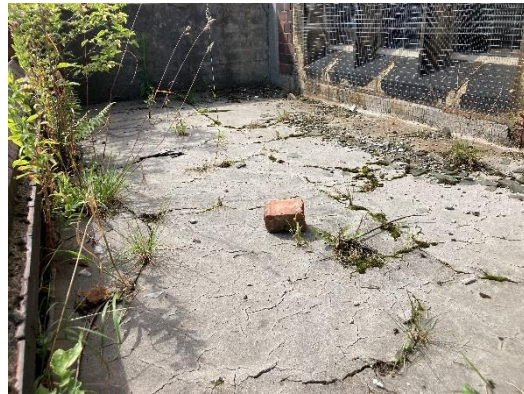
Boiler House

Covered in asphalt with brick parapet upstand walls. Generally in a very poor state. The previous QI noted that there has been discussion at PCC regarding demolishing this building.

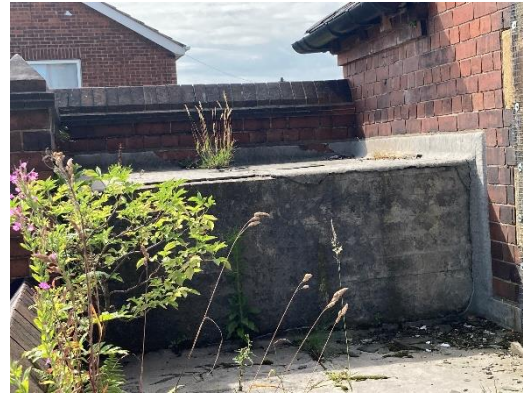
B The asphalt has completely broken away in areas and fallen off, particularly to the upstands of the higher-level roof where the asphalt upstands have come away to the parapet walls and at the junction with the Vestry roof. Vegetation is growing and the asphalt upstands on the lower roof gathering and peeling away. If the boiler house is to remain, the roof will require replacing due to water penetrating the fabric and affecting internal spaces.

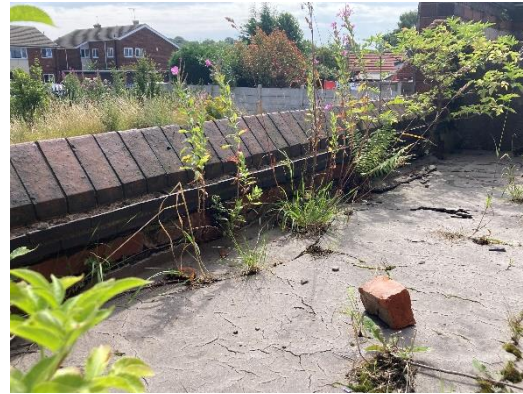
B There are a number of open joints and extensive vegetation growth to the parapet upstand walls; this should be removed.

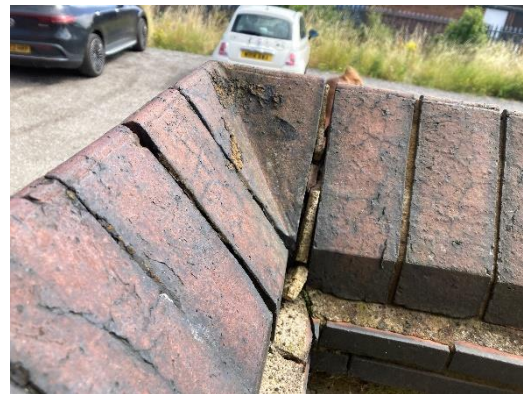
B The walls, the lower roof parapet and the brick copings should be repointed.

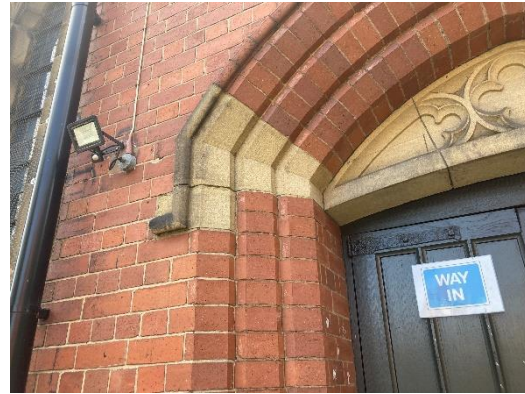
There is some sign of movement at the spring of the northwest door arch at the east. This should be kept under observation and the open joints repointed.

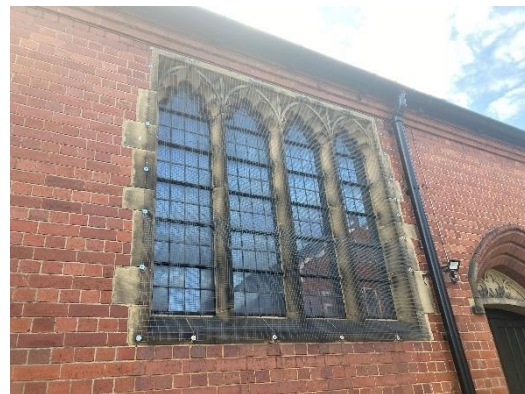
The steel guarding is rusting and should be replaced with a sympathetic option which is inset into the windows openings.

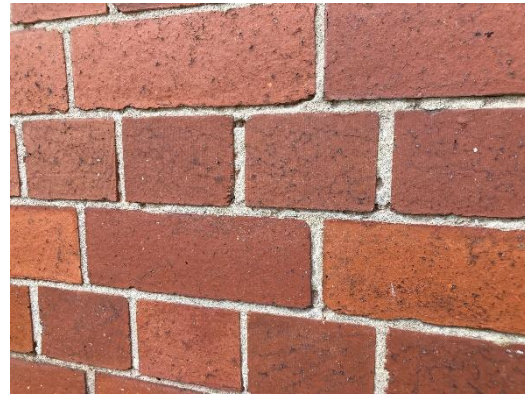
There is evidence of minor masonry bee infestation to the northwest which should be kept under observation.

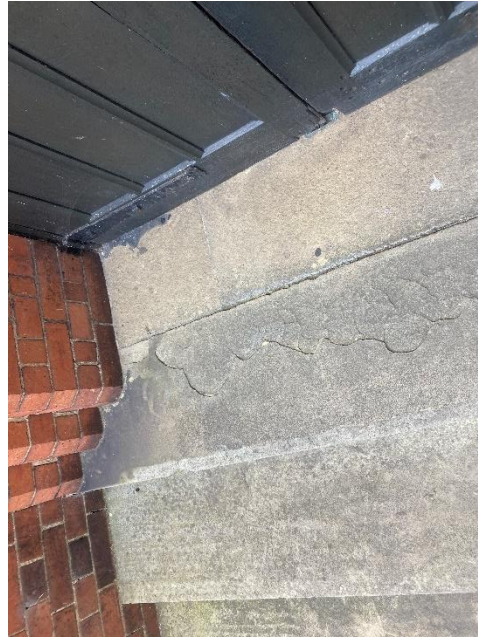
B Minor delamination to the top step of the northwest entrance door is causing a trip hazard. Consideration could be given to redressing the stone of the step to remove delamination.

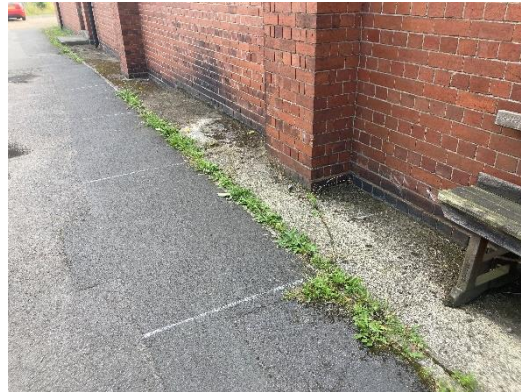
C The ground level has been built up towards the north, rising from the south, and the nature of the foundations is causing water to be held up at the base of the perimeter of the building. A first action should be to ensure all gulleys are free of debris and the underground drainage is getting water away from the building; a CCTV survey of the drainage may assist with this. Further remedial works could be to create a channel within the concrete to form a gutter and discharge rainwater away from the building.

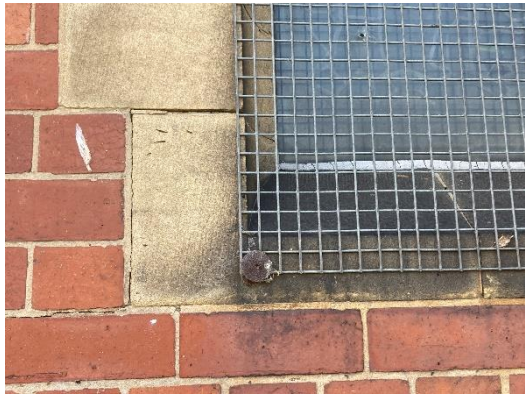
2
C	<p>There are small areas of open jointing to the east and west windowsills and to the west window east reveal. These should be repointed to stop rainwater penetrating the fabric below.</p>

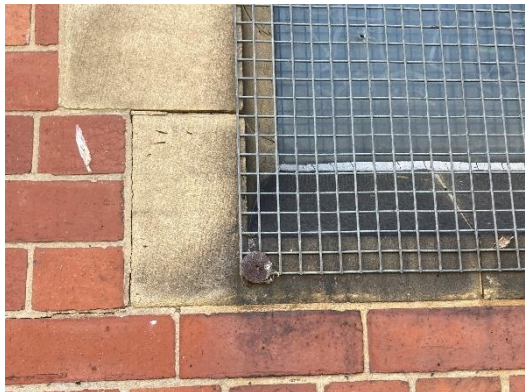
1
D	<p>The putty to all three windows of the Lady Chapel is in poor condition and should be replaced.</p>

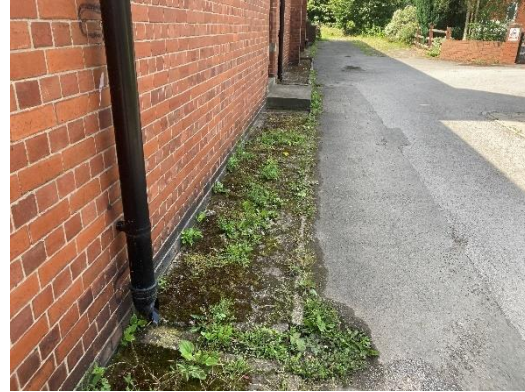
The gullies are full of vegetation which should be cleared out as part of an annual maintenance strategy.

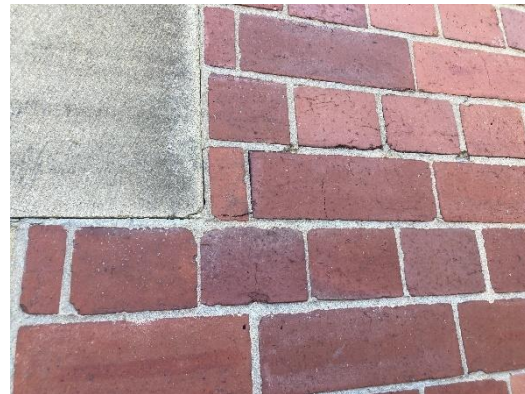
The building was originally constructed in a cement lime mortar and has been later repointed with cementitious mortar, which is generally in fair condition, but is showing some signs of cracking.

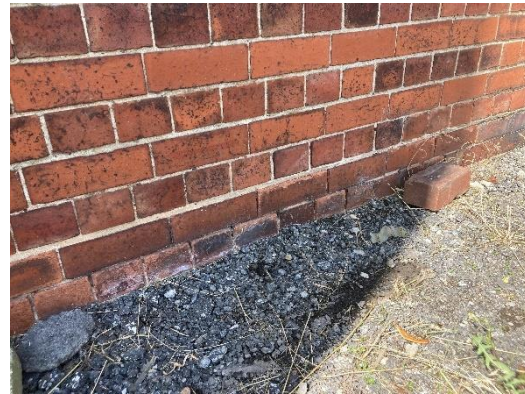
Lady Chapel – East Gable
There is open jointing at low level which should be repointed.

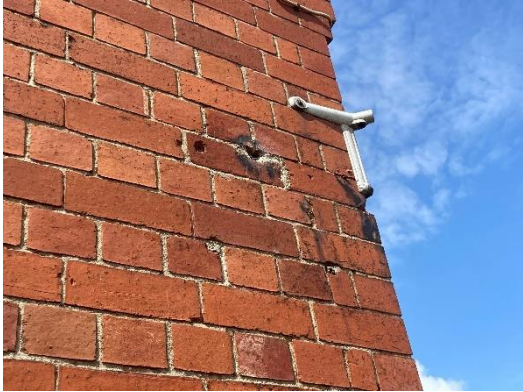
Priority	Description	Photograph	Costing Band
E	There are former fixing holes to the northeast corner that are unsightly. Consideration could be given to repoint if desirable.
