Church Commissioners
Mission, Pastoral and Church Property Committee
Mission and Pastoral Measure 2011

The parish of Castleford: the churches of St Paul, Glasshoughton; All Saints, Hightown; St Michael and All Angels, Castleford

Note by Joanna Chandler-Clarke

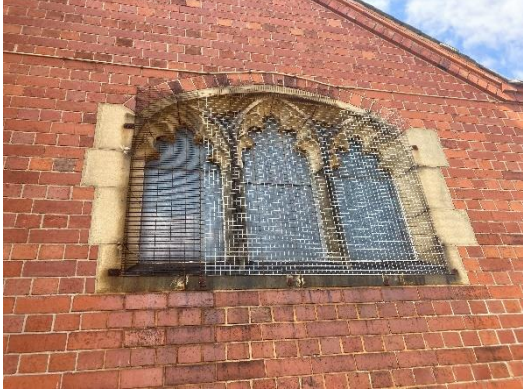
1
D	The putty to all windows should be renewed.

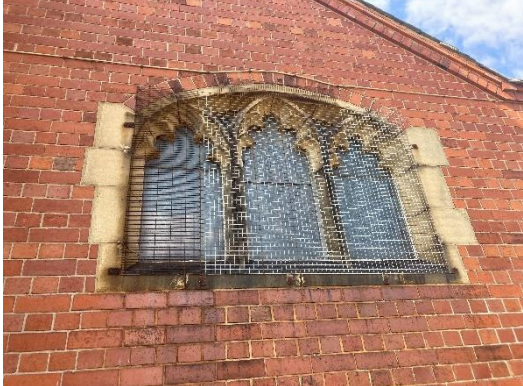
1
D	Minor rusting and corrosion to the ferramenta of the windows should be re-decorated.

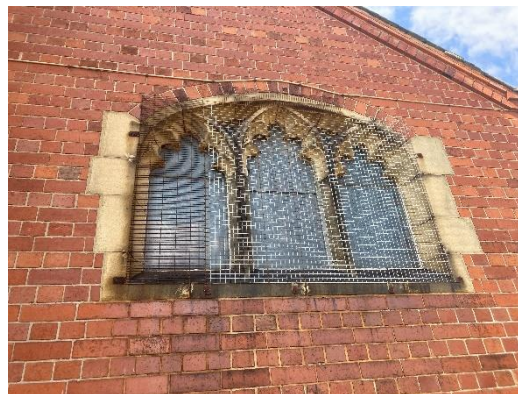
D The window guarding is corroding, and starting to fail. This should be replaced with an alternative type of window guarding which is inset into the reveals of the 3-light window.

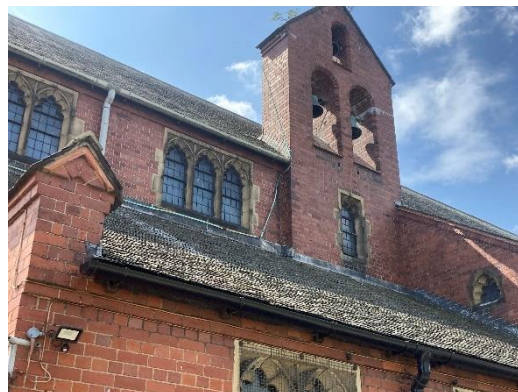
E *Chancel, Clerestory and North Elevation*
The lightning cable is haphazardly routed across the building. Consideration could be given to rerouting if desirable.

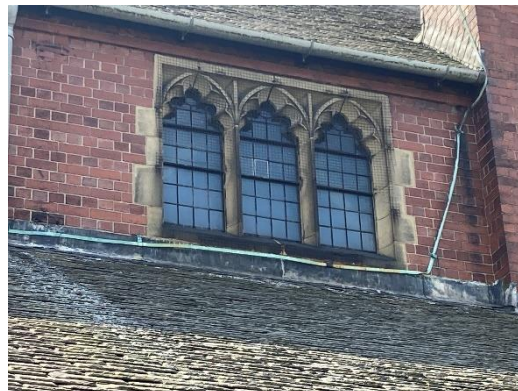
D The steel guarding to the two clerestory windows is disintegrating; this should be replaced in stainless steel powder coated which should be inset to the windows and quatrefoil opening.

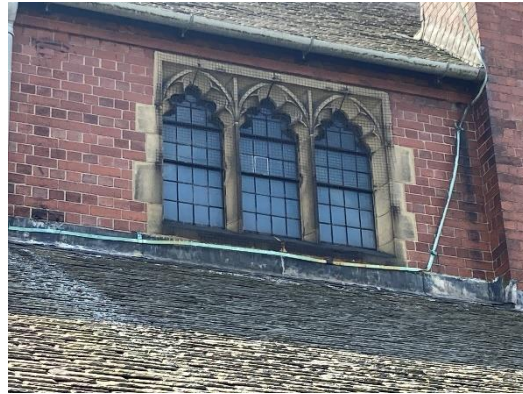
D Minor rusting and corrosion to the ferramenta of the windows should be re-decorated.

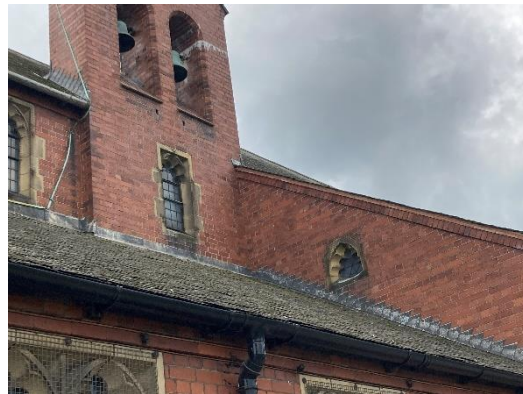
D *Bellcote*
Minor rusting and corrosion to the ferramenta of the windows should be re-decorated.

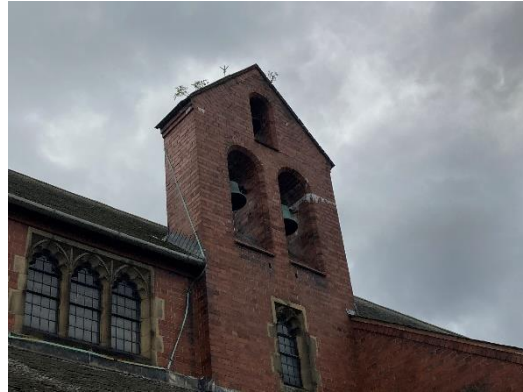
D There is an area of open jointing to the high-level brickwork including the bell openings. This should be repointed. Consideration to repointing the whole of the belfry when the scaffolding is in place would be advisable. The condition of the South elevation of the bellcote could not be assessed as it was out of view, but it can be assumed that there will also be open jointing to this elevation which will require repointing.

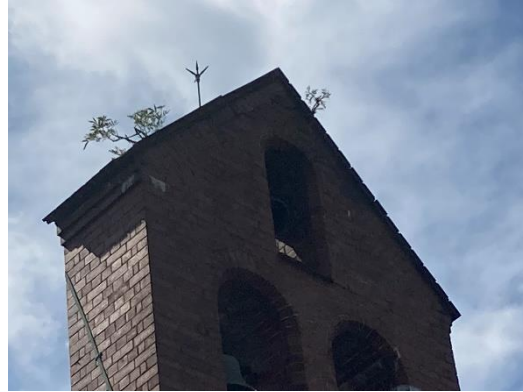
C There is vegetation growing on the roof coverings and copings, which should be removed when the wall repointing is done. All coping stones should be repointed.

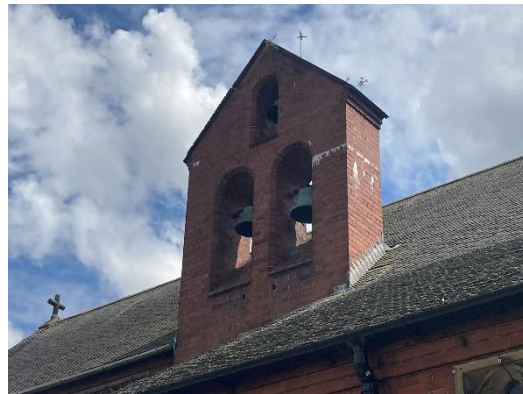
C A fracture was observed running through the tiles and eaves brick course. This was also identified in the last two inspections and is likely to be caused by iron in the masonry. This will require removal; partial dismantling of the masonry and the whole of the roof will require retiling. This should be done with the wall repointing.

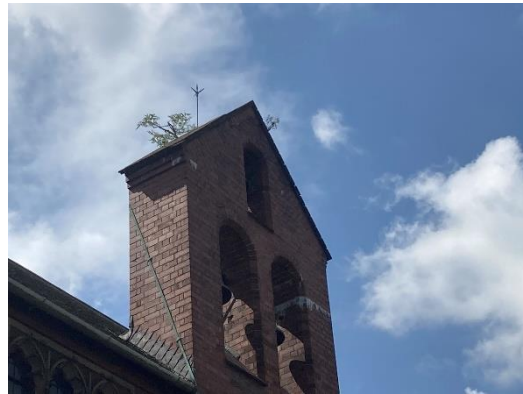
Obs There are brick salts to the two larger openings which should be brushed off and the area kept under observation.

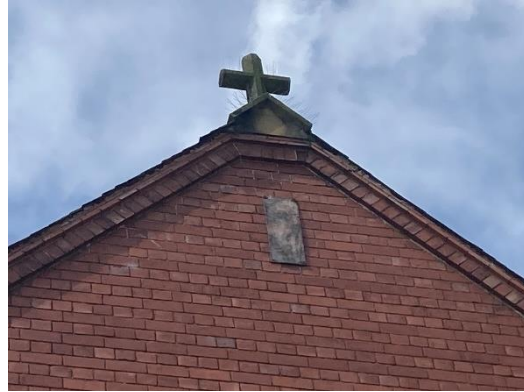
Obs *Chancel East Elevation*
There is a presumed small opening at high level which is boarded up, this should be investigated and ideally opened up to provide ventilation to the roof void.

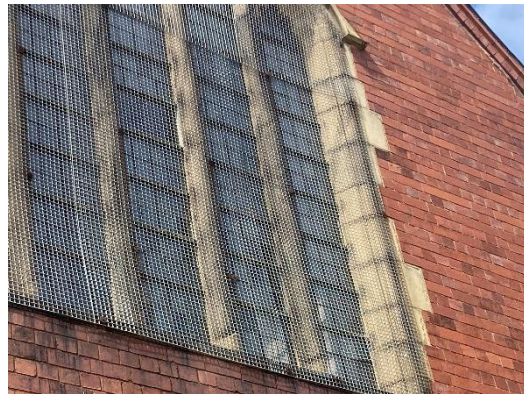
D The steel guarding appears to have been replaced since the previous inspection. It would be preferable to be mounted inset to each of the window reveals.

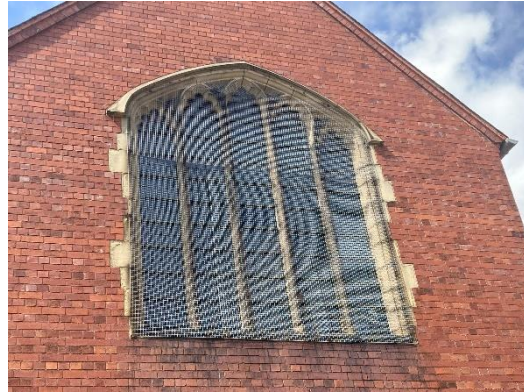
D Minor rusting and corrosion to the ferramenta of the windows should be re-decorated.

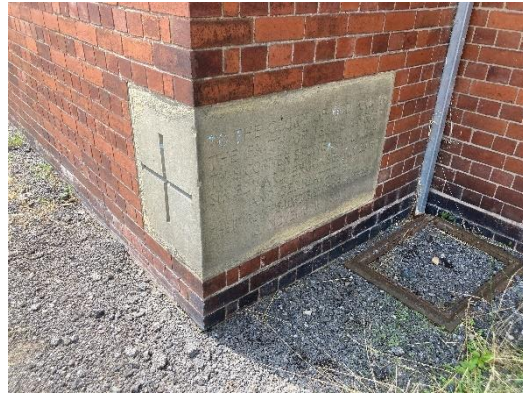
Obs The cornerstone to the north is showing signs of delamination. This should be kept under observation to help understand the rate of decay.

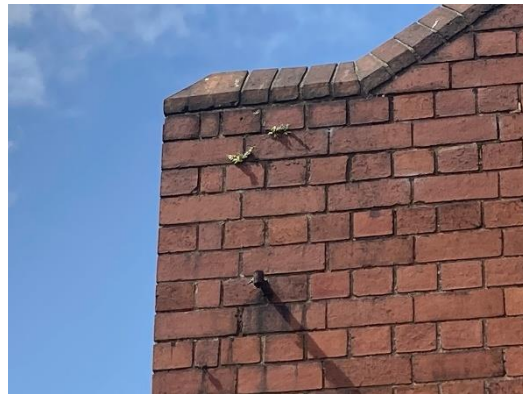
B *Vestry – East Elevation*
There is vegetation starting to take hold adjacent to the gable brick copings which should be removed, open joints repointed, and the area treated with herbicide. The copings to this upstand would also benefit from repointing at the same time to stop any moisture getting into this vulnerable area.

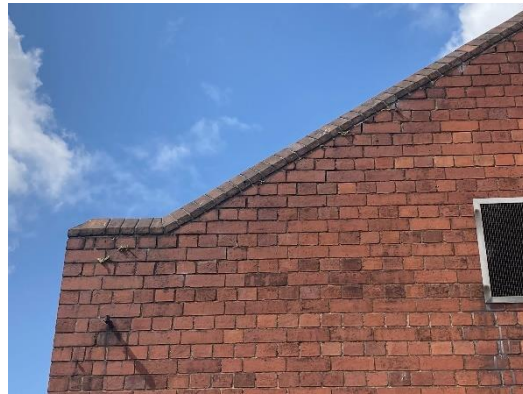
C There is an old iron fixing to the South just below the coping which should be removed as it is starting to fracture the brickwork. A stepped fracture is developing.

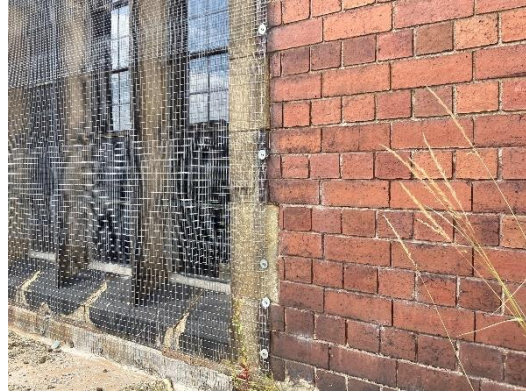
D Carried forward from the previous inspection, there is a small area of open jointing to the north of the window at low level and there are a number of fine open joints where the brickwork meets the stonework of the window. These should be repointed in lime mortar.

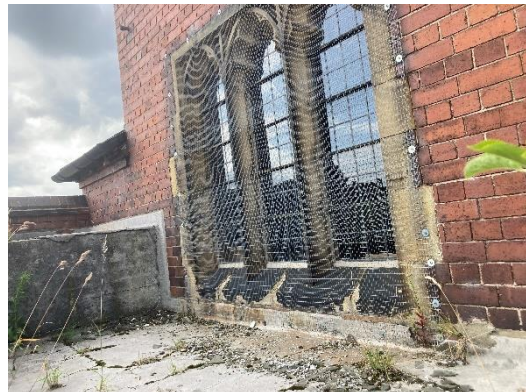
D The steel guarding appears to have been replaced since the previous inspection. It would be preferable to be mounted inset to each of the window reveals.

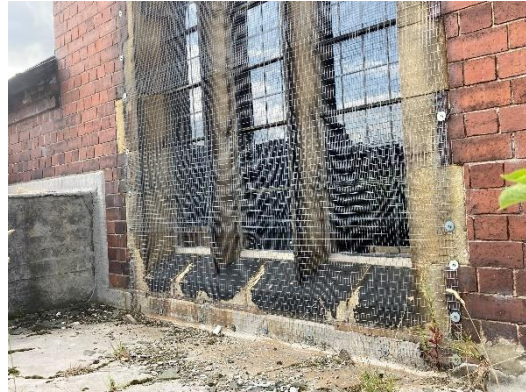
D Minor rusting and corrosion to the ferramenta of the windows should be re-decorated.

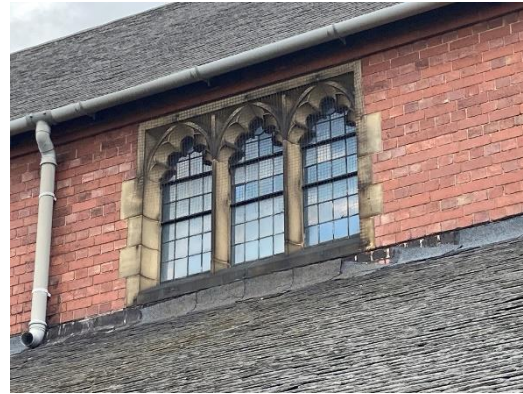
Chancel South Clerestory

Bitumen has been used to repoint one of the windowsills. This should be raked out and repointed in lime mortar.

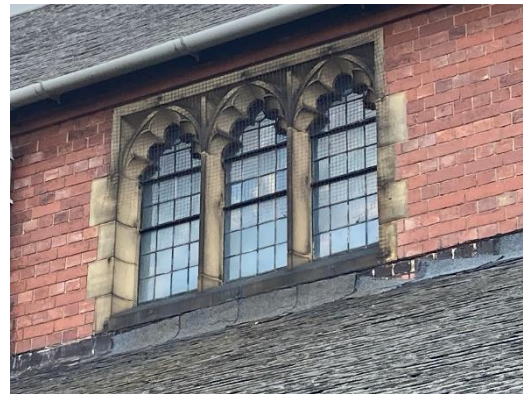
Below the section of missing fascia board there is bird guano. This could be indicative of birds nesting within the roof void. Further investigation is needed.

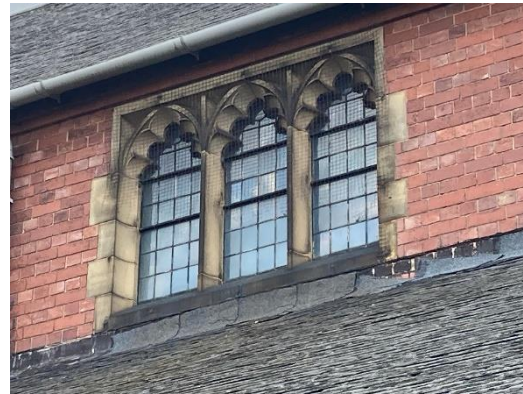
The steel guarding to the two clerestory windows is disintegrating; this should be replaced in powder coated stainless steel which should be inset to the windows and quatrefoil opening.

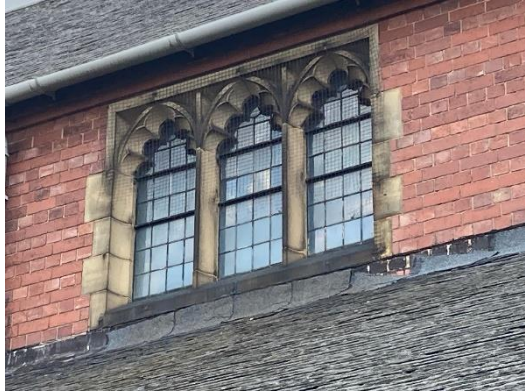
Priority	Description	Photograph	Costing Band
D	Minor rusting and corrosion to the ferramenta of the windows should be re-decorated.

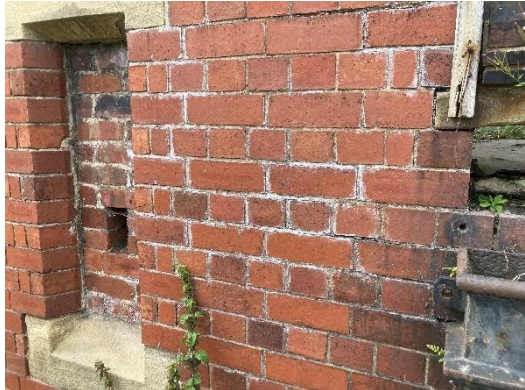
1
D	<i>Boiler House – All Elevations</i> There are a number of open joints and missing sections of pointing to the entire elevation which would benefit from re-pointing.

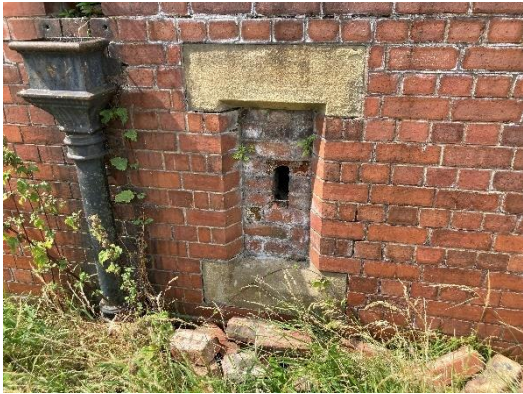
Priority	Description	Photograph	Costing Band
C	There are bricked up windows near floor level where the brick in the windows is starting to decay. Depending on how the building is used going forward, a decision on how these windows are used, reinstated, or repaired should be made.

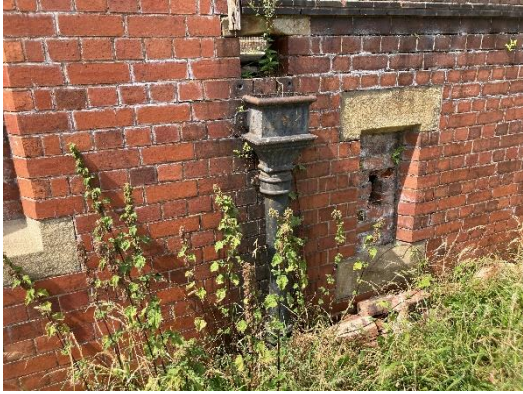
2
B	The existing cast iron hopper and downpipe is entirely dysfunctional, the existing roof does not extend into it, it is full of vegetation, and needs entirely re-decorating.

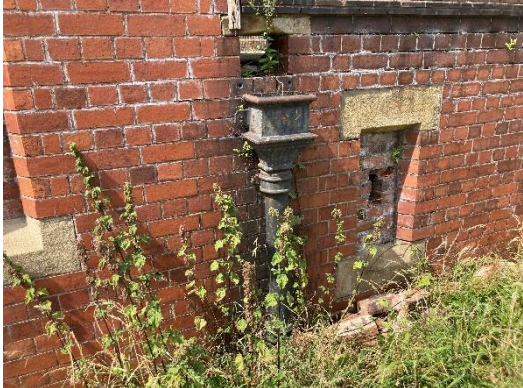
1
B	The rainwater goods should be overhauled as part of a potential reroof of the boiler house.

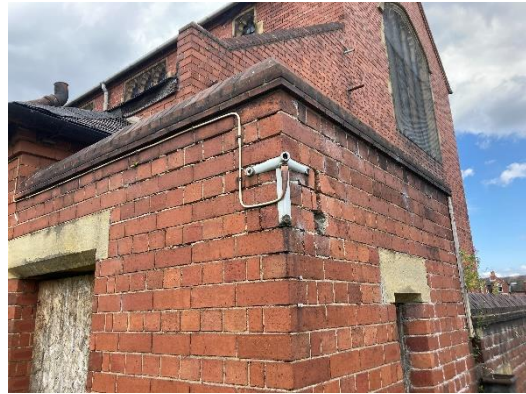
Old Toilet/Store – All Elevations

Open jointing to the window stone sills and headers. Large area of damaged brickwork in the east at higher level. Open jointing around the door reveals and at the high level to the South. Repointing of the open joints is required.

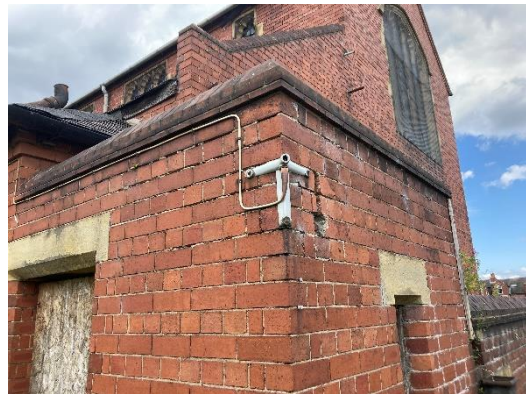
There is an old light fitting to the corner which is no longer working and should be replaced or removed.

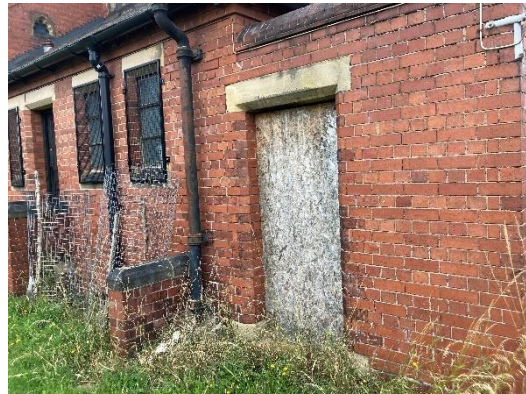
The current opening to the old toilet is boarded up. Depending on future use, consideration could be made to opening up and fitting a new door.

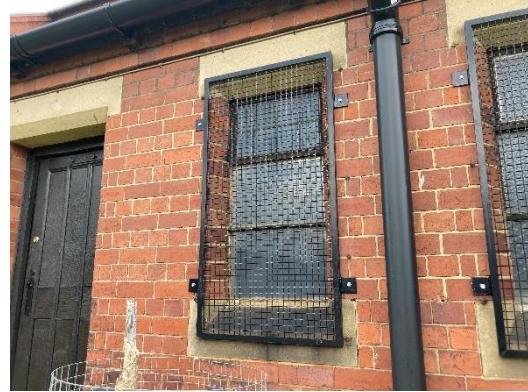
Vestry – South Elevation

Minor rusting and corrosion to the ferramenta of the windows should be re-decorated and the putty renewed.

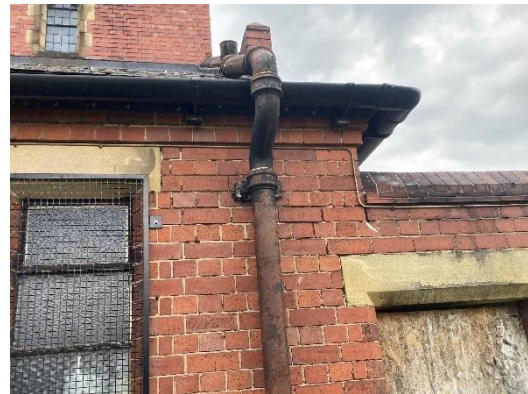
The cast iron downpipe is in poor condition with failing paintwork and a corroded back. This should be re-decorated with new paint, and joints should be re-sealed as part of the overhaul.

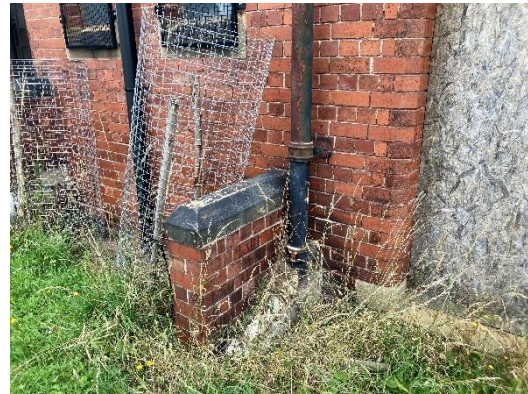
The gullies are full of vegetation which should be cleared out as part of an annual maintenance strategy.

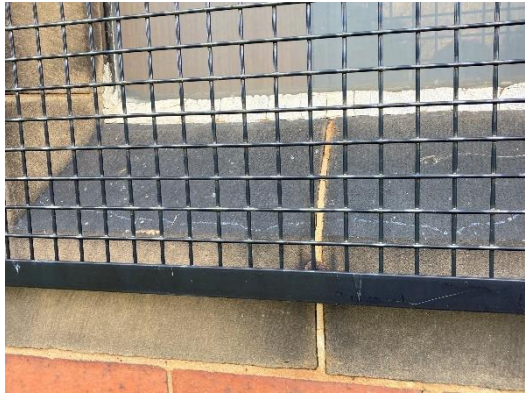
Priority	Description	Photograph	Costing Band
C	<p><i>South Aisle</i></p> <p>The are frequent open joints throughout the elevation, that require repointing. There are also isolated open joints to all the window sills, which should also be repointed to prevent water ingress.</p>

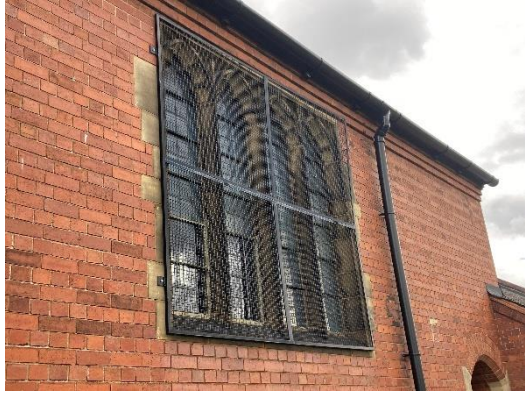
1
D	<p>The guarding to all windows is new and is largely satisfactory, although to the eastern window one of the fixing plates has come loose.</p>

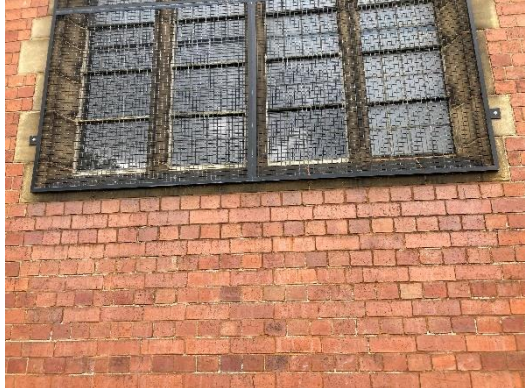
1
D	<p>Minor rusting and corrosion to the ferramenta of the windows should be re-decorate and the window putty renewed.</p>

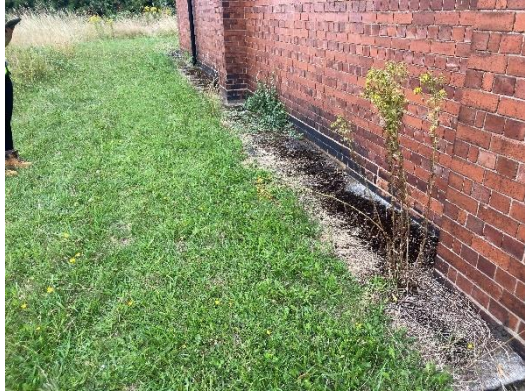
Priority	Description	Photograph	Costing Band
C	The ground level has been built up on the South elevation, and the nature of the foundations is causing water to be held up at the base of the perimeter of the building. A first action should be to ensure all gulleys are free of debris and the underground drainage is getting water away from the building; a CCTV survey of the drainage may assist with this. As previously mentioned, creating a channel gutter would be beneficial to direct water away from the building.

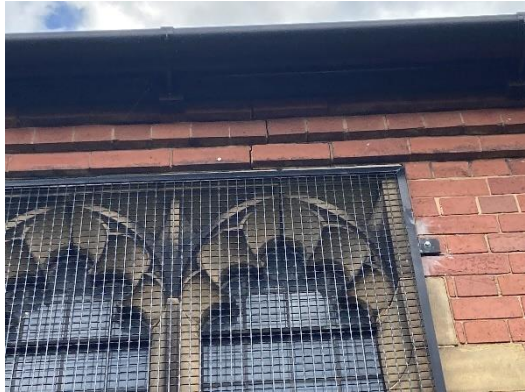
2
C	There is a fracture running through the head of the Middle window from the West into the eaves oversail, and is visible internally. The fracture should be stitched and repointed and repair kept under observation.

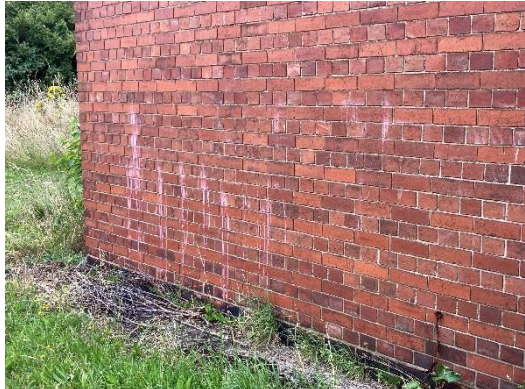
2
D	There is some graffiti at the extreme west end which should be removed so as not to encourage further vandalism.

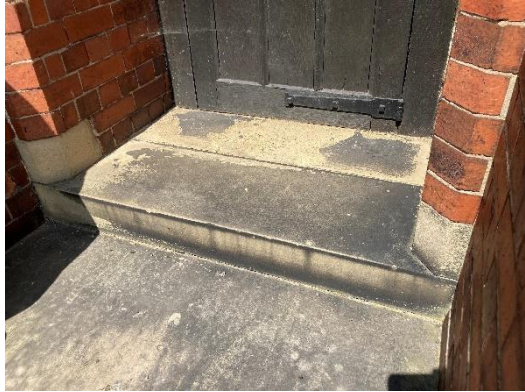
Priority	Description	Photograph	Costing Band
C	The top step outside the door has delaminated which is causing a trip hazard. Consideration to be given to replacing step or turning the stone block over.

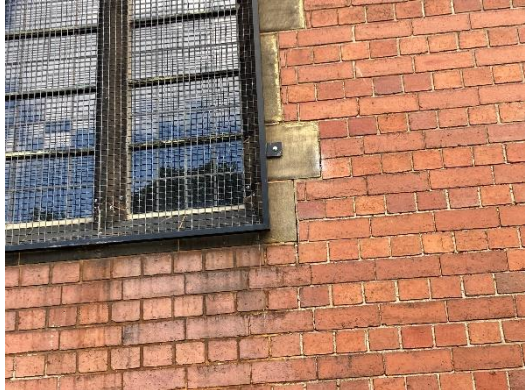
1
C	<i>South Aisle – West Elevation</i> There is deterioration to the jointing to the south, level with the windowsill, would benefit from repointing.

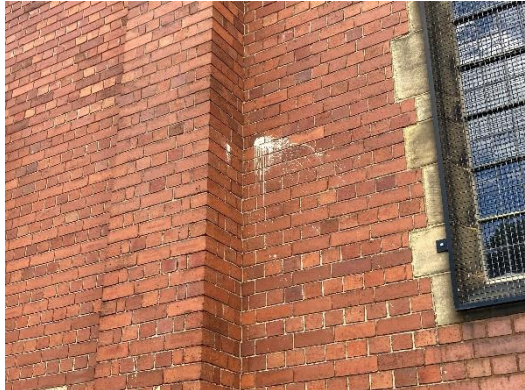
1
D	There are remnants of graffiti at higher level adjacent to the buttress and at low level which should be cleaned off.

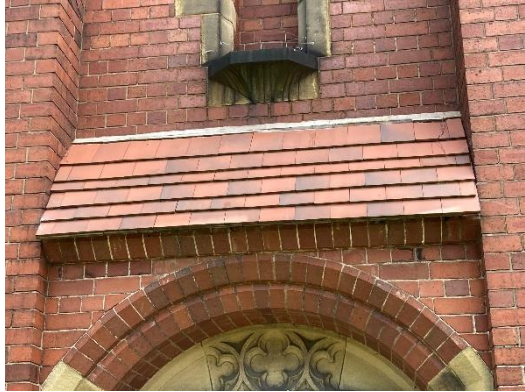
Priority	Description	Photograph	Costing Band
C	The mortar fillet to the top of the roof has cracked, come loose, and failed. This should be replaced with a metal flashing.

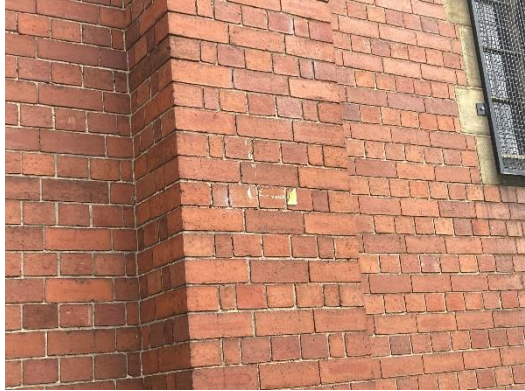
1
D	There are remnants of old signage which should be removed to improve appearance.

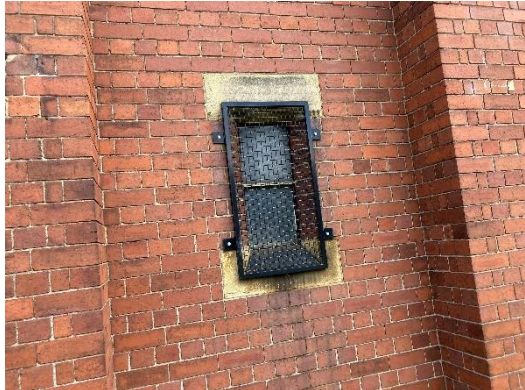
1
D	Minor rusting and corrosion to the ferramenta of the windows should be re-decorated.

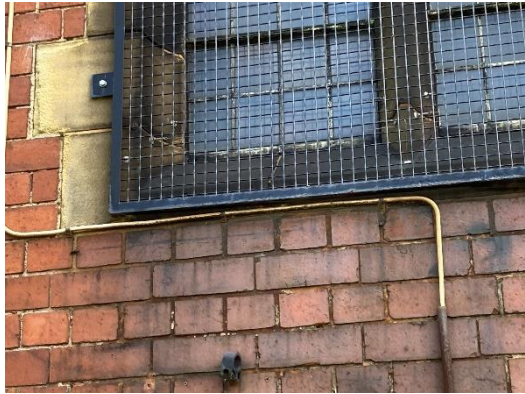
Priority	Description	Photograph	Costing Band
C	<p><i>North Aisle – West Elevation</i></p> <p>Open jointing to the windowsills, low level to the first brick course, and to the brick oversail should be repointed.</p>

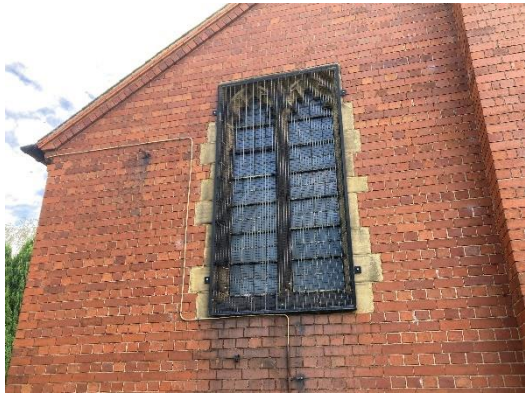
1
C	<p>Ferrous fixings should be removed below the window to stop damage to the bricks from rust jacking.</p>

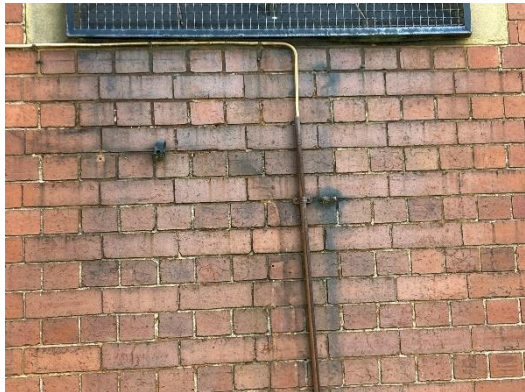
1
D	<p>The metal conduit around the window opening is rusting and should be replaced with a galvanised conduit alternative.</p>

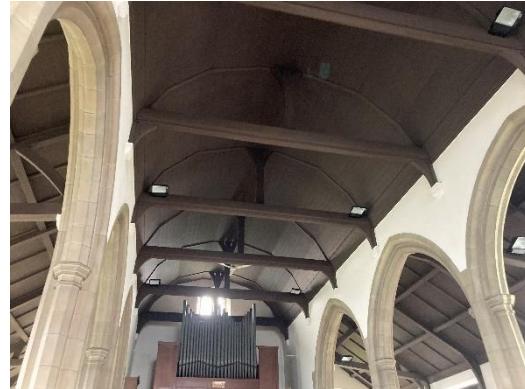
Obs *Nave*
Four arcades to North and South Aisles with plastered spandrels and sandstone columns on bases with capitols inset to the arcades. All in good condition, however, the painting to the arcade is in a non-breathable finish, this should be kept under observation.

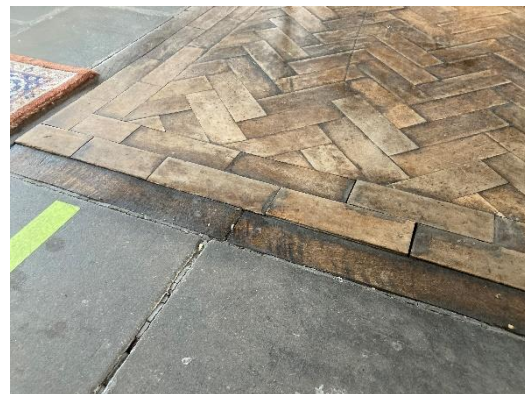
C Numerous areas of loose parquet blocks which should be re fixed into position.

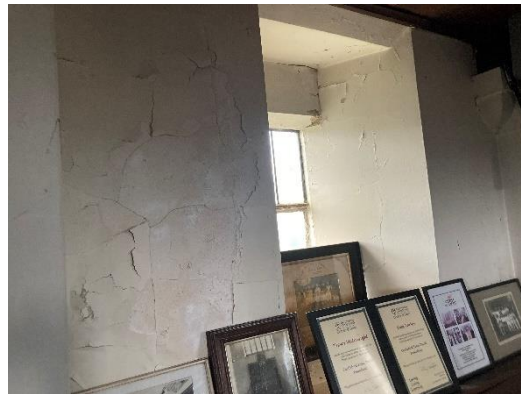
Narthex

There is paint flaking and salts appearing on the west elevation, north of the main door and a small area to the south on the west wall at low level and around the window. Flaking paint to the first column of the south nave arcade. Loose paint should be removed, and the salts brushed off, then the area should be kept under observation before repainting in a breathable finish.

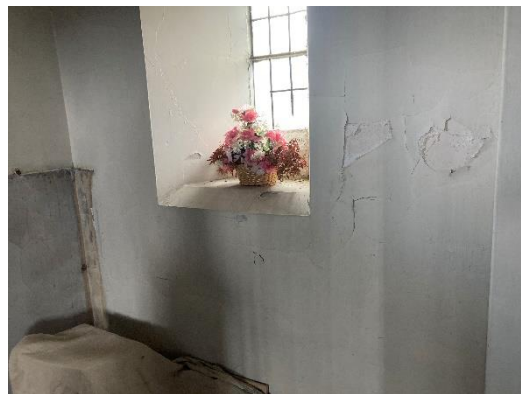
As highlighted in the previous inspection, two windows to the west wall of the Narthex have been damaged in the past and they have been repaired with full pieces of float glass with lead came planted on. If desired, these could be reinstated as they were originally.

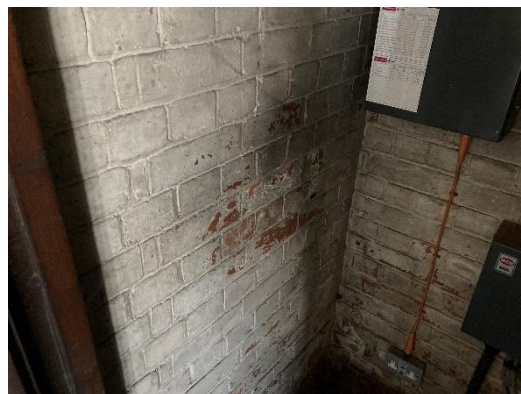
Electric Cupboard under Stair Cupboard

There are salts forming at low level and failing decoration, which should be brushed off the bricks and kept under observation.

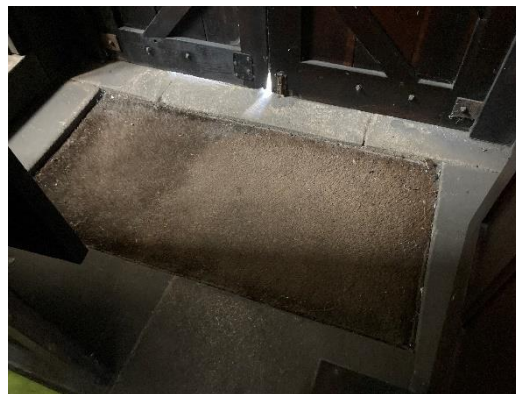
North West entrance Lobby

Inset door mat, now rather worn, and not flush with surrounding stone flooring. Replacement of mat on raised substrate to reduce lips and trip hazard.

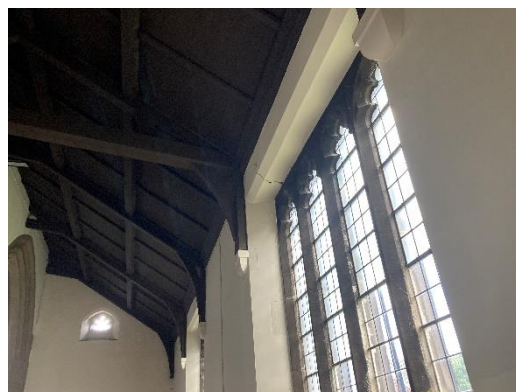
South Aisle

There is a movement fracture over the central window, also recorded externally. The previous QI mentioned that this must be kept under observation, repointed externally, and filled internally to help monitor any further movement. However, no monitoring has taken place since the last inspection, so it was not possible to determine whether the fracture has worsened.

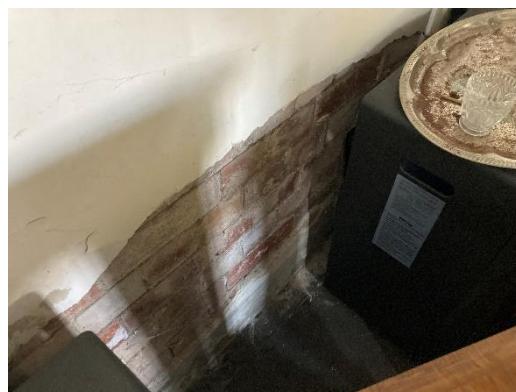
There has been a great deal of paint and plaster loss at the south altar on the south wall to the east. When external defects in these areas have been addressed, non breathable paint finishes should be removed and the area replastered in lime and decorated in a breathable finish.

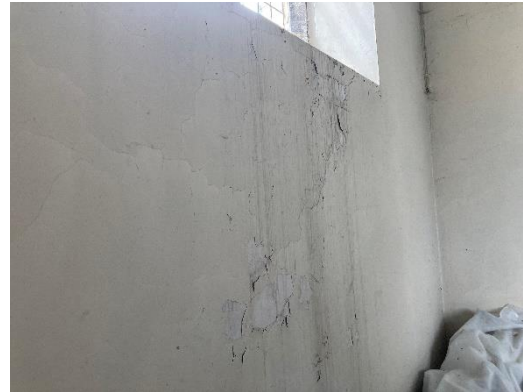
D Non breathable paint finishes has exacerbated water ingress due to open joints in the pointing and leaded windows. It would be beneficial to remove this and redecorate in a breathable decorative finish.

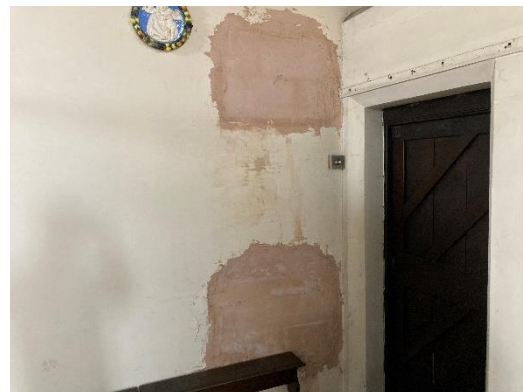
C There are patches of poor gypsum plaster repairs to the west wall. These have been poorly executed and salt is coming through, particularly at low level. Given the difficulty of reducing external ground levels, consideration could be given to introducing ventilated wainscoting.

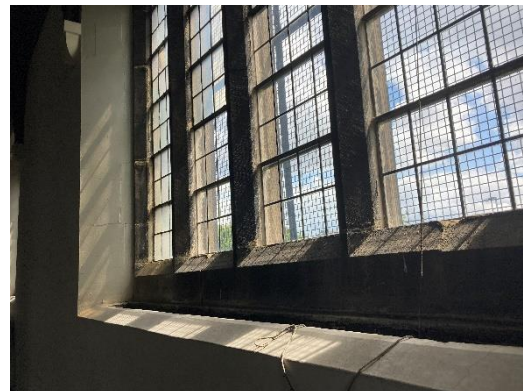
D The glazing bars to the interior of the windows are rusting and require replacing in stainless steel or bronze and redecorating.

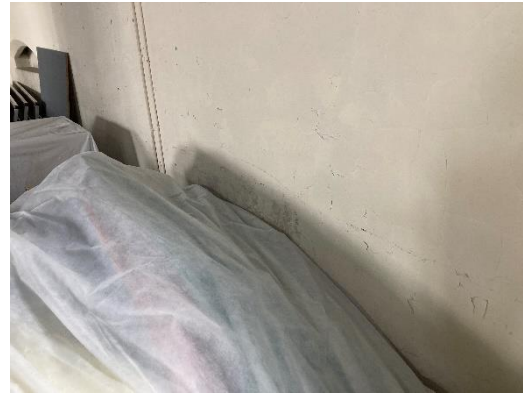
There is damp to the base of the eastern wall and at low level as on the South Aisle, where the same paint loss problem is occurring as the South Aisle due to surface water. The base of the wall was hard to survey due to items obstructing view.

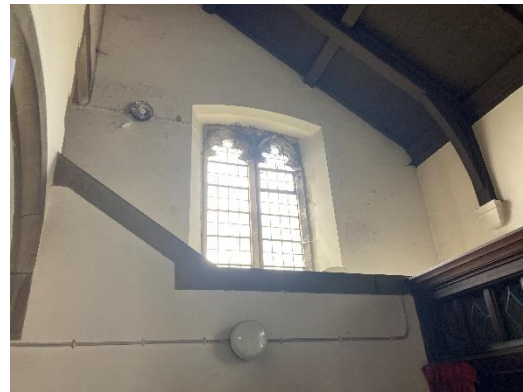
There is flaking, non-breathable paint which is quite dirty to the eastern end of wall and non-breathable paint which is failing to western gable end. This should be kept under observation and re-painted in a breathable finish if necessary.

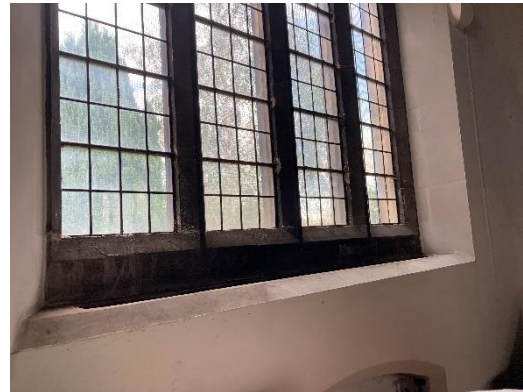
The glazing bars to the interior of the windows are rusting and require replacing in stainless steel or bronze and redecorating.

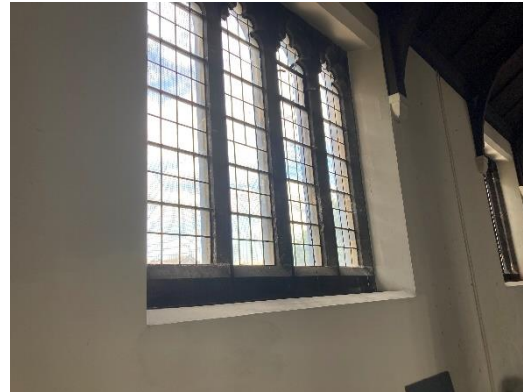
D There is a vertical lead came that is missing to the second window from the west, where a broken glass has been replaced in one piece. This should be removed and replaced as two pieces with a new lead came.

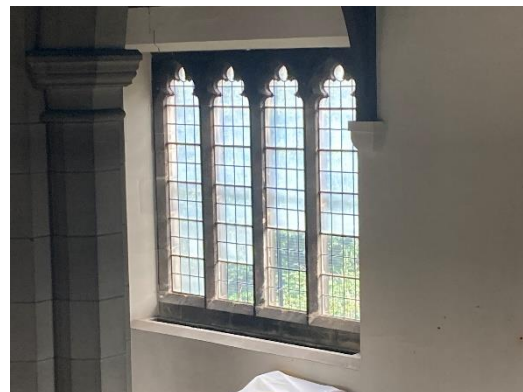
D The lower section of the third window from the west has been replaced in one piece of glass; ideally this should be remade to match the other window panels.

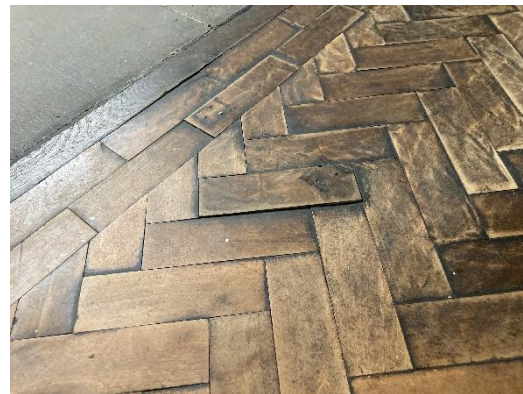
C Parquet flooring in fair condition with a few areas of loose parquet blocks to floor near the Nave.

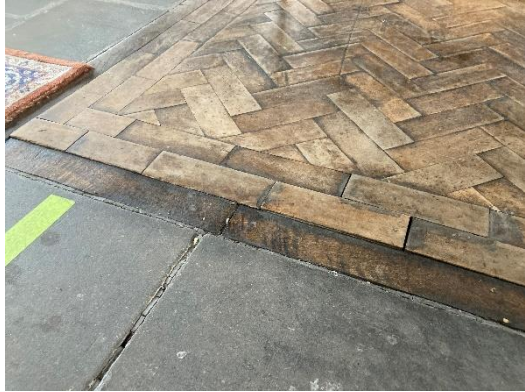
Priority	Description	Photograph	Costing Band
D	The previous inspection stated there were some loose flag stones running adjacent to the wall which should be re-bedded to avoid them becoming a trip hazard. The floor was hard to survey due to items obstructing view.

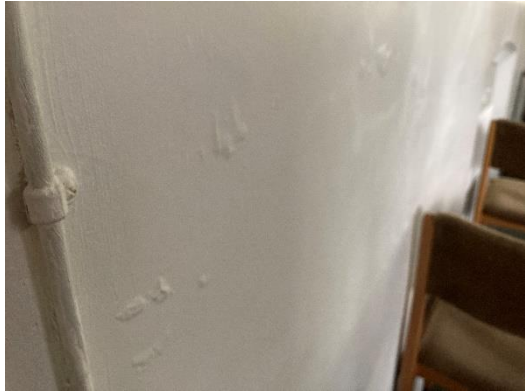
1
D	<i>Lady Chapel</i> The previous QI mentioned some signs of paint flaking off, particularly to the north wall at low level, suggesting the same problem with the damp proof course as above. This has been redecorated since the previous QI; however this is already starting to bubble due to the use of non-breathable paint. The paint should be stripped, and the walls redecorated in a breathable finish.

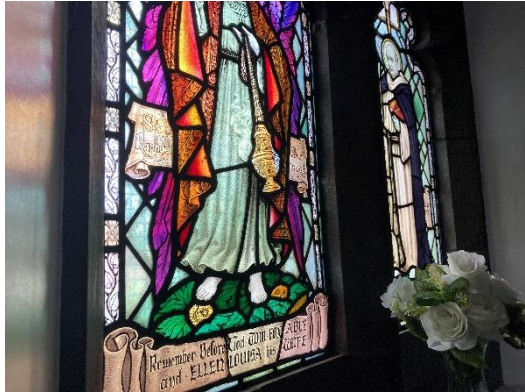
2
C	The Saint Raphael stained glass window is significantly bulging in the centre and should be fixed in place by a glazing bar to prevent further movement.

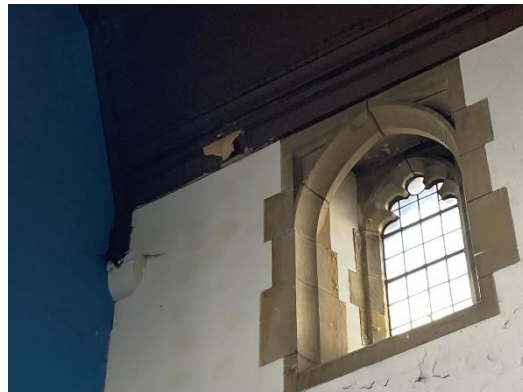
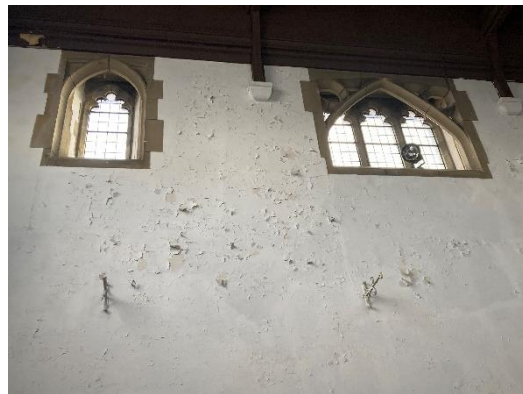
D *Chancel + Sanctuary*
The paint is flaking badly due to the use of non-breathable paint, particularly to the south wall. The north wall is also affected but not as badly. This should be scraped off and repainted in a breathable finish.

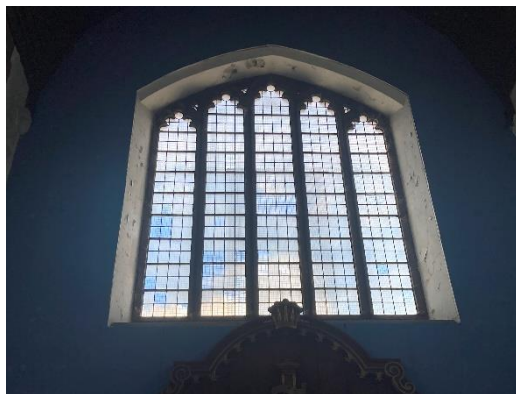
D There is badly flaking paint to the reveals of the east window. This is likely to be caused by condensation more than penetrating damp and redecoration will be required ongoing. The situation could be improved by renovating the window openers which would help with ventilating the building. A breathable paint finish should also be used.

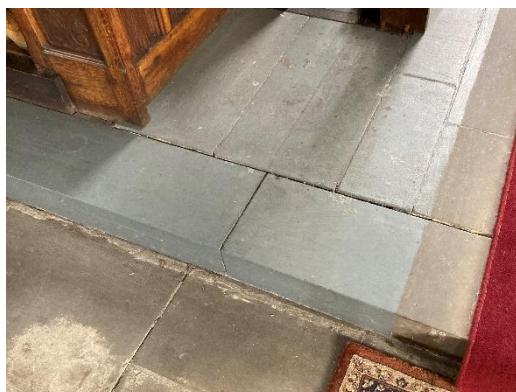
D There are some open joints to the flagstones which would benefit from repointing, particularly at the Chancel arch step. Non-breathable paint has been applied to floor; this could be removed if desired.

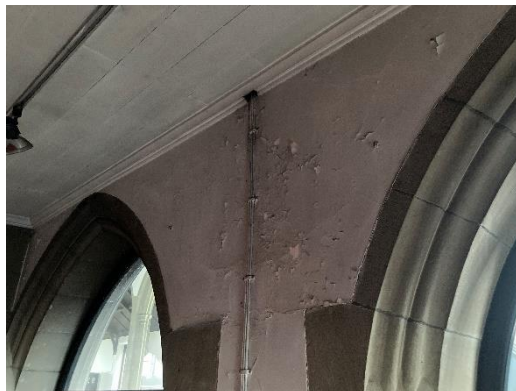
D *Vestry Passage*
Ceiling has areas of failed paintwork would benefit from repainting in a breathable paint finish.

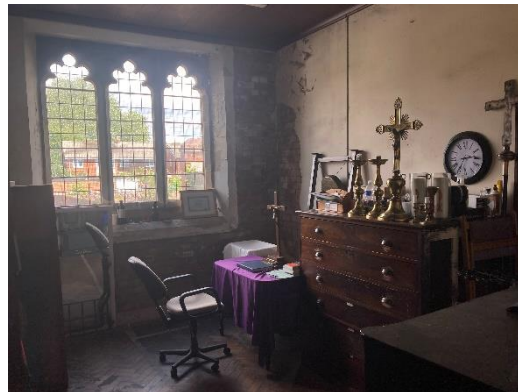
Obs There is a danger that dry rot could start in this floor adjacent to the boiler room. The carpet has been removed since the previous QI and there are currently no signs of dry rot, although, the condition of the boiler house roof would still indicate that this is a very real concern.

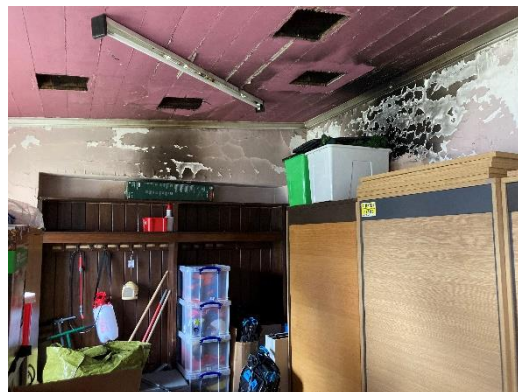
D *Choir Vestry*
Timber boarded and painted; the decoration is in very poor condition and would benefit from redecoration.

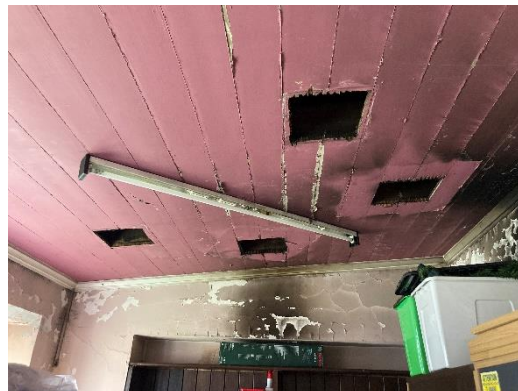
D There are several holes to the ceiling from the previously housed boiler. These would benefit from being patched in or the entire ceiling replaced.

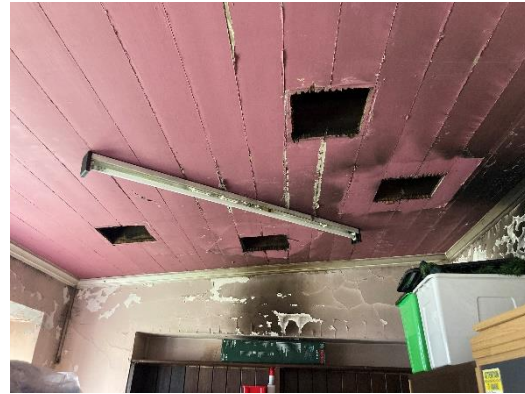
Obs Through the patches to the ceiling you can see through to the roof void, however, it was not possible to survey the roof void due to no access being provided.

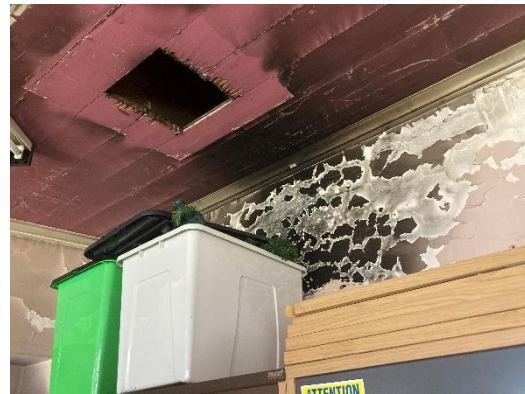
D The previous housing of the boiler in this location has left the room in extremely poor condition. The entire room should be fully stripped back to a sound plaster base and refinished in a breathable paint.

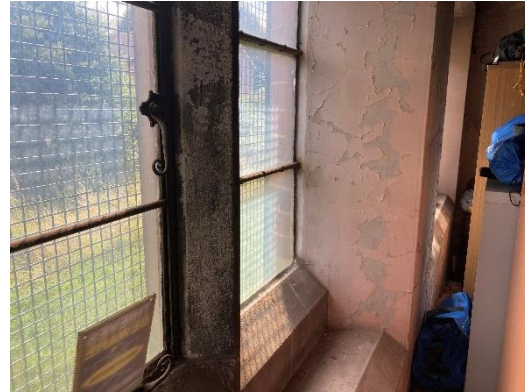
D The windows would benefit from a general overhaul with redecoration and re-puttying.

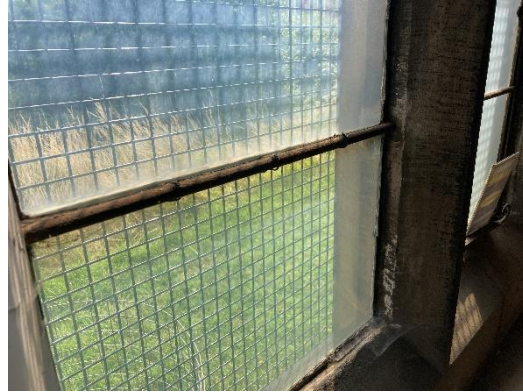
D The glazing bars to the interior of the windows are rusting and require replacing in stainless steel or bronze and redecorating.

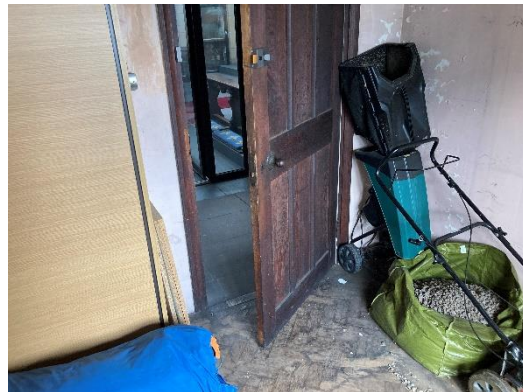
D Both doors are starting to catch and should be eased.

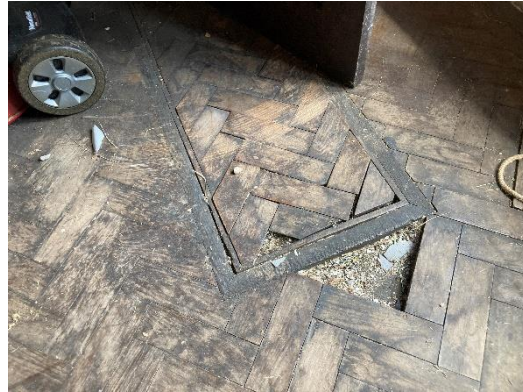
D Parquet flooring in poor condition. The finish is lost, and a number of blocks are coming loose, with some missing altogether. The floor requires relaying, and the missing blocks replaced.

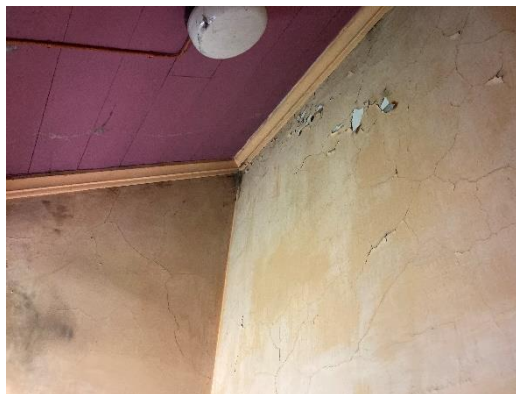
Areas of paint are starting to fail to both the boarded ceiling and the plastered walls, which would benefit from redecoration in a breathable paint finish.

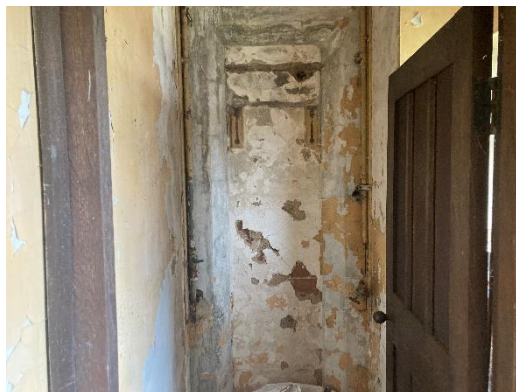
Failed paint and plaster to walls generally, and they would benefit from being replastered in lime, and addressing the external defects to the boiler house a priority.

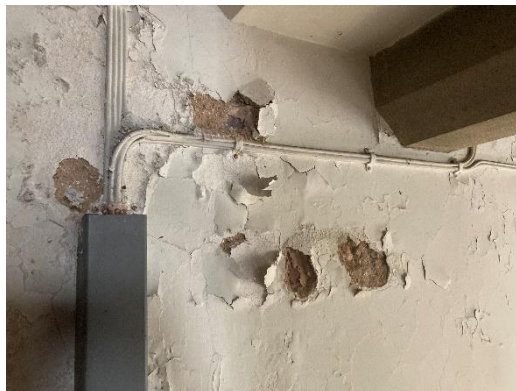
The walls of the West Gable have deteriorated since the last QI and areas of lost plaster have come away from the walls there is also salting to areas of the plaster. This should be brushed off and redecorated. There is also non-breathable paint finishes which are failing due to water ingress.

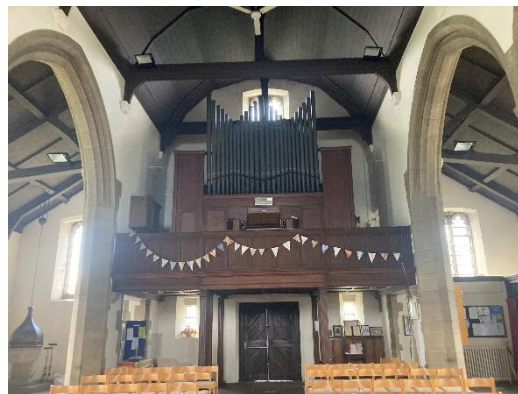
E The main west window behind the organ could not be accessed but would benefit from renovating so that they can be opened to improve ventilation to the building.

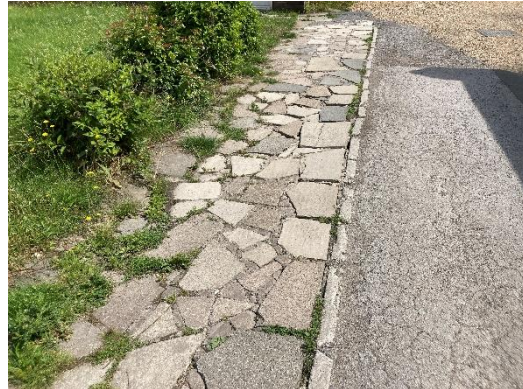
C There is cracking to the crazy paving to the northeast and loose stones this should all be re bedded.

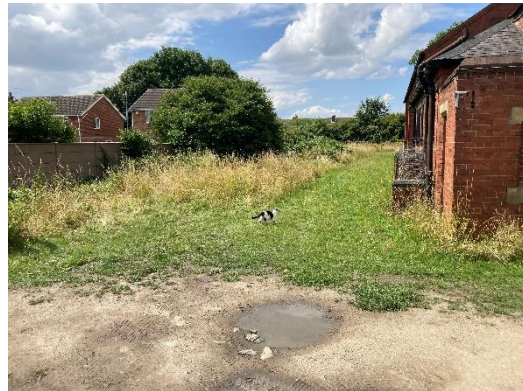
M The Church is surrounded by private housing to most sides. Generally the grounds are overgrown, which has made inspection of the boundaries difficult.
