Church Commissioners
Mission, Pastoral and Church Property Committee
Mission and Pastoral Measure 2011

The parish of Castleford: the churches of St Paul, Glasshoughton; All Saints, Hightown; St Michael and All Angels, Castleford

Note by Joanna Chandler-Clarke

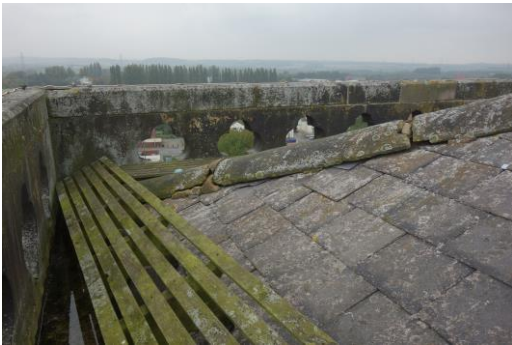
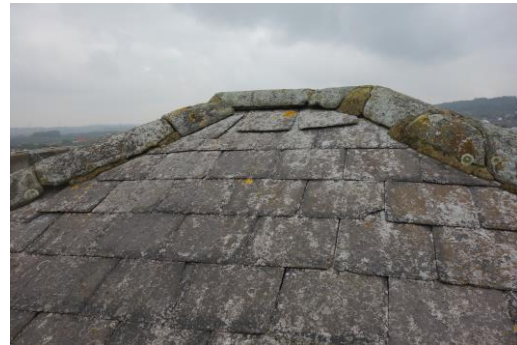
Formed with Welsh slate, two hipped ends with a short stone ridge. Stone falling to perimeter parapet gutters. All ridges and hip tiles need taking off and re-bedding. Slate condition is variable to the slopes but given the size of slate area re-roofing would make sense.

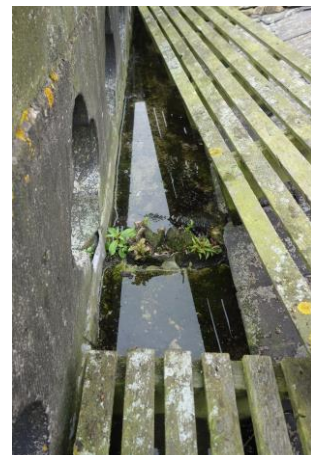
- 3.2 Lead parapet gutters, blocked on the south and east sides. Vegetation is evident and there is a shrub root lodged in the east gutter which is blocking and breaking up the lead.

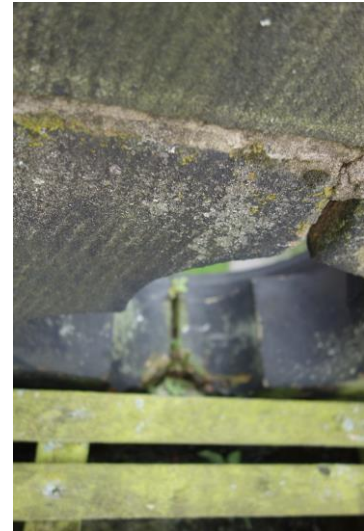
- 3.3 The parapet work is perforated with quatrefoil openings and the joints between the individual stones. Some are significantly open allowing water penetration into the bed joint of the base of the parapet work. The lead parapet gutter is largely concealed by the duck boards but there is considerable debris below. Removing the boards temporarily, cleaning out and inspecting is essential. There's a chute from the parapet gutter to an external hopper only 75mm wide so quite restrictive.
