Church Buildings Report PM 2460 Milford, Holy Trinity (612250 CHR)

PART 1: Summary

PART 2: Detailed assessment and significance

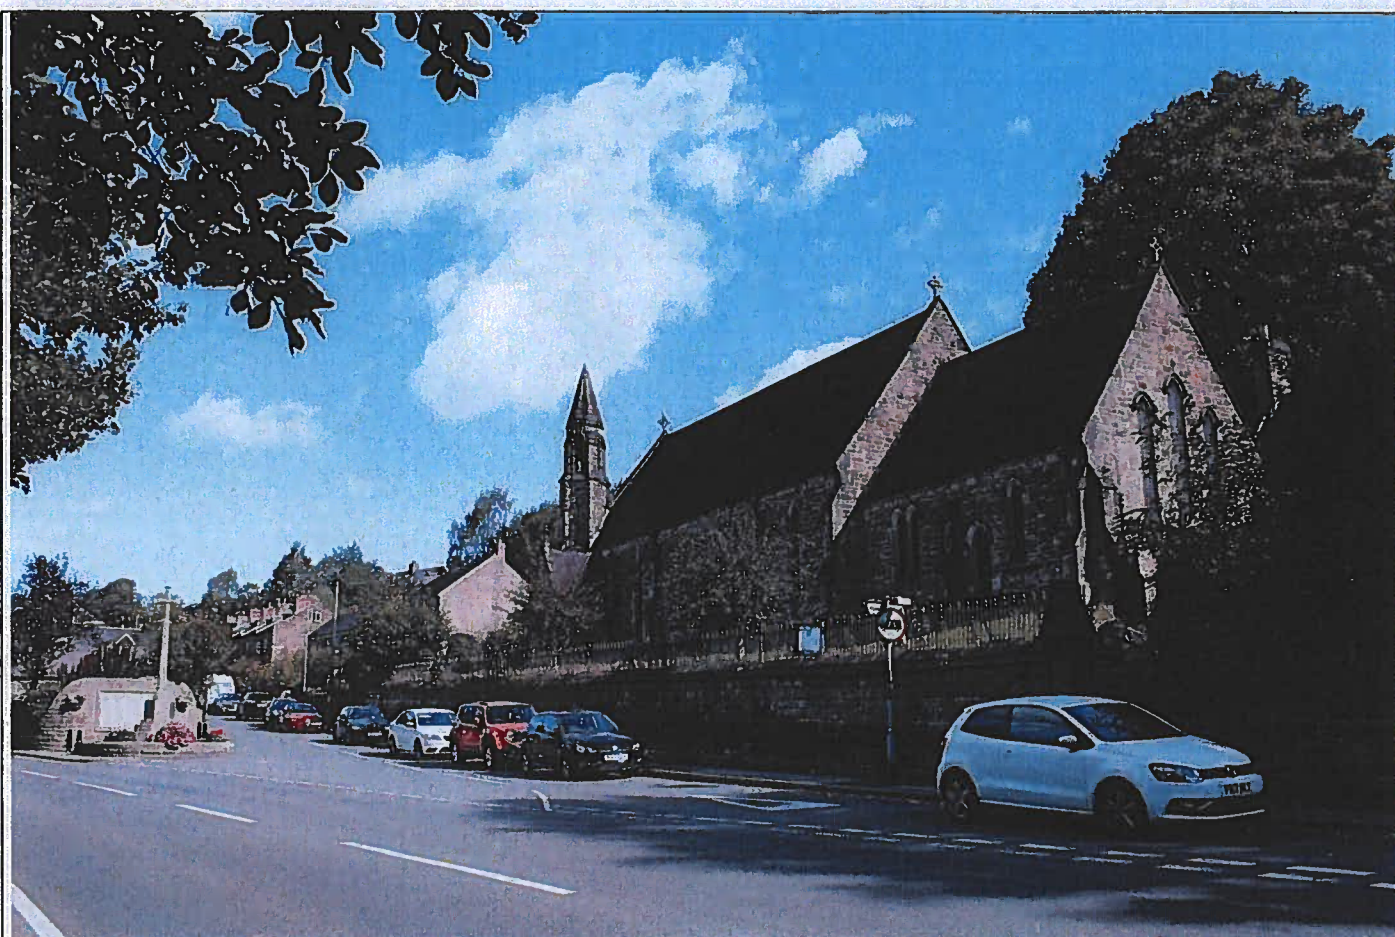
Exterior view from S

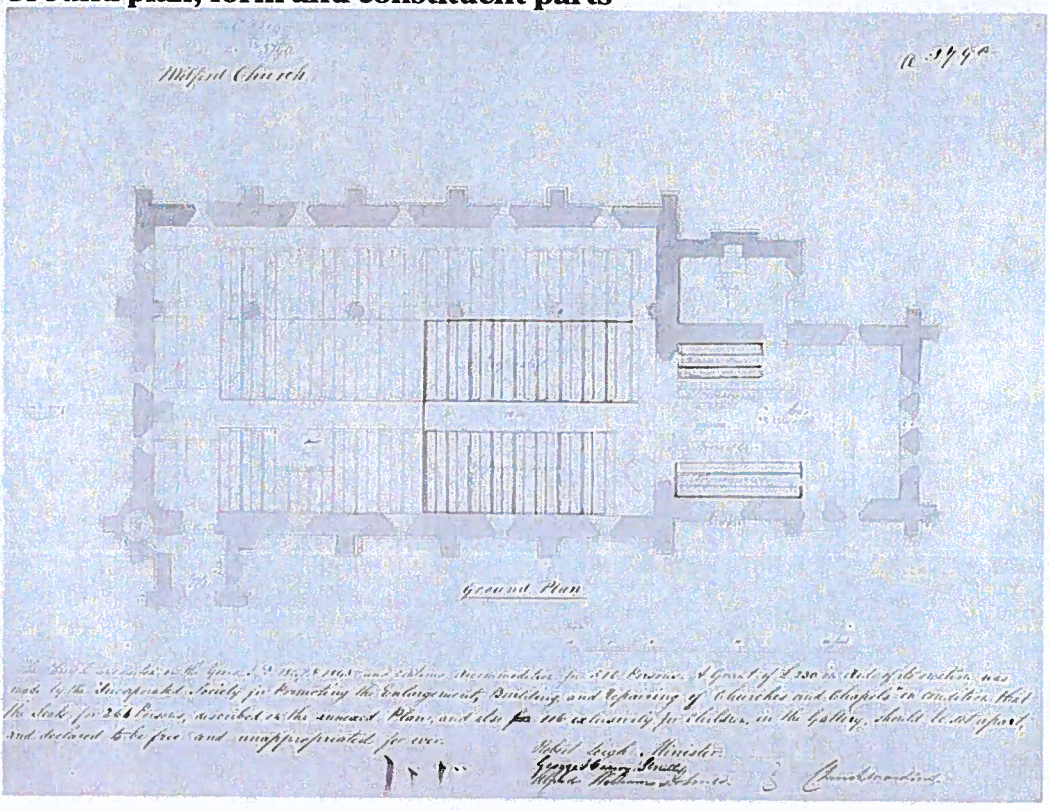
<p><i>Mitford Church</i> 1846</p> <p>1846</p> <p>ground Plan</p> <p>The Church was built with funds of £1500, and existing accommodation for 100 persons. A grant of £250 in aid of its erection, was made by the Incorporated Society for Promoting the Enlargement, Building, and Repairing of Churches and Chapels in condition that the work for 250 persons, ascribed in the above Plan, and also for 100 extra persons, in the gallery, should be at once, and declared to be free and unappropriated, for ever.</p> <p>Walter Smith, Minister. George Henry Smith, Warden. Walter Thomas & Sons, 3 Chandlers Row.</p>	<p>Two-bay chancel and sanctuary, five-bay nave and N aisle, S porch and SW bell turret, vestry N of W bay of chancel, with passage and kitchen further N linked to WCs and three-bay hall further E (all assuming liturgical E orientation)</p> <p><i>Plan c1846 (not signed by the draughtsman but signed by the minister and churchwardens after construction, 1847-8); from Lambeth Palace ICBS Collection (ICBS03790). NB does not show alterations and additions of 1904-10.</i></p>

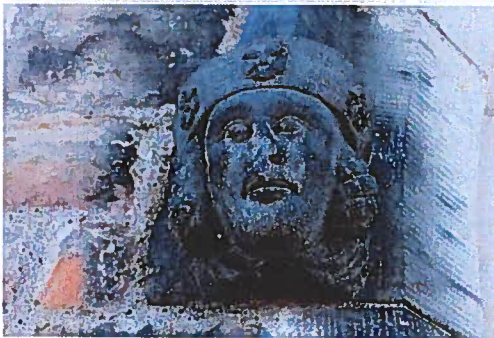
S Porch headstop (left)

The nave is of five bays. The westernmost bay is occupied by the porch hard against the bell turret in the corner. It is gable-ended and plainly-wrought. It has a twice-chamfered ashlar opening with a hoodmould terminating in nicely modelled headstops. The double doors are of vertical oak boards with studs and foliate strap hinges. A cast iron cross tops the gable. The other four bays are just as plain. Each is defined by a twice-weathered buttress above the weathered plinth. Each bay has a plain lancet window in a chamfered reveal. Above this is the large expanse of plain-tiled roof with a cross at each end like that on the porch gable. The bands of fishscale patterned tilework shown in the approved drawings (see *Furnishings: Miscellanea* below) are not in evidence. Either they were dropped from the project or a subsequent re-roofing has done away with them.

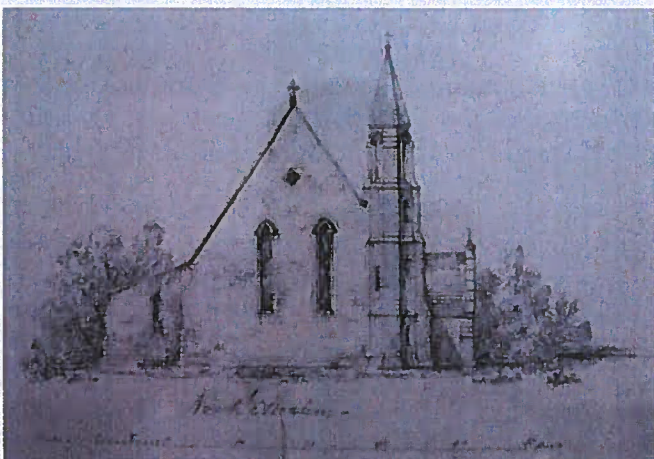
W end design drawing, 1846 (presumably as built) W end following 1919 remodelling

The W end is dominated by the five-light window with plate tracery inserted by Currey and Thompson in 1919 to accommodate an ambitious stained glass war memorial (P H Currey was Southwell Diocesan Surveyor). This replaced the modest pair of lancets of Moffatt's church which must have given little light and made the W end rather gloomy. The replacement masonry round the new opening can just be discerned. The window openings have shallow chamfers so that the glass is barely recessed at all. The ashlar surrounds are generously wide but clumsily shaped and the tallness of the centre lancet compared to the outer ones is also ungainly.

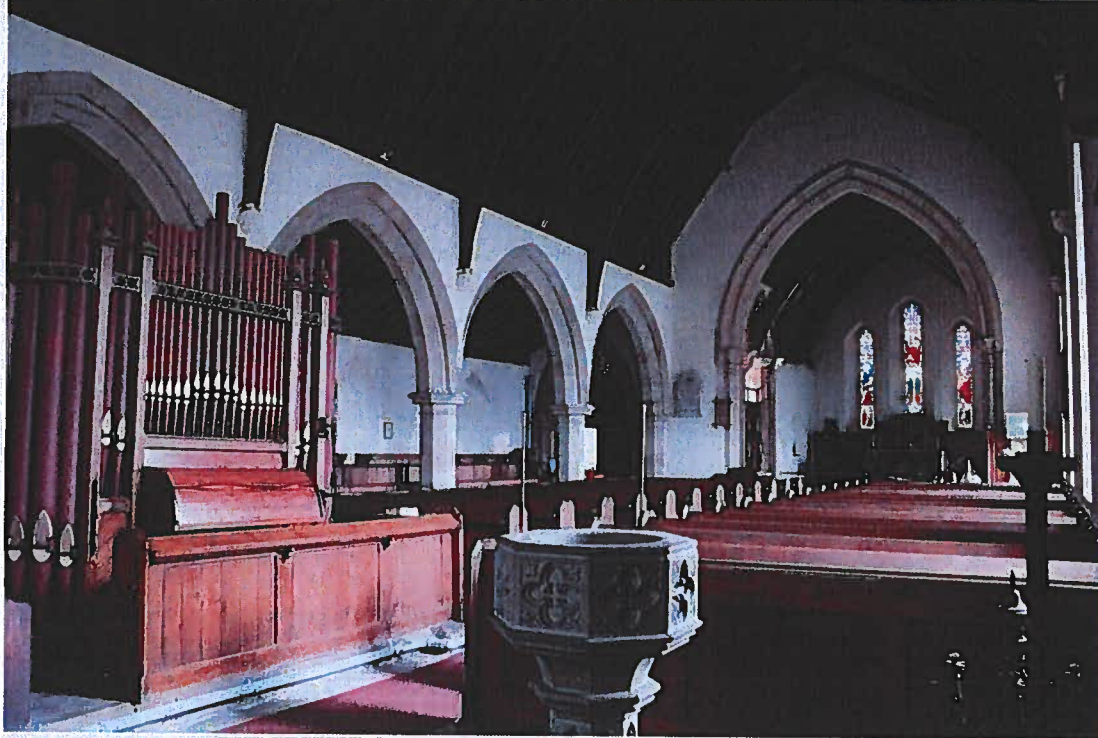
Interior view from SW corner

The church is entered via the S porch on the W bay of the nave. The porch, having no windows, is dark. The inside face of the outer door shows its heavy ledged and framed construction, with chamfered cross braces in each of the square panels formed by the framing. In the NW corner is the door to the turret stair in a chamfered arch opening. The double doors to the nave are modern: three panels each, the upper two are glazed.
