Church Commissioners
Mission, Pastoral and Church Property Committee
Mission and Pastoral Measure 2011

Benefice of Upper Ryedale
Church of Saint Michael, Cold Kirby
(Diocese of York)

Note by Shaman Durrant

QUINQUENNIAL INSPECTION REPORT
on the Church of St Michael,
Cold Kirby, Yorkshire.

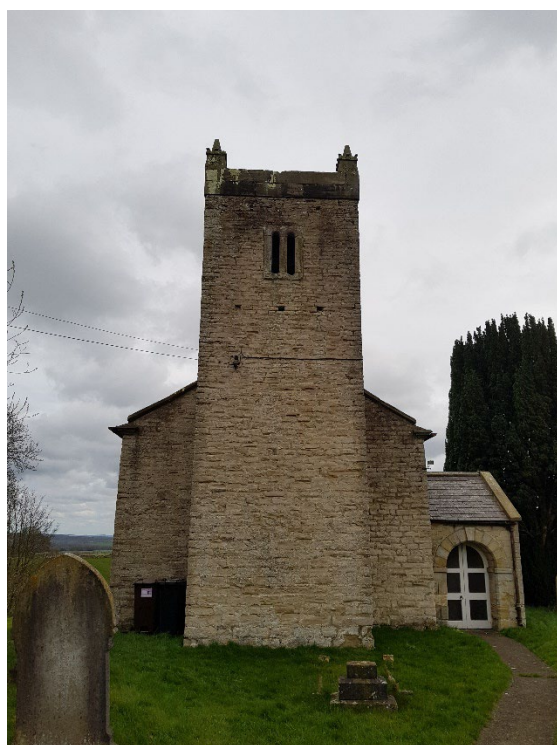
LHS: Exterior view of west elevation with main entrance RHS: Exterior view of north elevation

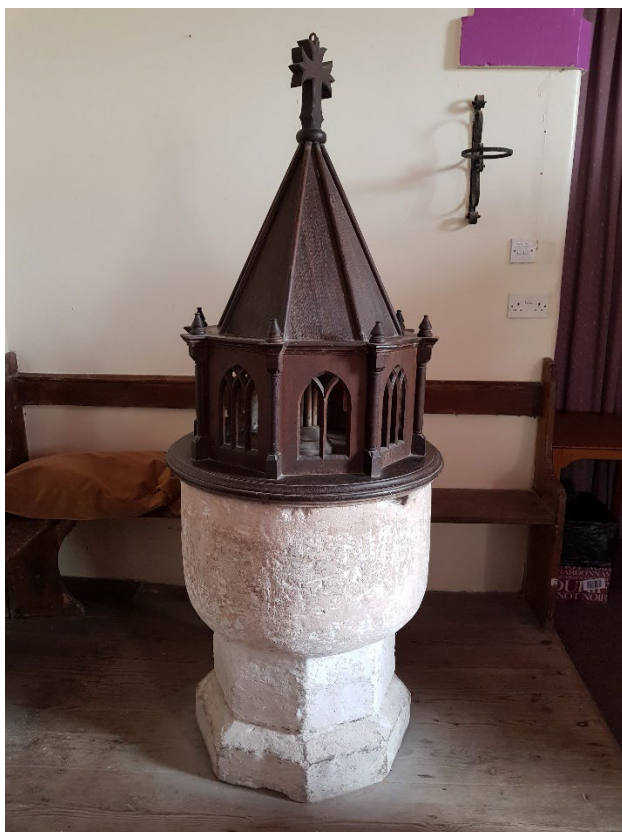
LHS: C12 font with C19 cover

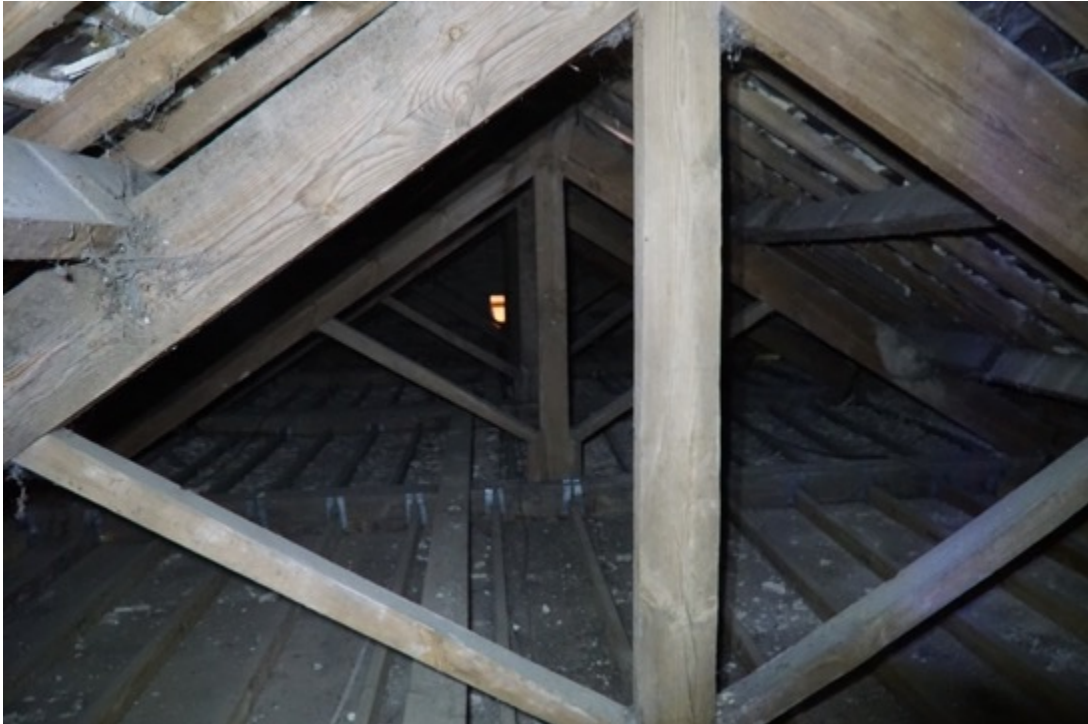
The Nave Roof Space

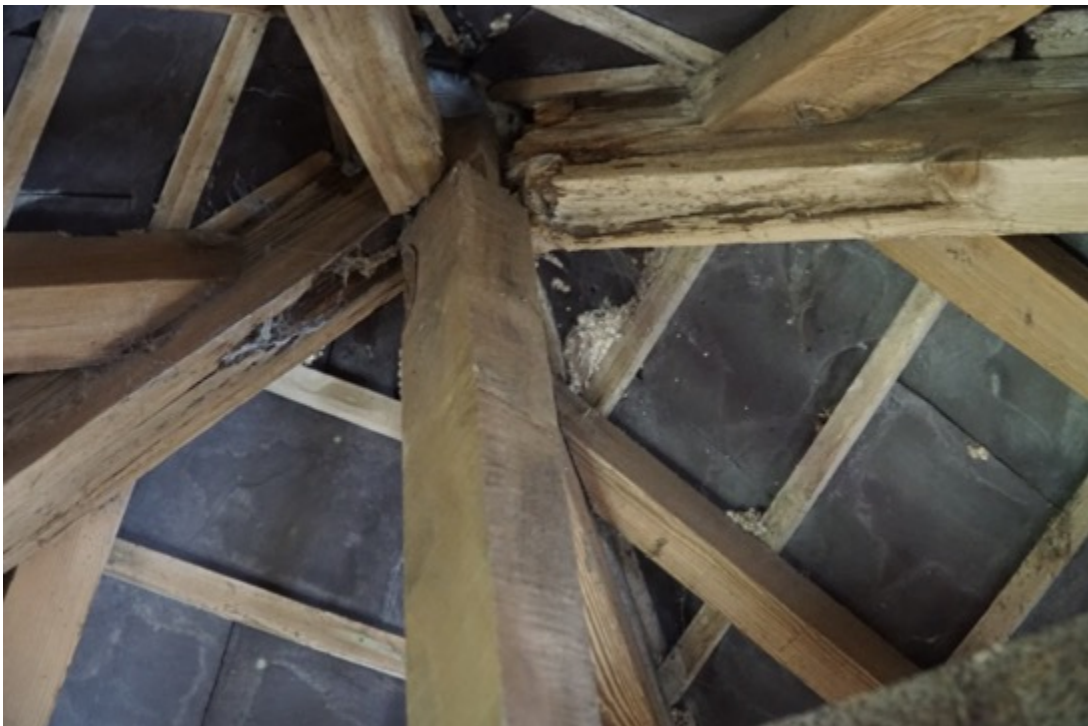
Tower Roof

- 3.1.6 Condition: TOWER ROOF: access prevented inspection of the exterior. The internal structure is severely decayed. There is evidence of past water ingress, this appears to have been addressed. Some greening of timbers and beetle activity suggests water ingress continues.

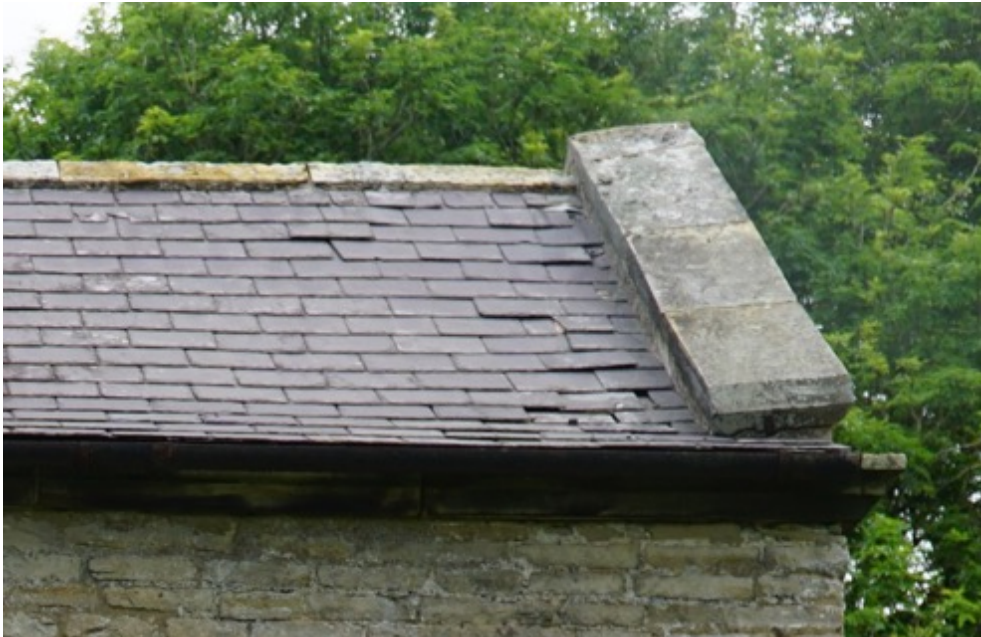
Chancel Roof south: note slate disruption at east gable, rotation of gable coping also noted.

3.6.3 Structure: Generally, the wall structures appear structurally sound with few signs of significant structural concern. The spreading of the roof at the abutments to nave east gable are causing the slippage of the wall corner head. This can also be seen in the slippage of the Chancel cornice south side. The gable coping at the chancel east gable is rotating back, unless curiously built with a backward fall. Some localised cracks, at south porch above arch.

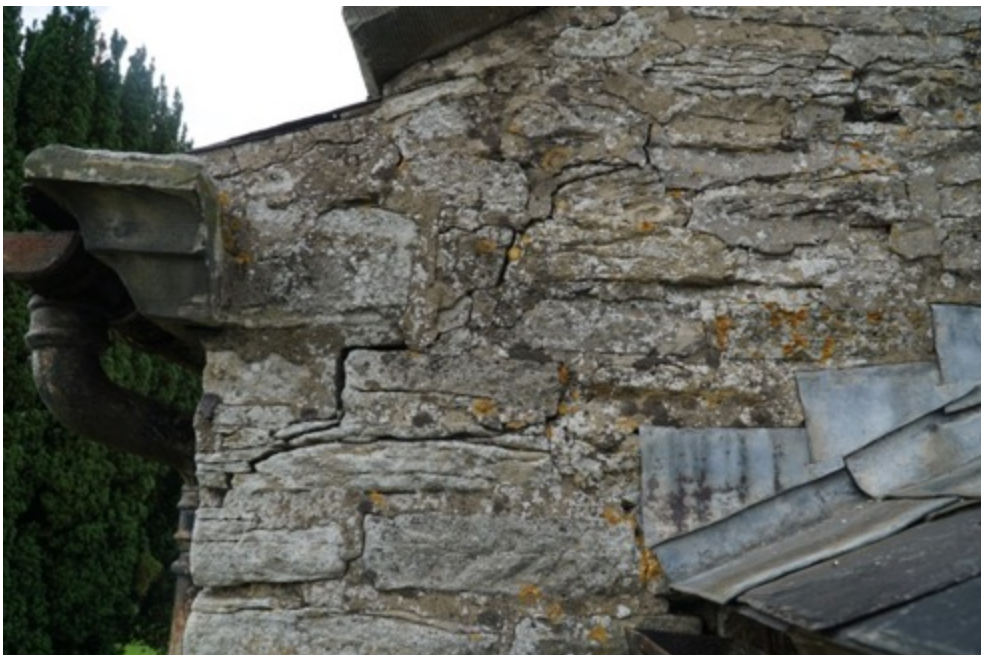
Roof structure settlement and spread has loosened the wall head and masonry at the Nave east gable return where there is insufficient tying of the roof. (Note diagonal cracking).

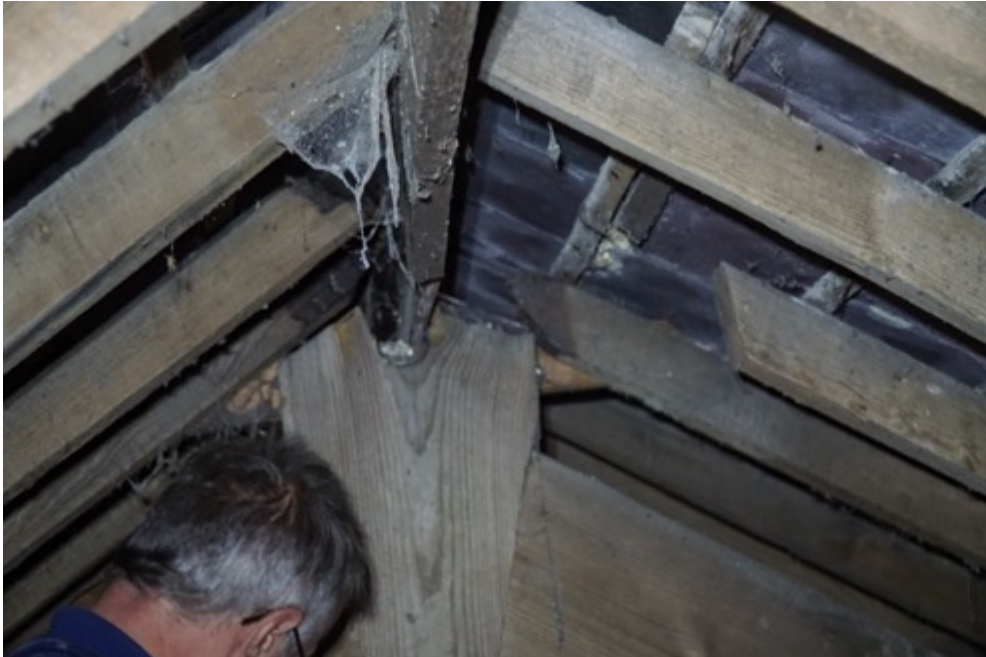
Loadbearing rafters cut short, scorched ridge plate.

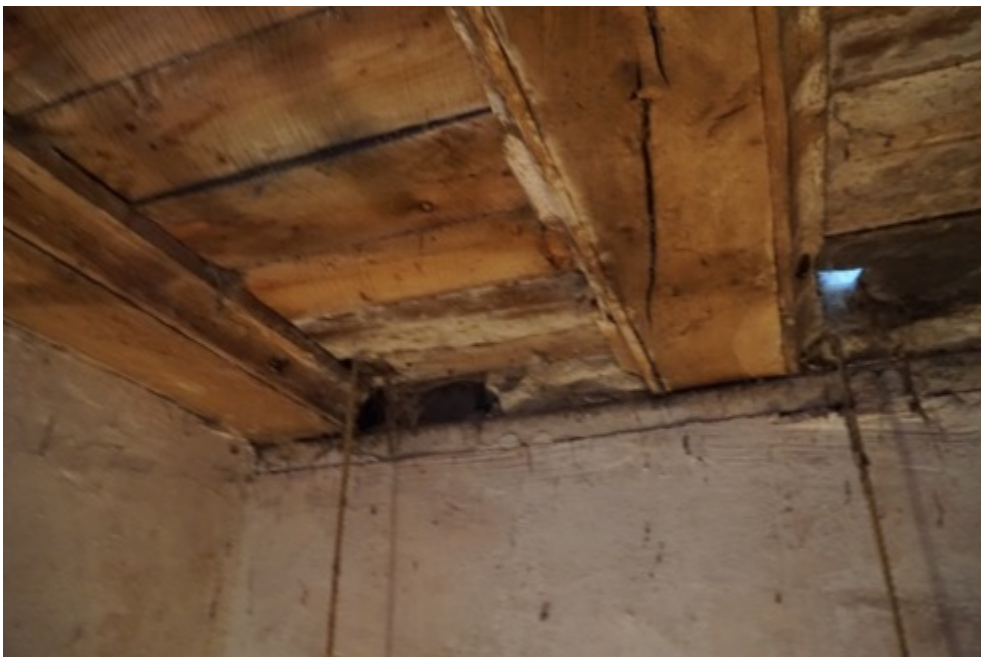
Water ingress damage at Belfry floor from Tower roof above.

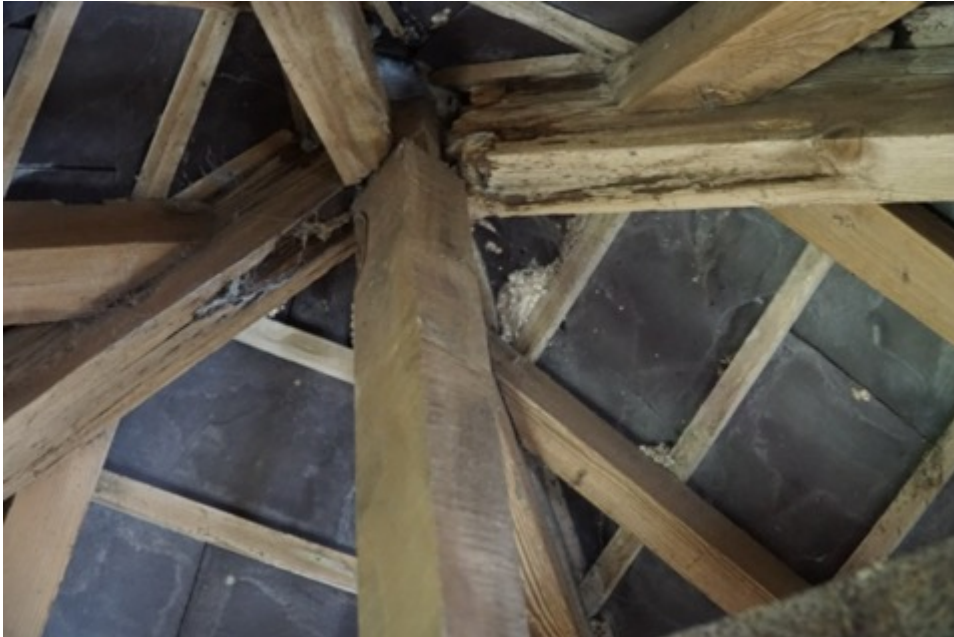
Significant timber decay at the structural joints of hips and kingpost.

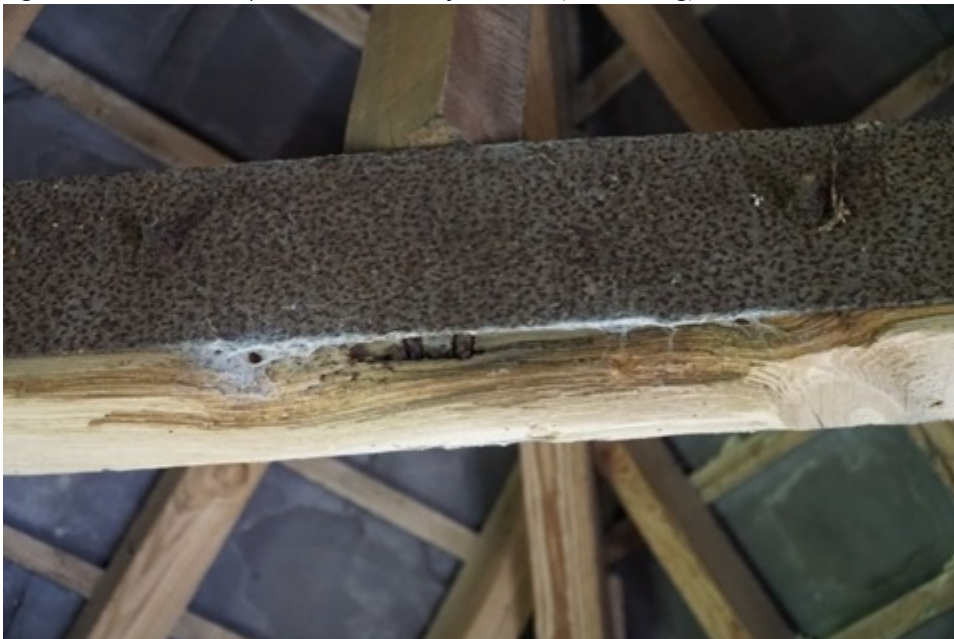
Tower Roof; timber plate repair to bottom cord.

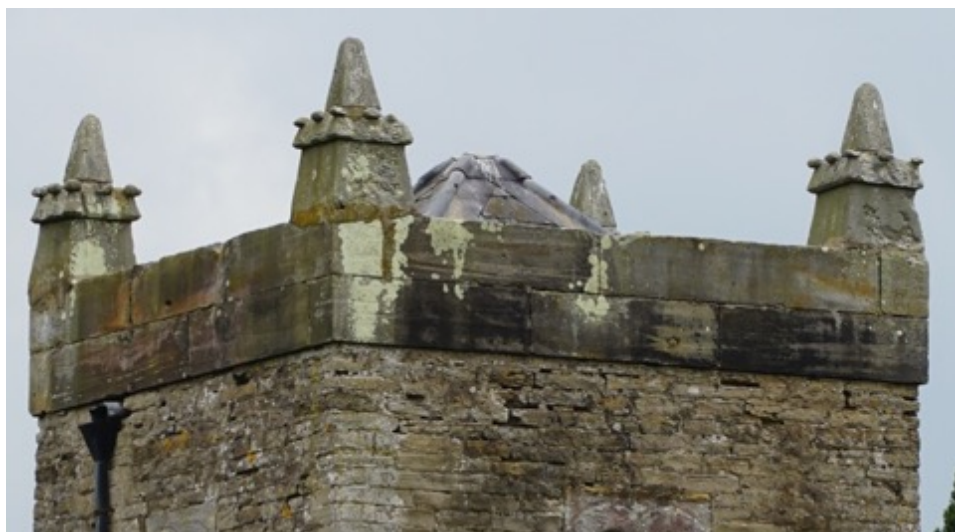
Tower apex lead capping appears in two layers with possible hollow, this may be channelling water into structure. Parapet is open jointed and masonry beneath dressed stone parapet is very open jointed.

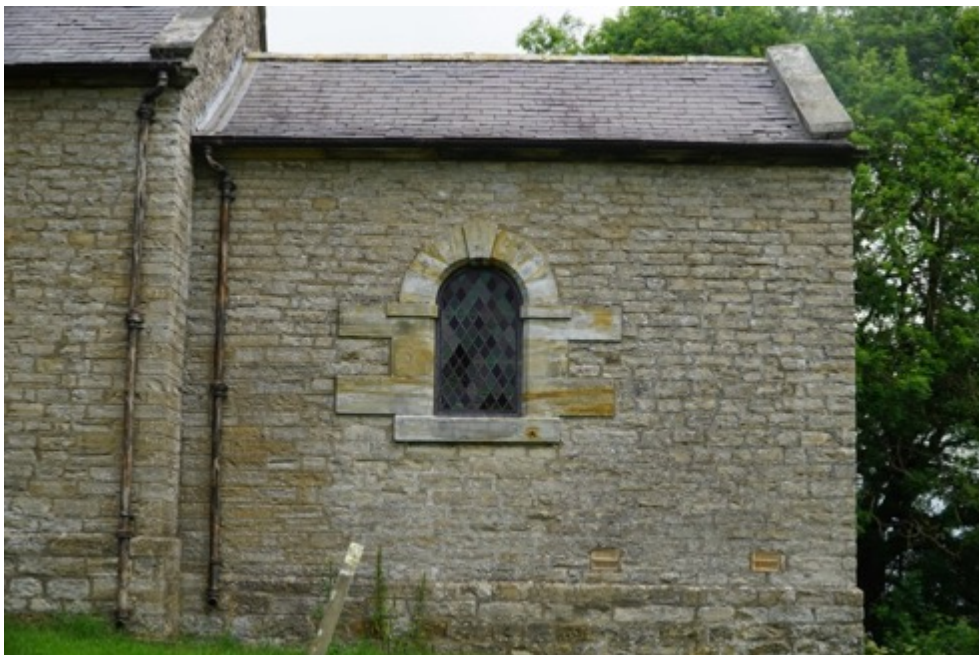
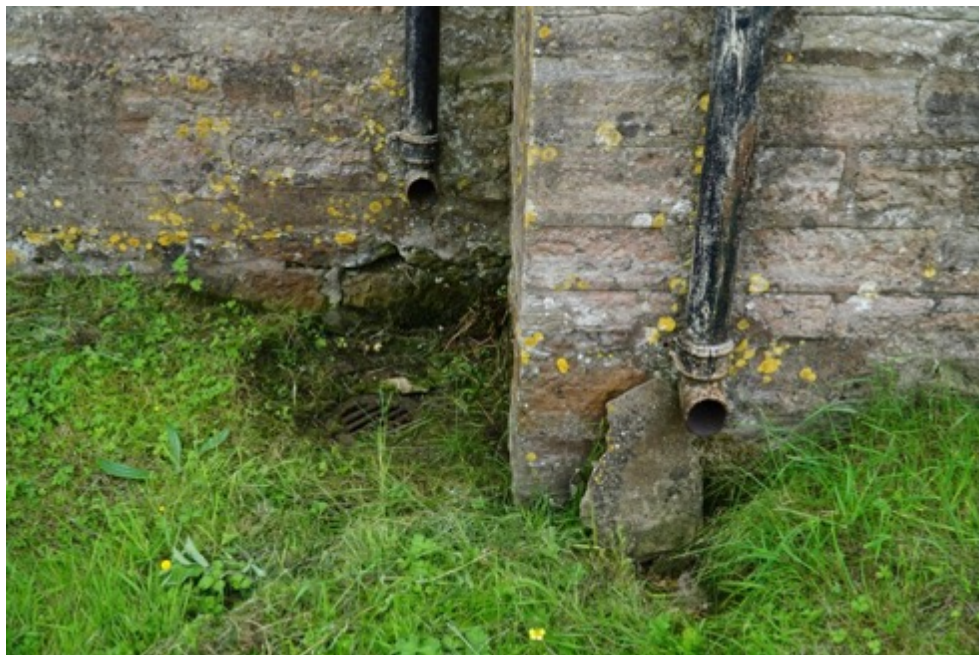
North discharge into gulley and ground. Wall saturation at Chancel where downpipe shoe is positioned too high.

- 3.3.2 Condition: Cast Iron Wares are in fair for age. Refurbishment and redecoration of the cast iron wares is due. Porch gulley is blocked; North nave and Tower outlets discharge into ground. There does not at this stage appear to be associated structural movement, this may occur if the current arrangement continues. An alternative to the ongoing commitment of maintaining the cast iron wares is replacement with a pre-finished aluminium system such Alumasc, this will be an initial higher cost with lower future maintenance. Given the building is not listed, this seems a reasonable alternative.

- 3.3.4 Priority D: RAINWATER DISPOSAL SYSTEM CAST IRON WARES:** Service, refurbishment and redecoration during the quinquennium. Carry out adaptations to the Tower and Nave North ground outlets to discharge collected water well away from building.

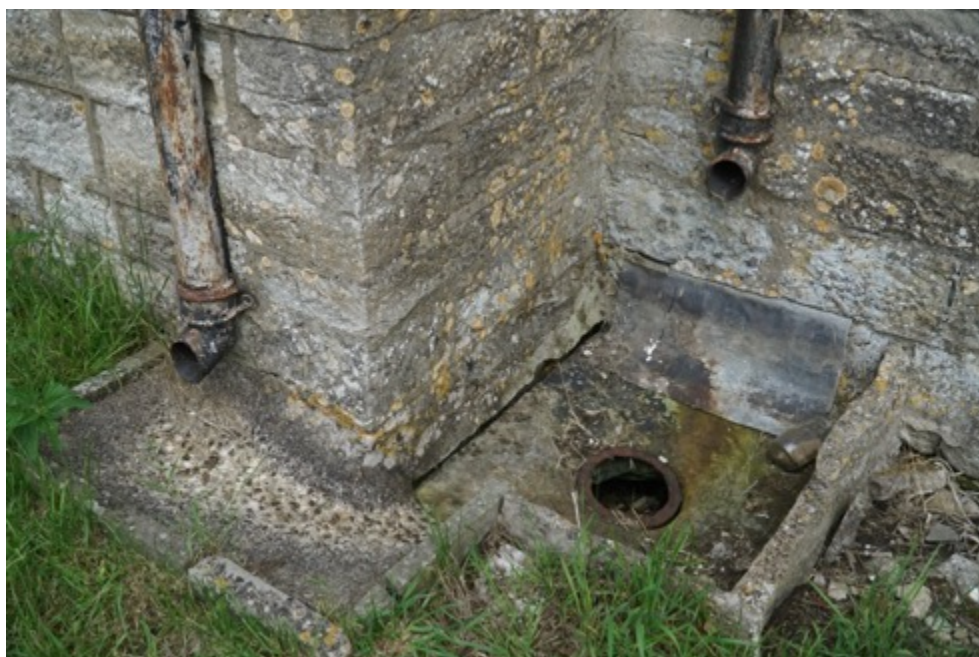
South discharge into gulley collection.

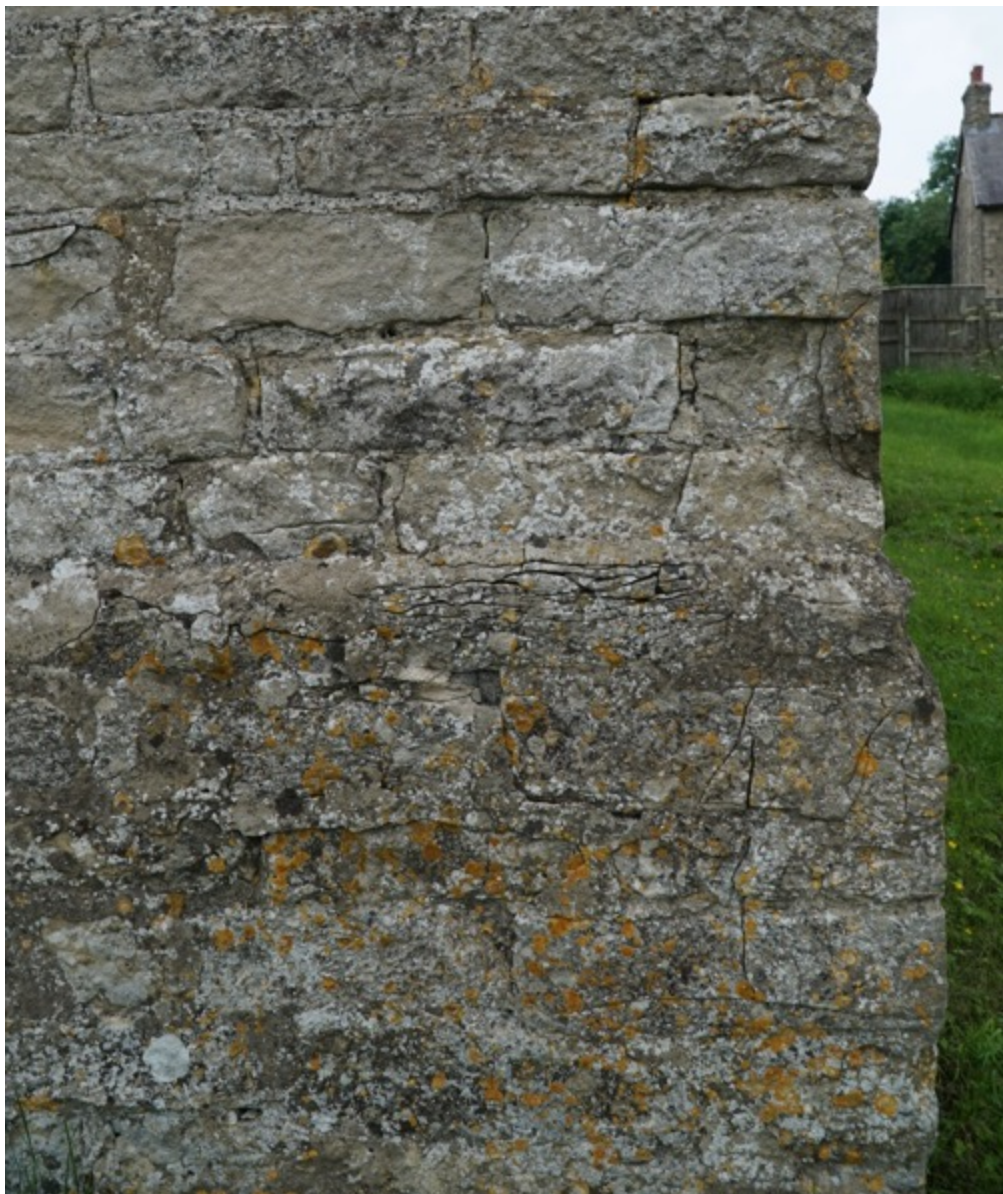
Masonry fracture at Chancel northeast corner. This could be exacerbated by ground substructure movement and ground water

3.6.4 Masonry: The masonry units are in fair condition, there are localised areas where the masonry is delaminating in large section depths up to 4", at the northeast corner of the tower above the nave roof and at the Chancel north east corner. Localised disruption of masonry at Chancel and South Porch gable apex stones which are now more susceptible to water ingress. Some bursting of stone at the Nave east gable upper level. Fractured but stable stone a north nave wall.

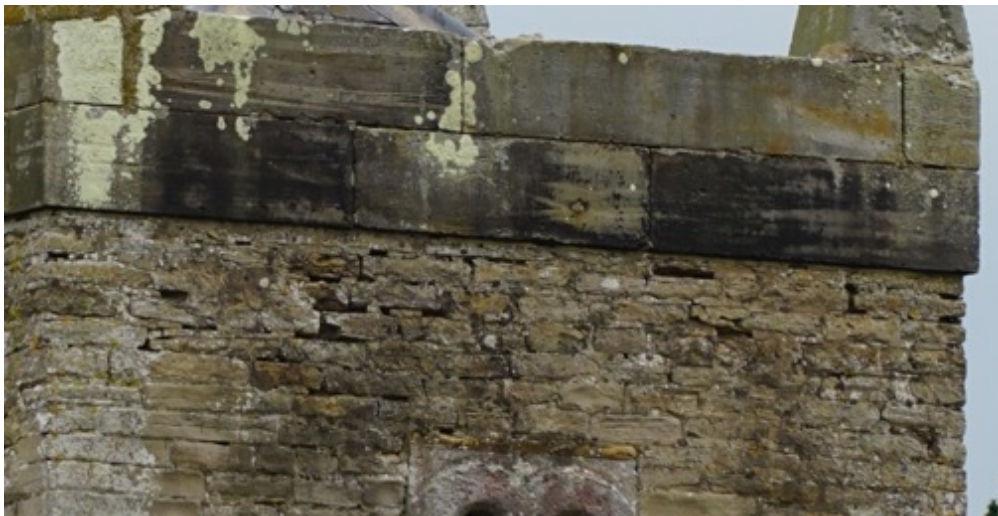
West Tower Open joints and missing masonry to course rubble, open joints at ashlar.

- 3.6.5 Pointing: some areas of localised and defective pointing where cements are deteriorating. The upper 8 courses of the west tower are very open and in poor condition, internally these open joints have been erroneously filled with an expanding foam; this creates a challenging repair issue for the wall head of the Tower, the ashlar parapet is also open and permitting water into the wall head below. The pointing repairs to the high-level masonry of the Tower are the priority for this element of the building. Pointing should only be executed in lime mortars without any Portland cement or other additives. (Lime mortar will help the transfer of moisture out of the wall and masonry and help its preservation). The cement pointing is now entering a phase of detaching from the building, this is not a concern and walls are generally watertight. In due course repointing will be beneficial, some localised spot pointing could be carried out to more vulnerable areas.

- 3.6.9 Priority D: WALLS: MASONRY POINTING: It is recommended that that the open joints to the wall head of the Tower are pointed and missing masonry replaced, including the three square holes at the lower Bell Frame level. If this work is deferred for a significant period could lead to worsening of the wall and loosening of the masonry.
- 3.6.10 Priority D: WALLS: MASONRY POINTING: It is desirable to carry out spot pointing of open joints.

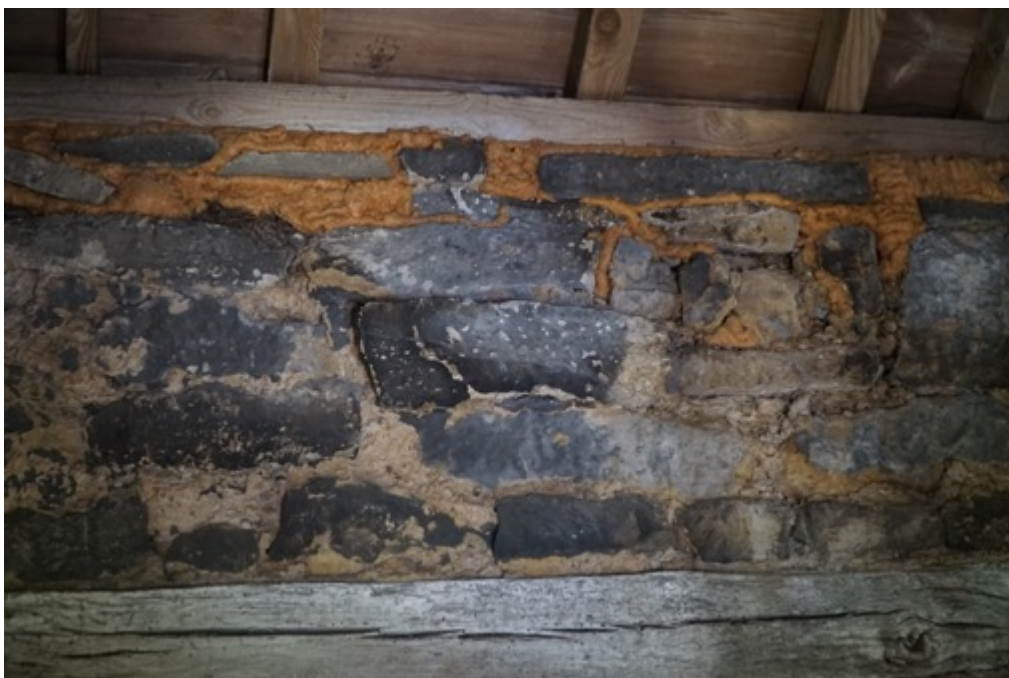
West Tower Open joints filled with adhesive expanding foam – difficult to repair

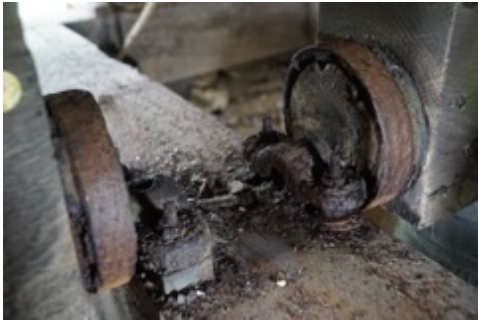
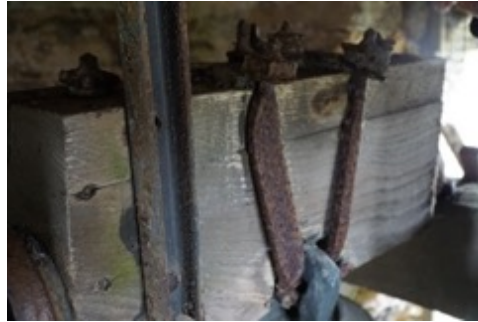
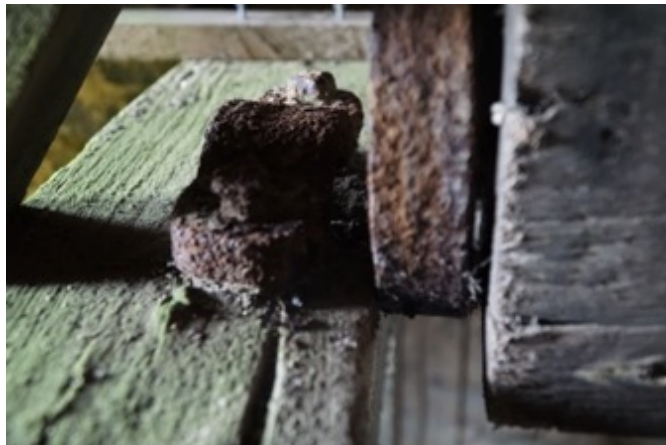
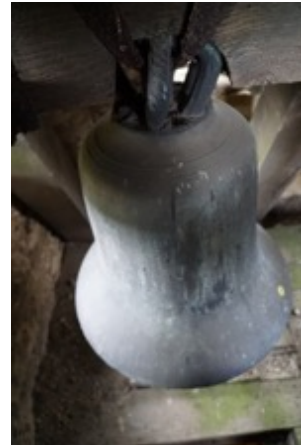
- 5.3.1 Description & Condition: Two bells, small bell circa 1300 (bell is listed by the Council for the Care of Churches as being worthy of preservation), larger bell 1662. Frames, timber three low sided frames in parallel.
- 5.3.2 Condition: Poor condition and will require rehangng to bring back into use. fully seized and unsafe to use. Refer to E. John Arthur 2016 detailed report on the Bells, referring to opportunity for restoration and funding. Repairs should only be undertaken by experienced professionals in the field. Short term recommendation lubrication of gudgeons and bearings and greasing of staples. Programme of Bell restoration and funding options should be considered.
- 5.3.3 **Priority E (Desirable): commence bell restoration project as E John Arthur's report 2016.**

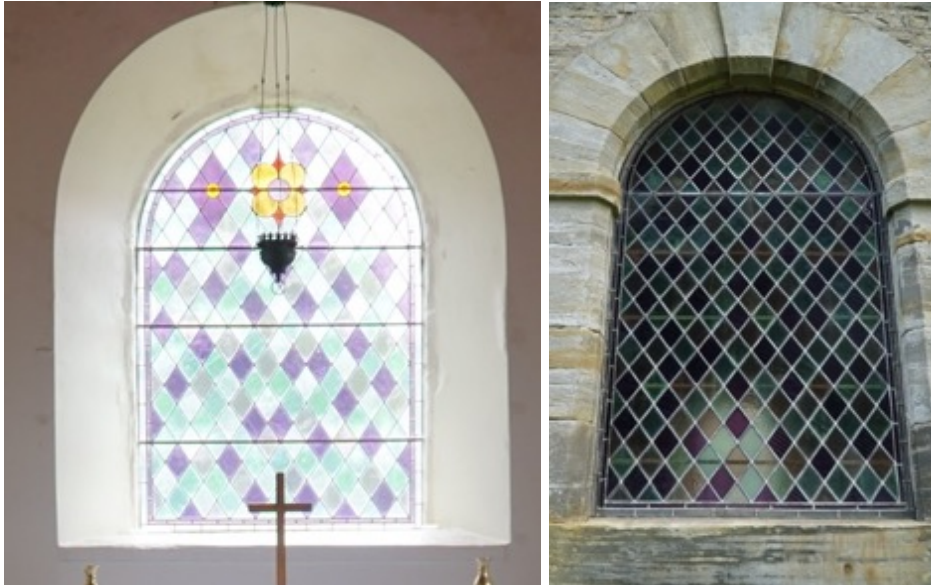
- 6.1.1 Windows are glazed in clear and coloured diamond leaded set in single light round head windows.
- 6.1.2 Glazing, ties, lead matrix and tie bars are all in fair order to all windows. Adequately watertight. Some deterioration to the external mortar pointing which may need attention during the quinquennium if not the next.
