CASE STUDY ELECTRIC HEATING SYSTEM

- Chalgrove, St Mary (Diocese of Oxford) is one of the first in the country to move to fully electric heating based on far-infra-red radiant panel heaters mounted on the nave ceiling, with electric under-pew heaters in the chancel.
- The radiant panels sit unobtrusively within the rafters of this Grade I-listed church. The under-pew heaters in the otherwise unheated chancel ensure that the choir is kept comfortable whilst reducing fluctuations in temperature that might affect the important wall paintings.

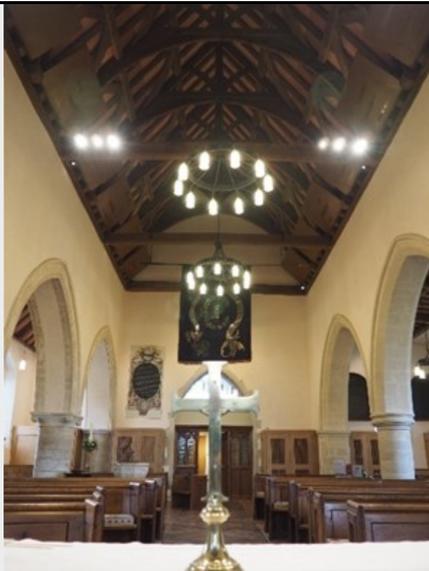
1 The brown rectangles on the nave ceiling are electric far-infra-red radiant panel heaters. They warm the church through a combination of radiant and convective heating. The brown powder-coating was chosen to match the ceiling trusses.

- 16 x 3kW far-infra-red heating panels on the nave ceiling, on metal fixing brackets, powder-coated in brown to match the ceiling trusses.
- 14 x 2kW far-infra-red heating panels on the aisle ceilings, powder-coated in off-white to match the wall plaster.
- 6 x 2kW under-pew electric heaters.
- 3 heating zones: nave, north aisle and south aisle, plus timers for the chancel heaters.

In theory these panels should warm by radiant heating alone, i.e. warming the surfaces that the radiation from the panels reaches. Radiant heating is very responsive, requiring little warm-up time, and so uses less energy than conventional space heating. **However**, perhaps because they are mounted so high up, the church team finds that it needs to keep the panels on for longer periods: this makes them more like conventional convective heaters, warming the air of the church, and reduces their efficiency.

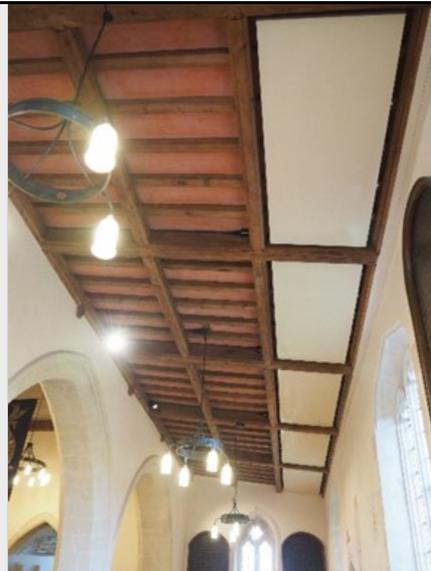
2 The radiant panels on the north and south aisle ceilings are powder-coated off-white to match the walls. They are controlled by a separate set of controls to the nave, allowing the areas to be heated separately.

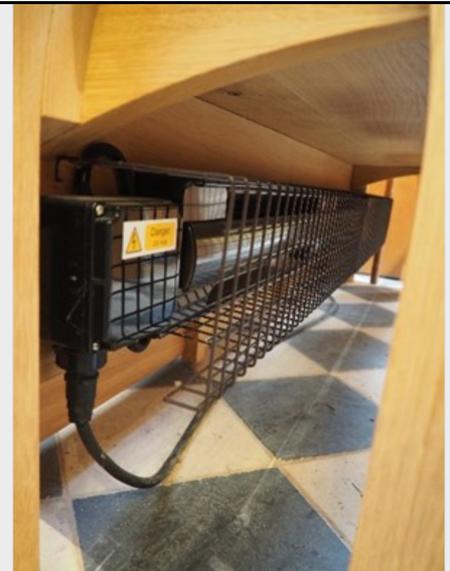
3 New choir stalls in the chancel house electric pew heaters that warm the user from below. The heaters are turned on for half an hour during the service, to keep the choir comfortable.

The chancel heating is very successful: the under-pew heaters keep the choir comfortable without attempting to warm the whole space. This also limits excessive heating and cooling of the medieval wall paintings. The heaters run for 30 minutes during the service and have an automatic cut-off.
