Church Buildings Report PM 2384
 Leeds, Richmond Hill, All Saints
 (646373)

PART 1 : Summary

PART 2 : Detailed assessment and significance

IMAGE SHEET

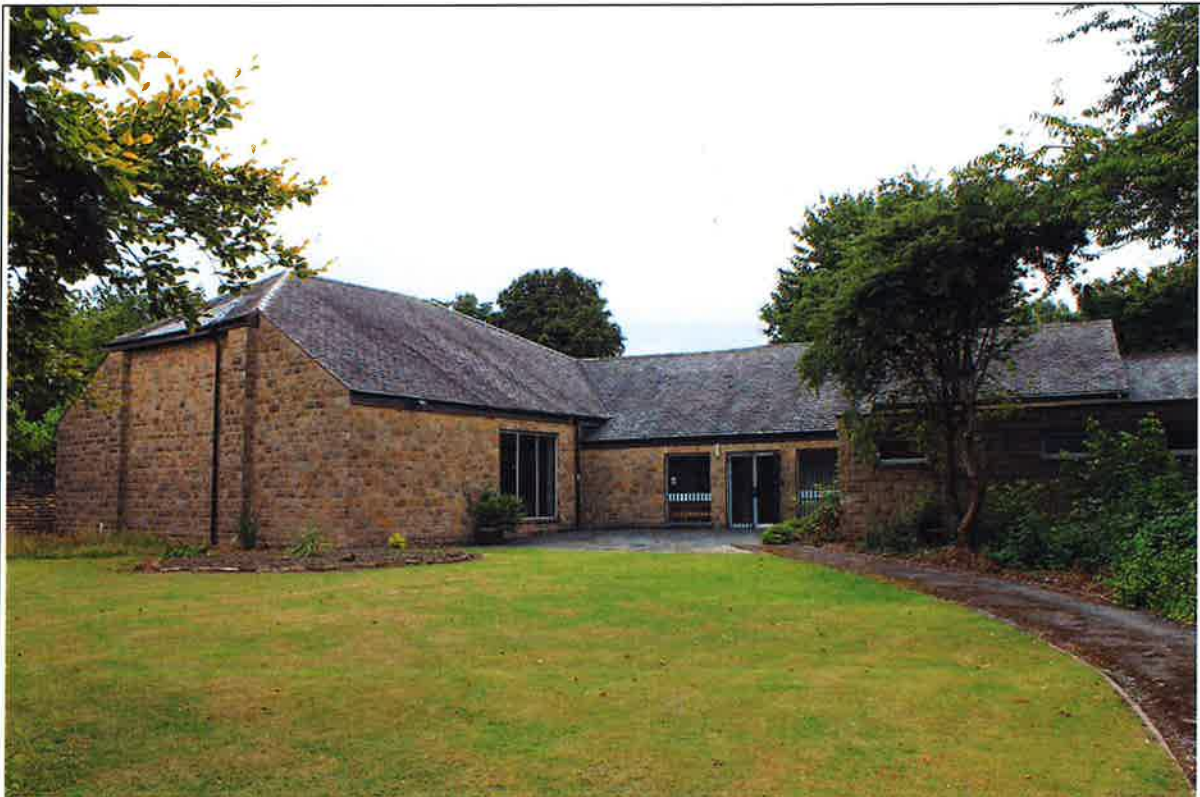
Exterior view of south elevation from churchyard on north side (worship area is to the left).

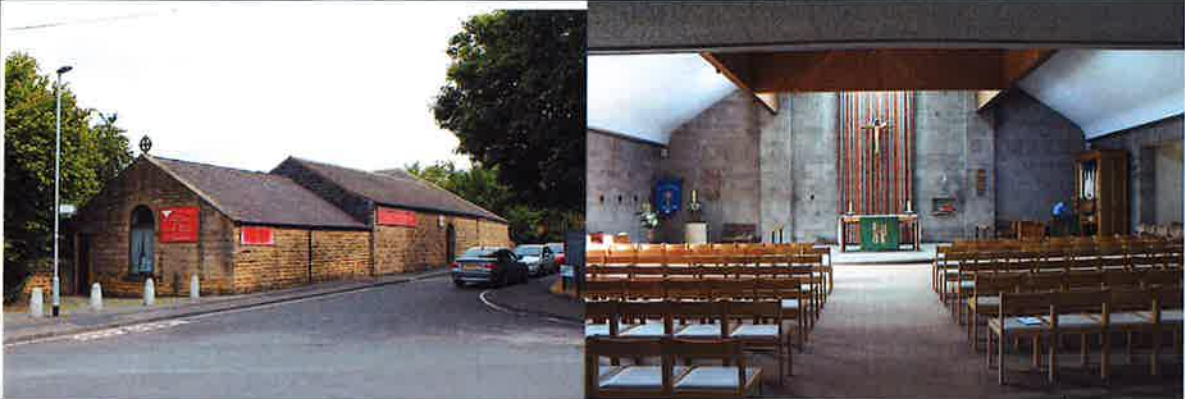
<p>From Cross Aysgarth Mount the single storey structure poses a long windowless stone elevation with slightly varying rooflines. The L-shaped building has three main parts. A lower gabled section to the geographical west is the hall building, with a doorway and central round-headed window in the elevation facing the road junction. A stone cross finial marks the apex. Then a slightly higher gabled section has a round-arched gateway in the centre which opens into a passageway leading to the lobby. Extending geographically north from here is the worship space. In addition to the north side of the hall is a flat-roofed extension containing kitchen and WCs.</p> <p>From the carpark and churchyard, the worship area can be appreciated in full. Its design has a barn-like quality. The stone has been nicely dressed. The liturgical east (geographical north) elevation is windowless and has two buttresses. The only windows are French doors in the liturgical north elevation. The lobby area in the join between the hall and the worship area is lit and accessed through French windows with an additional side window, both with security bars.</p>	<p>Exterior</p>

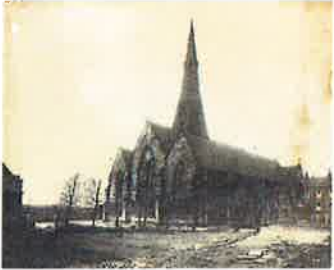
<p>Images of the old church</p>	<p>The original stone church of All Saints, Leeds was built 1849-51 by Mallinson and Healey. The decision was made to replace it in light of the need for major repair to the spire. The Council for the Care of Churches produced a pastoral measure report in 1971 (PM 213) in which it expressed its concerns over the proposed demolition.</p>

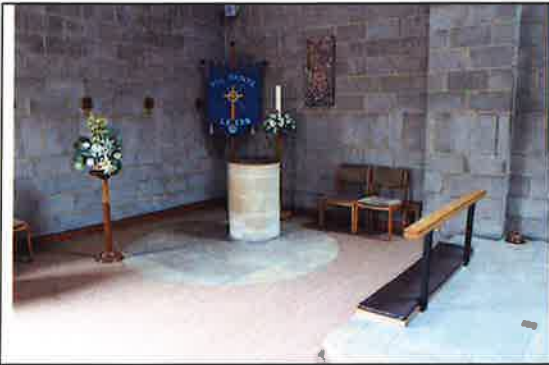
Font

<p>Circular stone drum with flat wood cover with iron scrollwork. The cover relocated from the old church.</p>	<p>L</p>
<p>Reredos</p>

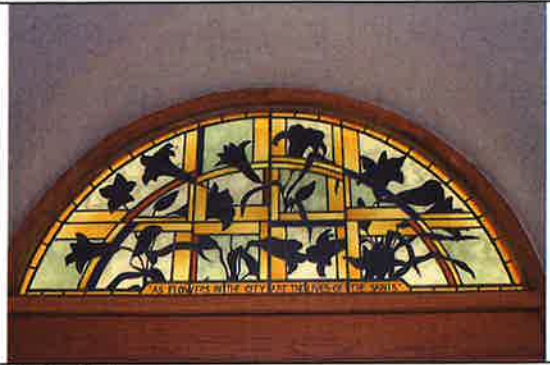
Monuments	None	
War memorials	A chalice is inscribed in memory of lives lost in WWII.	L
Stained glass	A semi-circular panel above the lobby door, installed c.1985 commissioned by a previous incumbent.	L

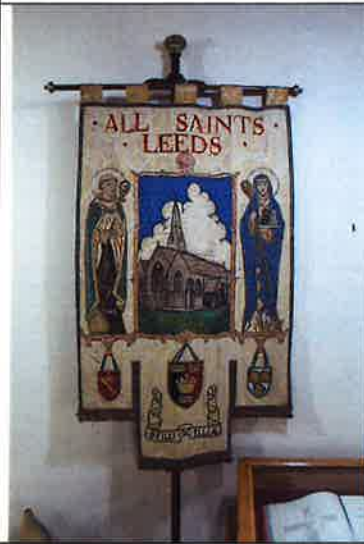
Registers	Those before 1948 are stored in archives	
Miscellanea	<ul style="list-style-type: none"> • Banner relocated from former church, embroidered with an image of the original building. • Small stations of the cross – metal on wood grounds – fixed to north wall. • Priests' desks. • Processional crosses and wooden candleholders relocated from old church. 	L

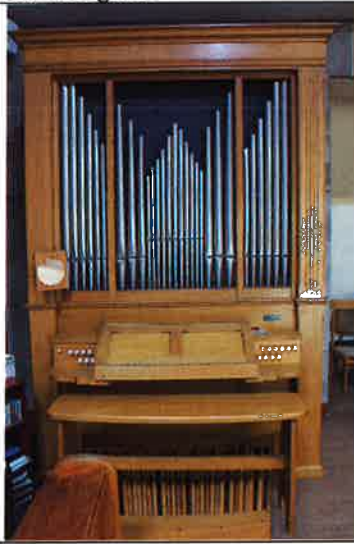
<p>2 manual organ by Wood of Huddersfield, c.1980. Not historically interesting but not a bad instrument and worthy of relocation.</p>	<p>L</p>

CHANGE TO THE CONTENTS (REMOVAL / RELOCATION)
Constraints: <ul style="list-style-type: none"> • Contents relocated from previous church such as banner and prayer-desk have local historic significance. • Organ merits relocation.
Scope for change, potential impact and possible mitigation: <ul style="list-style-type: none"> • Good. Organ and contents of local historic interest should be preserved by relocation if possible. A photographic survey of the building should be made prior to any removal of contents and deposited in the diocesan archive.

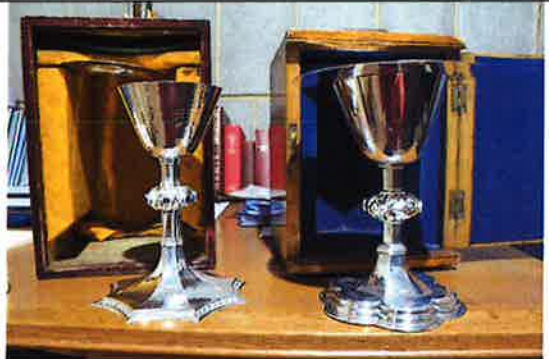
Communion plate	Various including: chalice and paten dated 1898 inscribed All Saints Church and signed Pratt & Sons; chalice and paten dated 1893 inscribed in memory of Sarah Lumb, and another chalice (with paten) inscribed in memory of those who lost lives in war between 1939 and 1945.	L
