Ruined Churches

Ruined Churches – Problem or Opportunity?

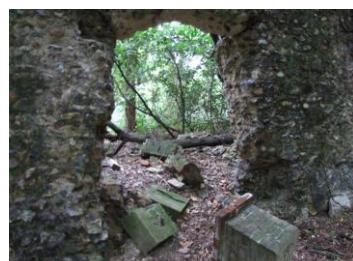
The effects of uncontrolled erosion

Birds, animals and insects burrow into and undermine ruined walls, and vegetation can undermine foundations and lever walls apart. The roots of trees can run inside the core of walls, and climbing plants penetrate and cloak masonry.

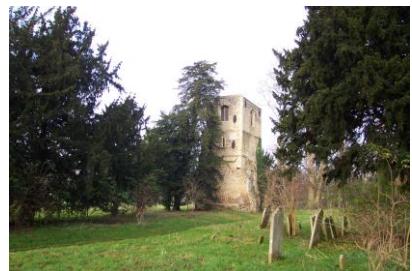
Thundridge Old Church

The Medieval tower is all that remains of the church which once stood here, but the underground remains of the rest of the church survive, and there are burials since the early medieval period within the well-defined churchyard. There have been various schemes to build a dwelling onto the tower, which have obvious archaeological and aesthetic implications. However, such solutions

Example 2: The tower of the Medieval church at Thundridge (Diocese of St Albans) is within a moated enclosure which is a Scheduled Monument. This isolated ruin is near to walking paths and has been regularly affected by low-level vandalism.

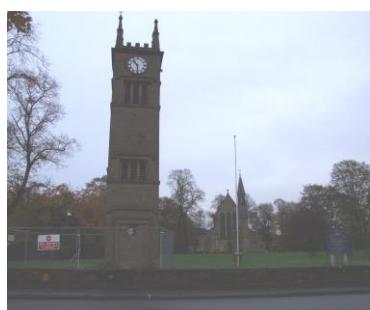
The old church tower at Ringley

The tower incorporates material from the early 17th-century chapel, the first building on the site, which was rebuilt by Richard Lane in 1826. The chapel was demolished except for the tower when the “new” church, seen in the background, was built in 1854. It is now used as a clock tower, and preserved as part of the Ringley Conservation Area.

Example 2: The early 18th-century tower within the churchyard of the Victorian church at Ringley (Diocese of Manchester) is now looked after by the local authority.

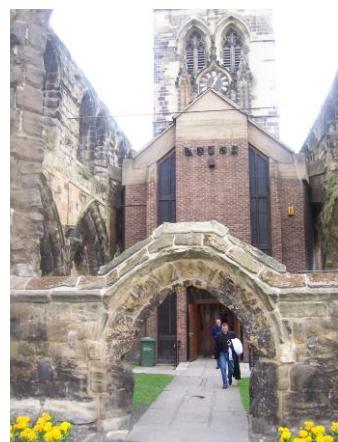
Pontefract All Saints – church within ruin

It was re-used with a new church built within the shell in 1831, expanded in the 1960s. Recently an ambitious project has been started to build a new worship space and community centre within the ruined walls.

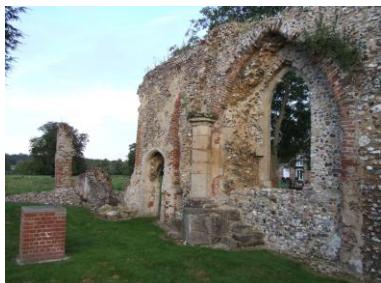
West Raynham, St Margaret with new altar

Example 3: The ruined Medieval church of St Margaret in West Raynham (Diocese of Norwich) has been consolidated with an English Heritage grant and brought back into occasional use for worship with an open air altar. It is very well maintained by the village community.
