Rochester Cathedral: Roof Repairs (1 project funded in 3 phases)

Awarded a total of £832,000 between November 2014 and July 2016

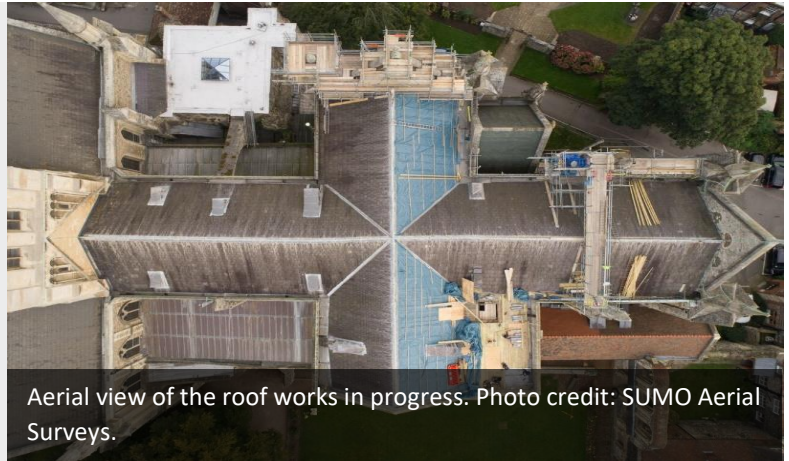
Aerial view of the roof works in progress. Photo credit: SUMO Aerial Surveys.

The work started with the repair of the library roof, addressing damaged roof slates, lead flashings and rainwater goods on slopes to the east of the central tower. The second phase, which began in September 2014, consisted of repairs to the nave roof, the flat roof of the choir store and numerous smaller areas of roofing, alongside the cleaning and repairing of guttering. The Gundulf tower was also de-vegetated and repointed and a new skylight was installed. The third phase of the works consisted of repairs to the eastern roof of the cathedral, which includes the quire, quire transepts and presbytery roofs. They have all been re-covered, gutters have been reconfigured and renewed and some masonry repairs have taken place, principally repointing of copings and flashings.

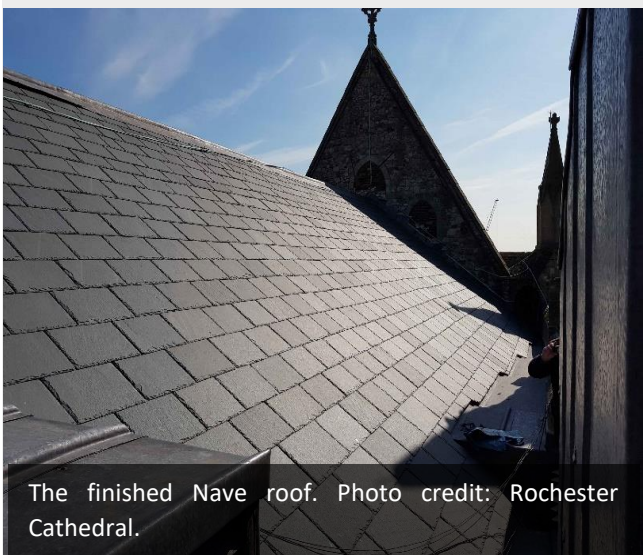
The finished Nave roof. Photo credit: Rochester Cathedral.
